Cozy Building Compliance

Pre-Purchase House Inspection

ADDRESS:	Sample report
CLIENT:	Young
AGENT:	Sample
INSPECTION DATE & Weather Conditions:	
PEOPLE PRESENT:	Buyer
TENANTS DETAILS:	The property was vacant at time of inspection.

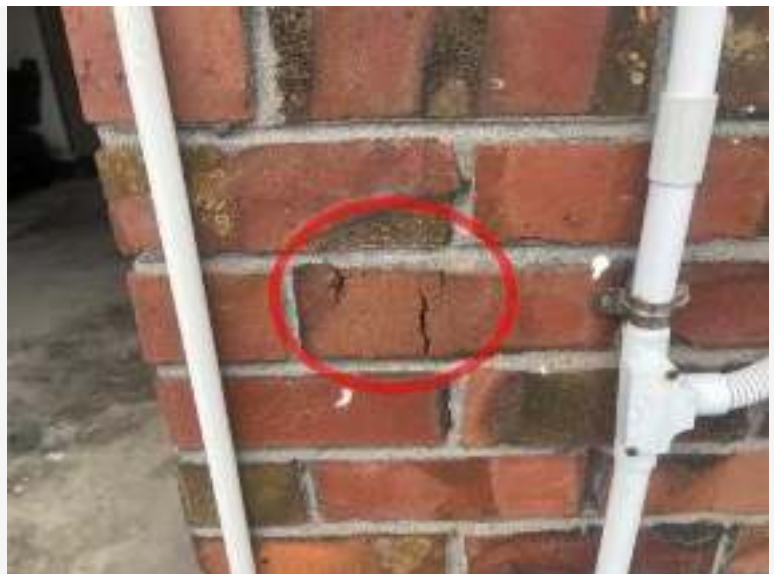
Minor cracking was observed to the brick wall/brickwork at the time of inspection (including small cracks to bricks and/or mortar joints). Minor cracking can occur due to normal building movement, mortar shrinkage, thermal expansion/contraction, and age-related wear.

Recommendation
Monitor the cracking for any changes (widening, lengthening, "stepping" cracks, or new cracks developing). Where appropriate, arrange repointing/sealing of affected mortar joints to reduce water ingress. If cracking worsens, appears widespread, or there is visible displacement, engage a suitably qualified builder for further assessment. A structural engineer may be required if significant movement is suspected.

Trades to engage: Bricklayer/mason (repointing/repair); Builder (assessment); Structural engineer (if movement appears significant).

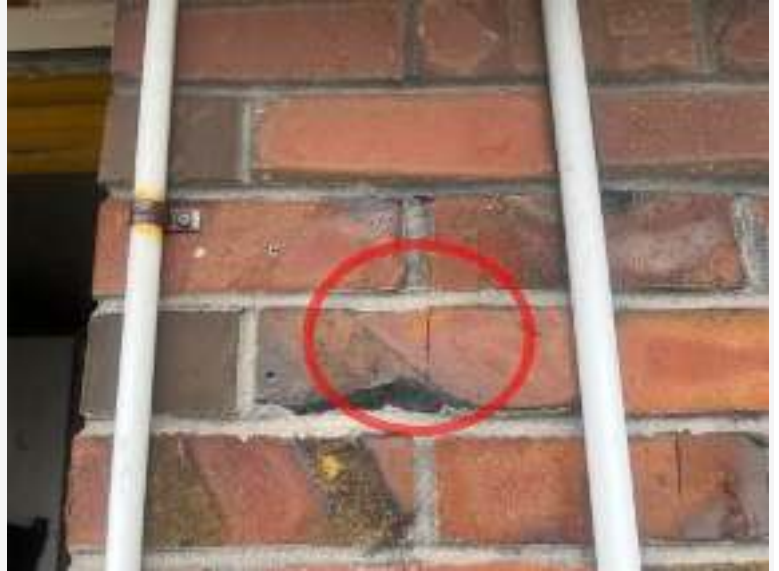
Minor cracking was observed to the brick wall/brickwork at the time of inspection.

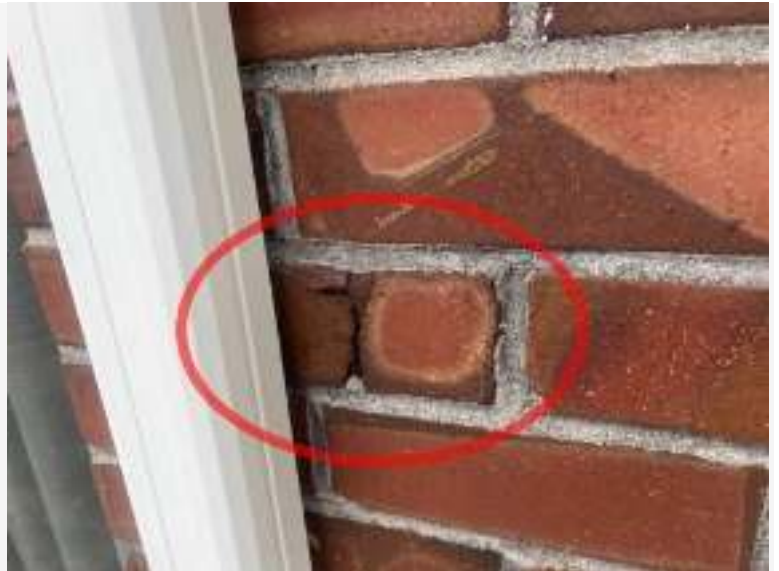
Minor cracking was observed to the brick wall/brickwork at the time of inspection.

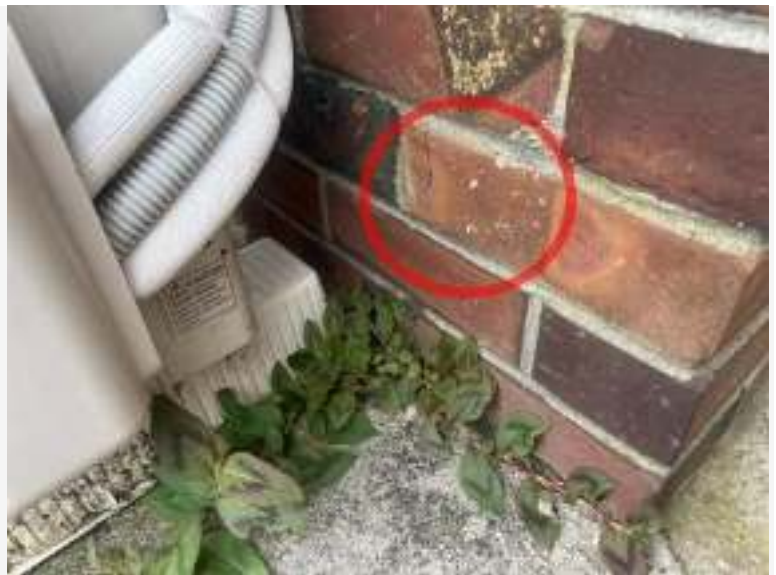
Vegetation growth was observed at the bottom of the brick wall. This typically indicates the area is staying damp and/or debris/soil has built up against the wall, allowing plants to take hold.

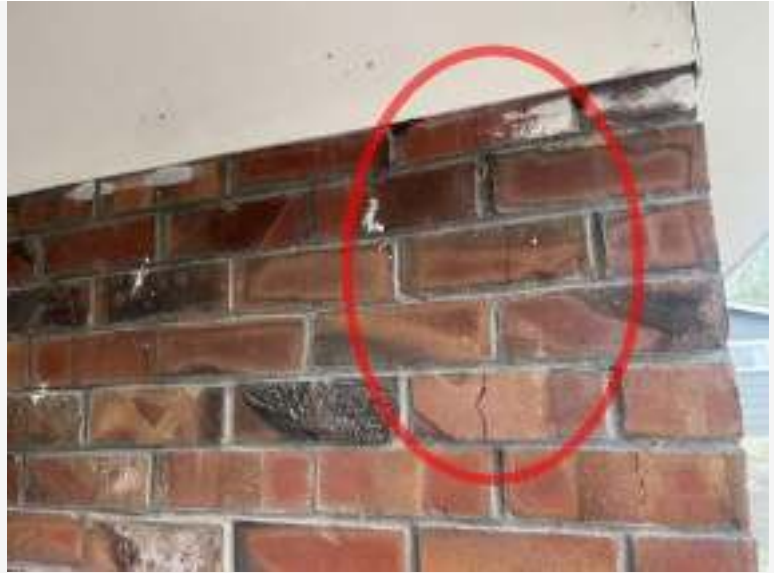
Minor cracking was observed to the brick wall/brickwork at the time of inspection.

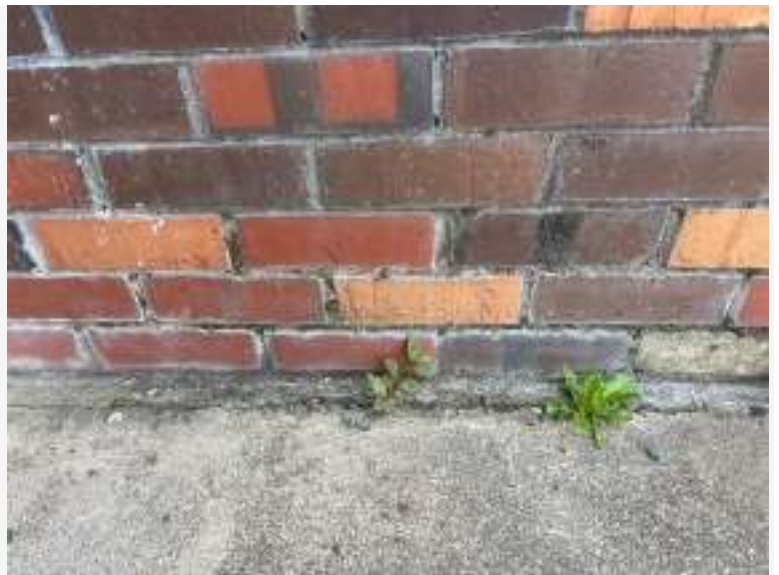
Vegetation growth was observed at the bottom of the brick wall. This typically indicates the area is staying damp and/or debris/soil has built up against the wall, allowing plants to take hold.

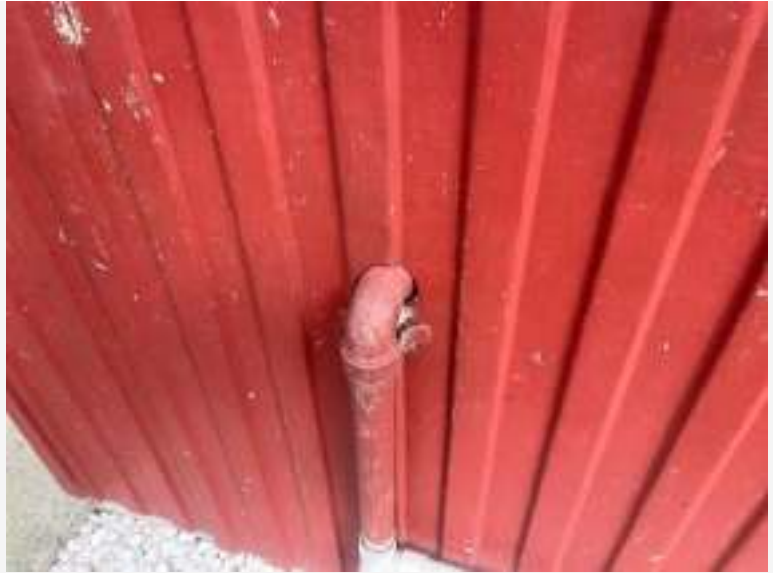
Pipe penetrations through the exterior cladding were observed.

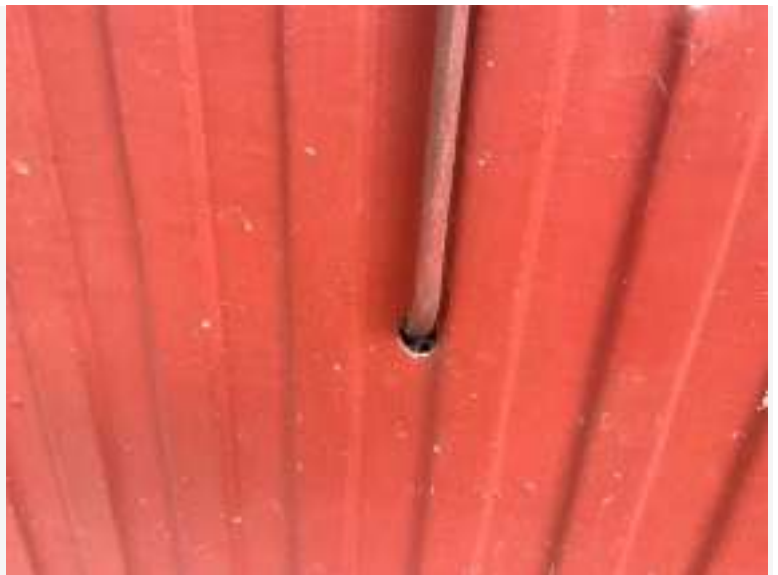
Pipe penetrations through the exterior cladding were observed.

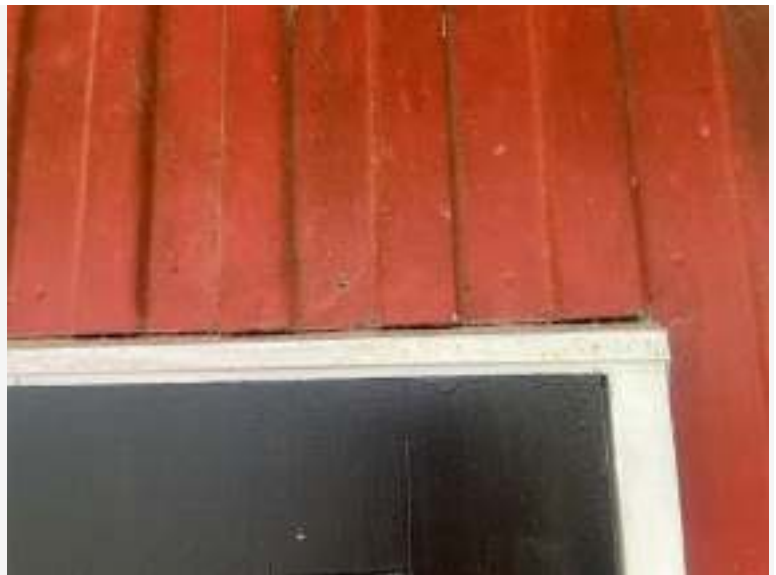
At the time of inspection, there appeared to be no sufficient gap/clearance between the head flashing and the cladding at the top of the opening. A small clearance is generally important so water can drain and drip clear of the wall, and so capillary action does not draw moisture back into the cladding/junction. Where cladding is tight against flashings, moisture can be trapped, which may increase the risk of water ingress and premature deterioration of cladding/paint systems.

This inspection is visual only. The condition of concealed underflashings/building wrap, fixings, and any hidden moisture damage cannot be confirmed without further investigation.

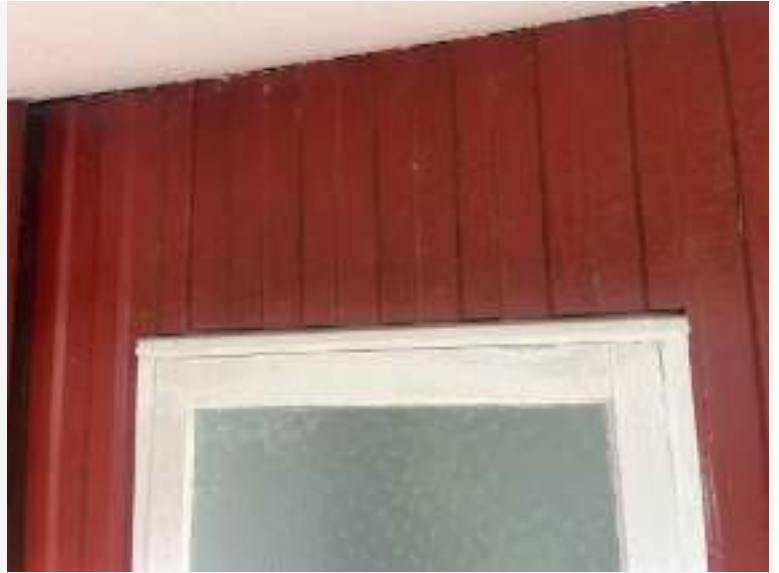
At the time of inspection, there appeared to be no sufficient gap/clearance between the head flashing and the cladding at the top of the opening.

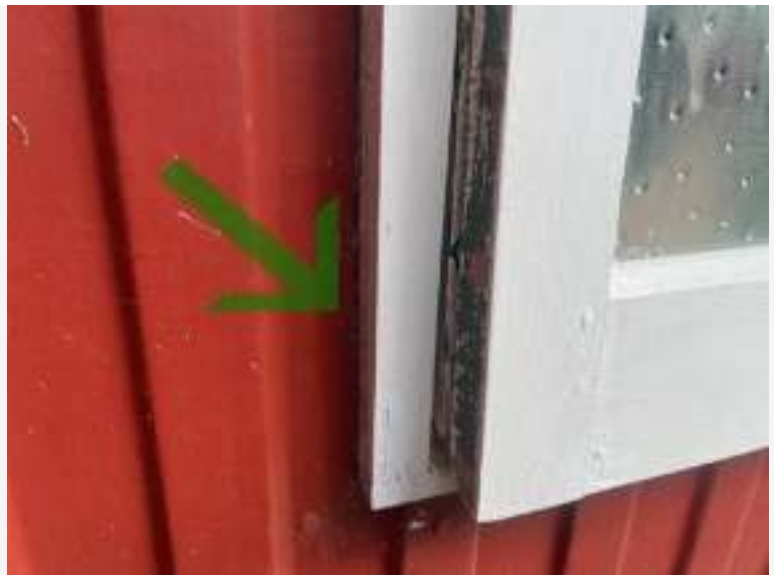
A gap was observed between the exterior cladding and the window jamb/trim at the time of inspection.

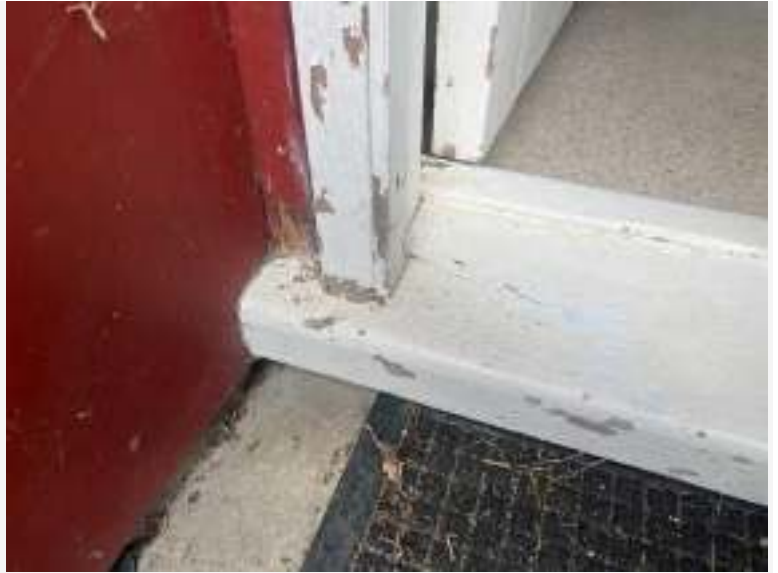
The paint finish was observed to be aged with areas of peeling/flaking at the time of inspection.

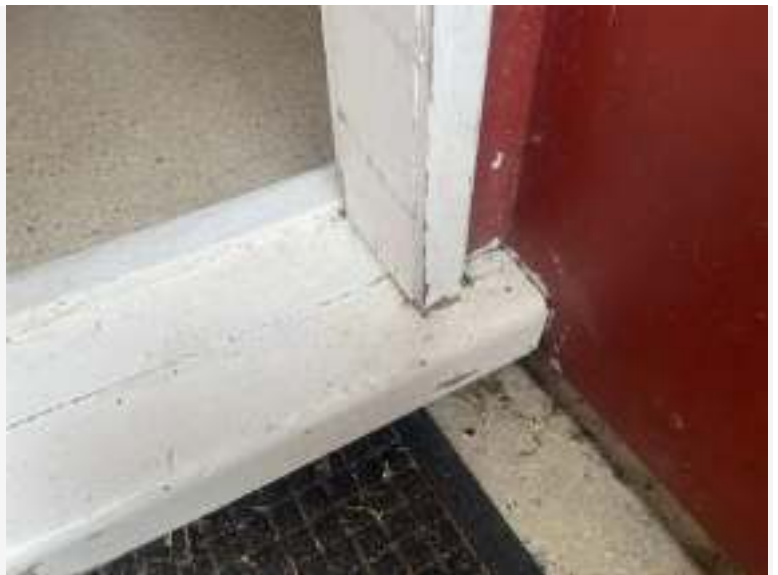
The paint finish was observed to be aged with areas of peeling/flaking at the time of inspection.

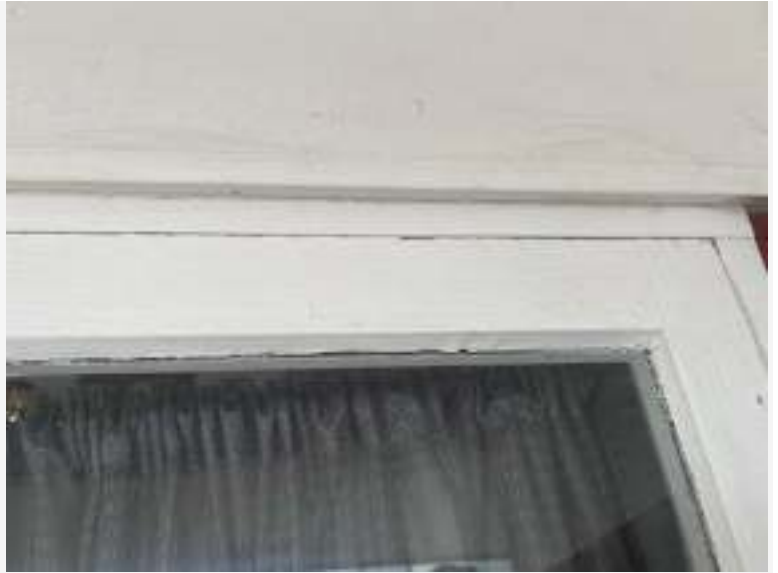
The paint finish was observed to be aged with areas of peeling/flaking at the time of inspection.

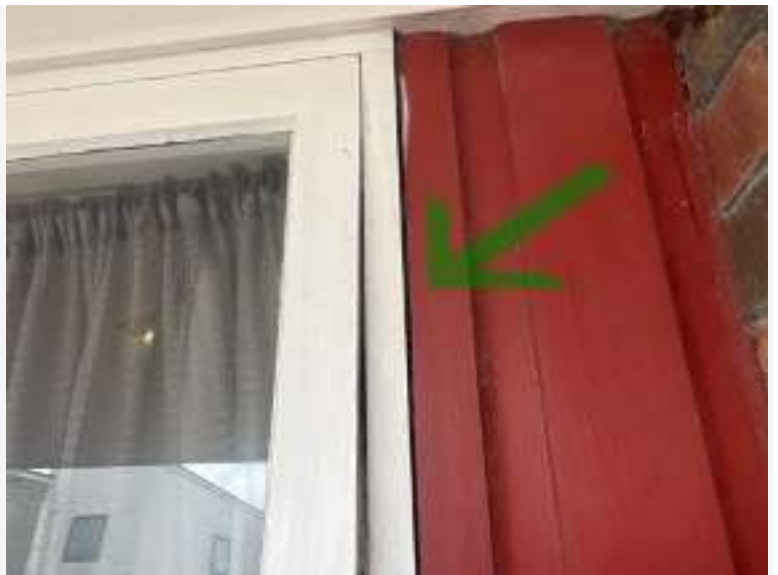
A gap was observed between the exterior cladding and the window jamb/trim at the time of inspection.

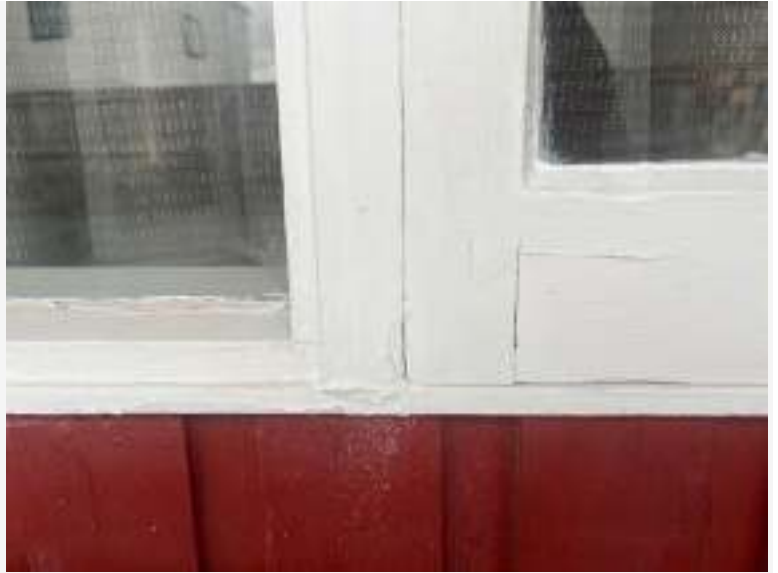
The paint finish was observed to be aged with areas of peeling/flaking at the time of inspection.

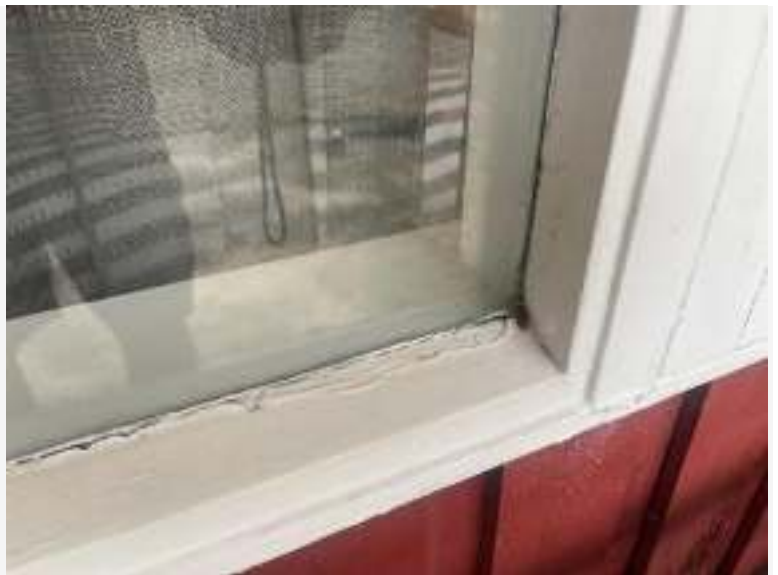
The paint finish was observed to be aged with areas of peeling/flaking at the time of inspection.

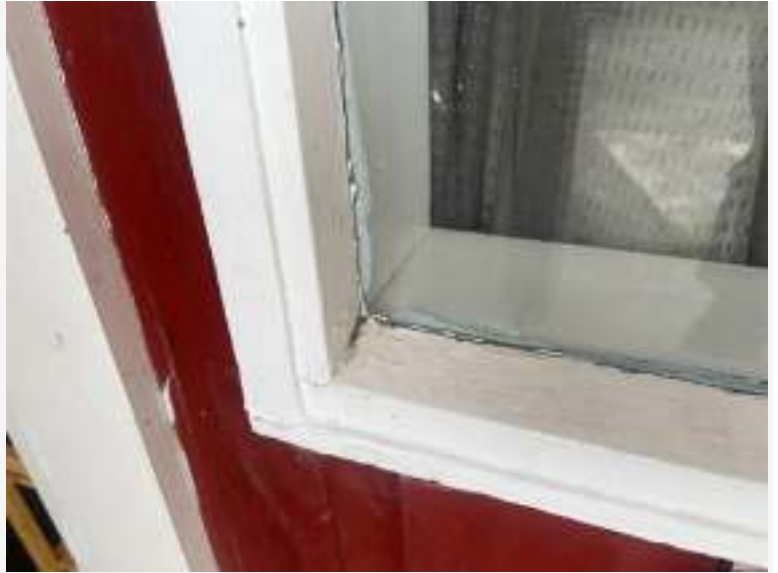
The paint finish was observed to be aged with areas of peeling/flaking at the time of inspection.

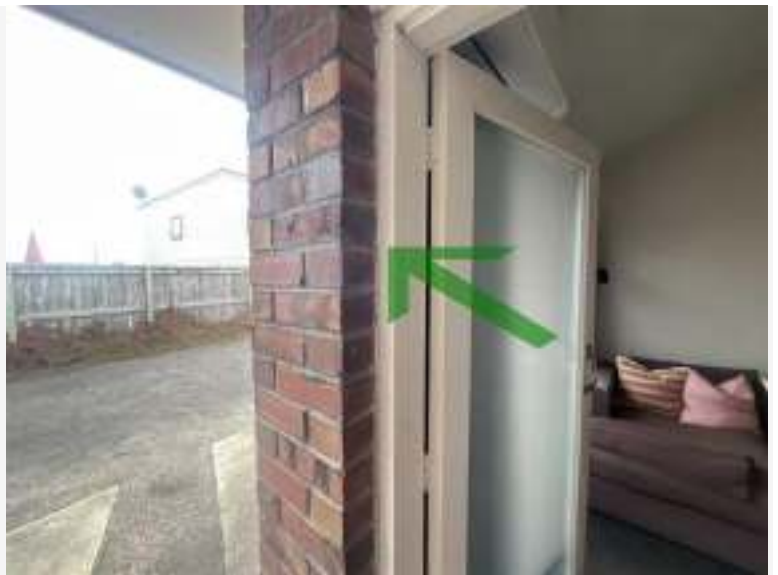
A gap was observed between the exterior cladding and the door jamb/trim at the time of inspection.

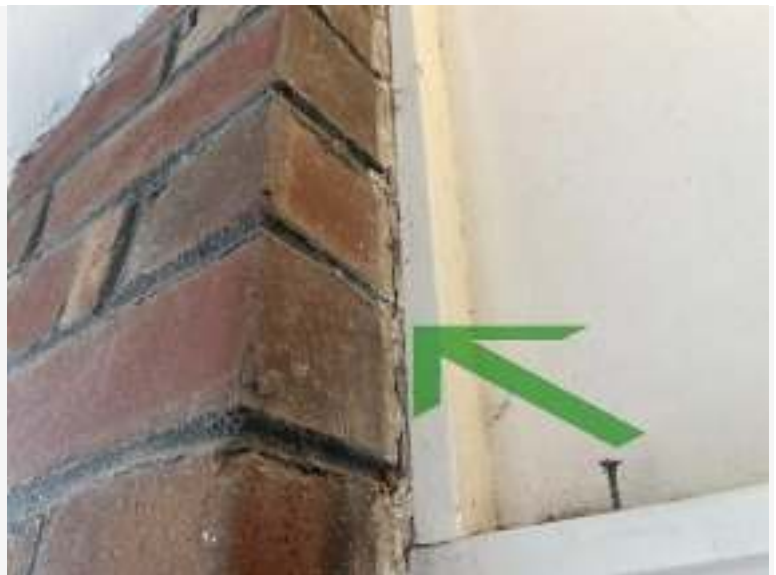
A gap was observed between the exterior cladding and the door jamb/trim at the time of inspection.

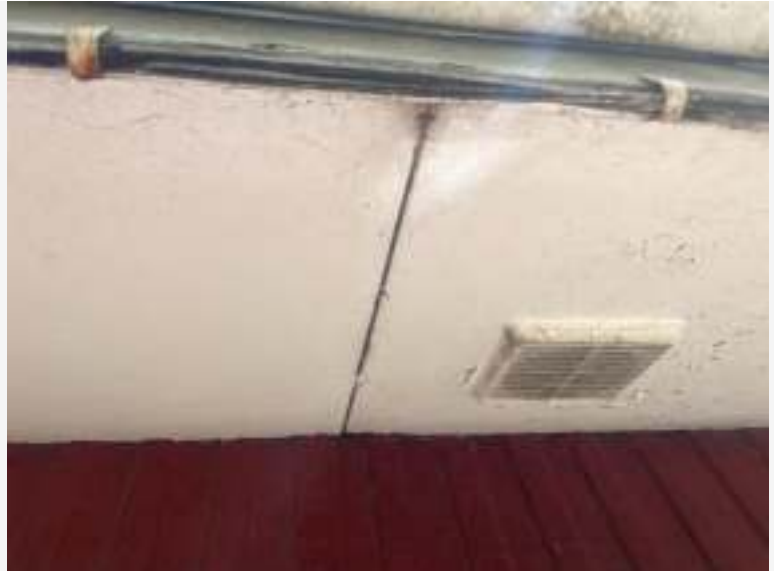
The soffit/eaves lining paintwork
was observed to be aged with areas
of peeling/flaking at the time of
inspection.

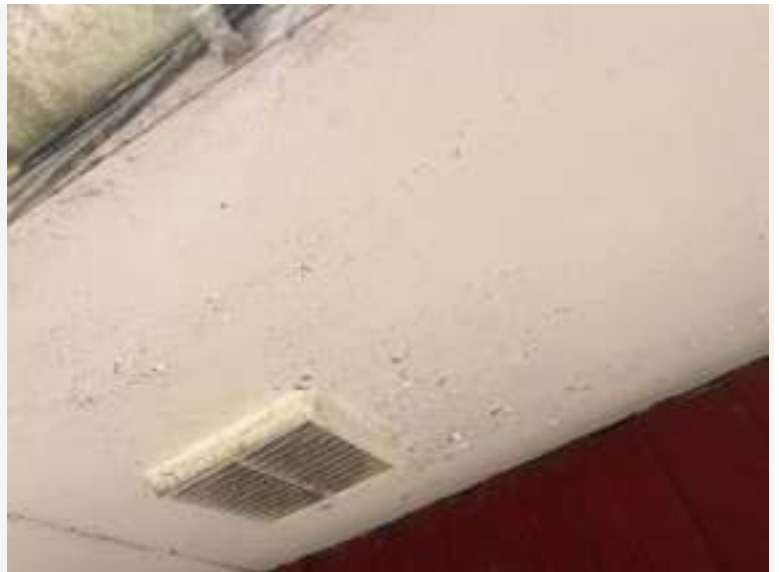
The soffit/eaves lining paintwork
was observed to be aged with areas
of peeling/flaking at the time of
inspection.

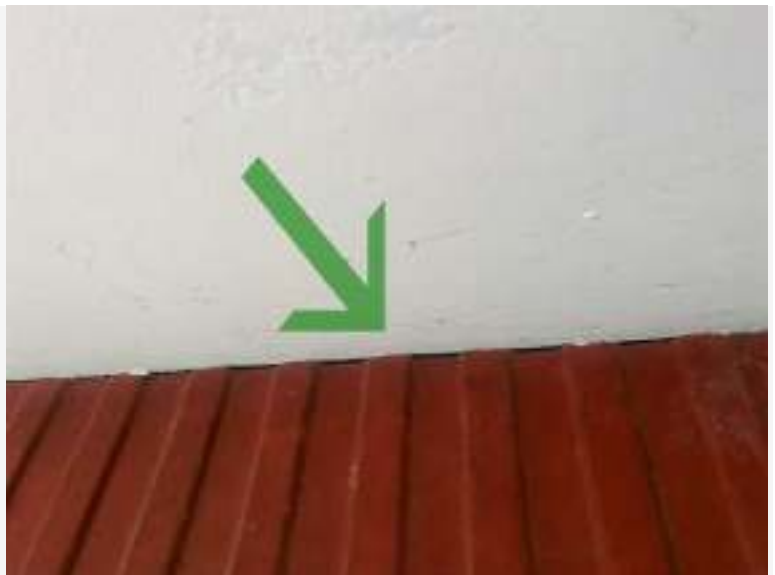
A gap was observed between the soffit (eaves lining) and the exterior cladding at the time of inspection.

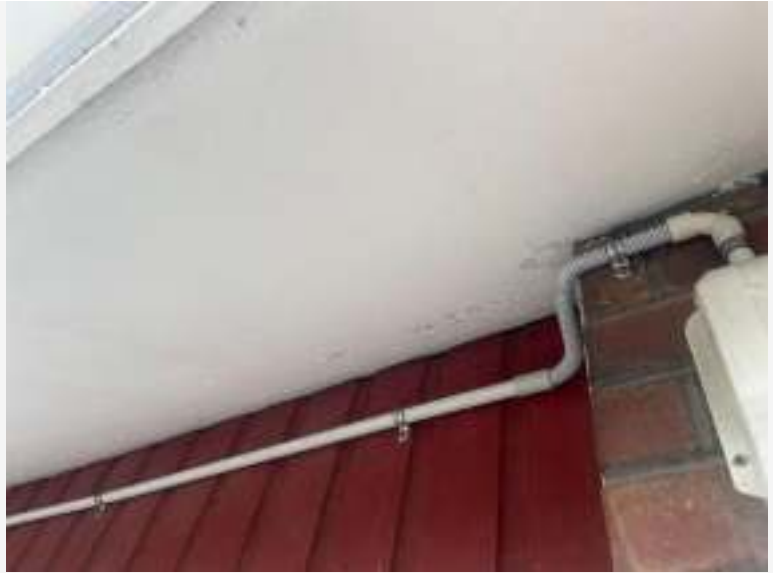
The soffit/eaves lining paintwork was observed to be aged with areas of peeling/flaking at the time of inspection.

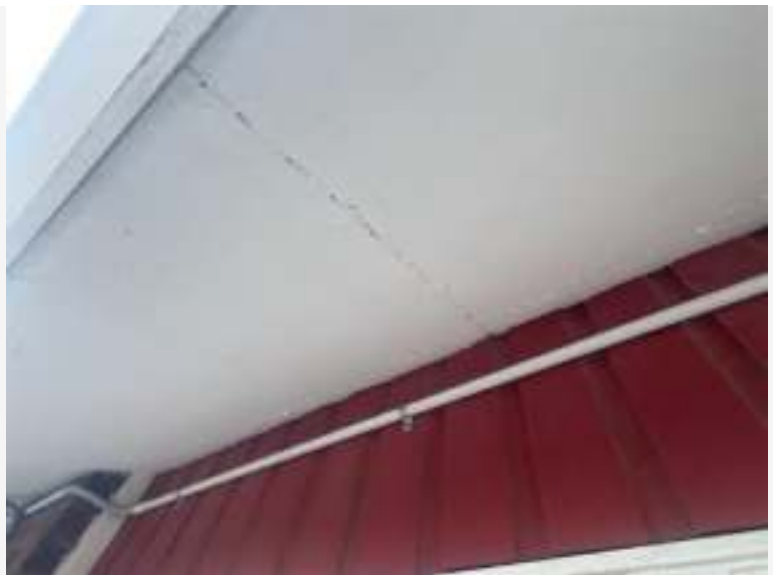
The soffit/eaves lining paintwork was observed to be aged with areas of peeling/flaking at the time of inspection.

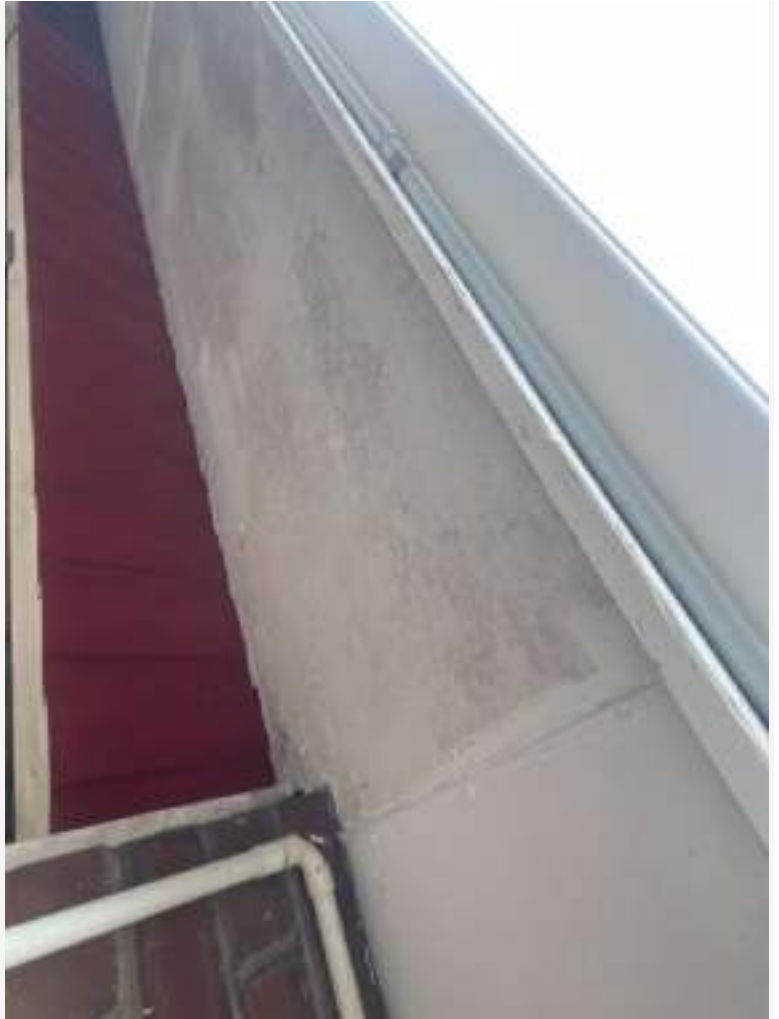
The soffit/eaves lining paintwork was observed to be aged with areas of peeling/flaking at the time of inspection.

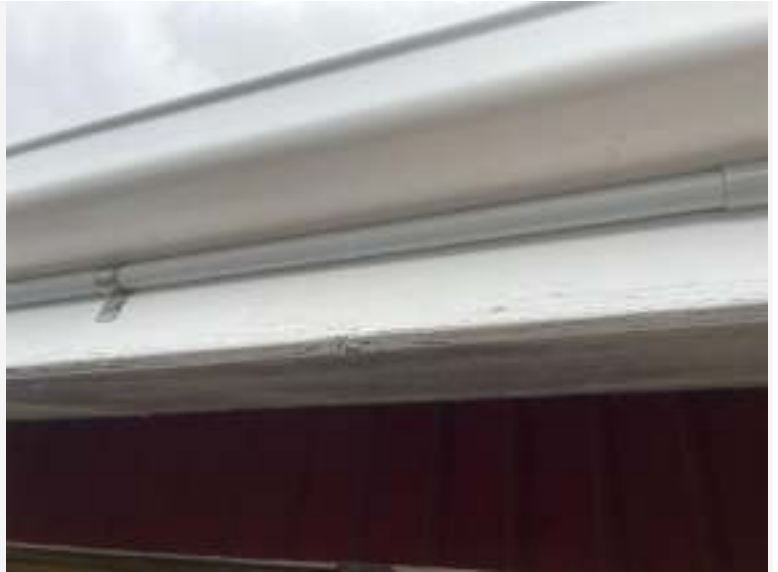
The fascia paintwork was observed to be aged with areas of peeling/flaking at the time of inspection.

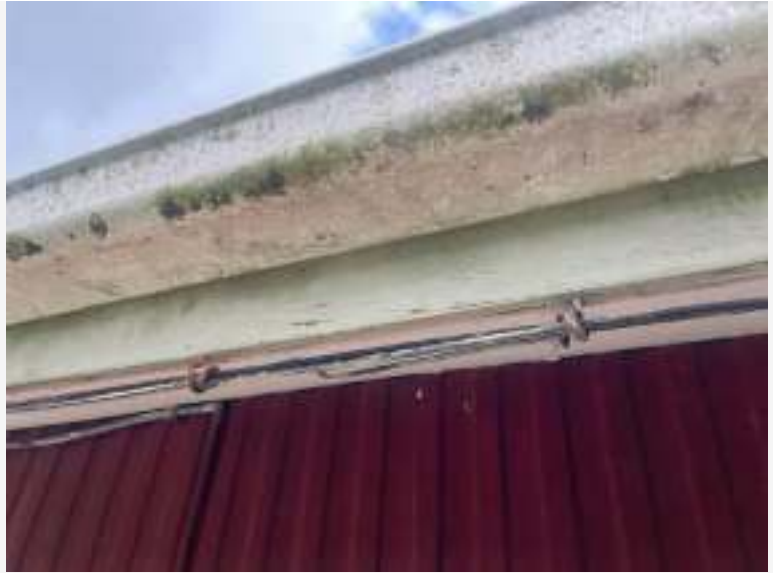
The fascia paintwork was observed to be aged with areas of peeling/flaking at the time of inspection.

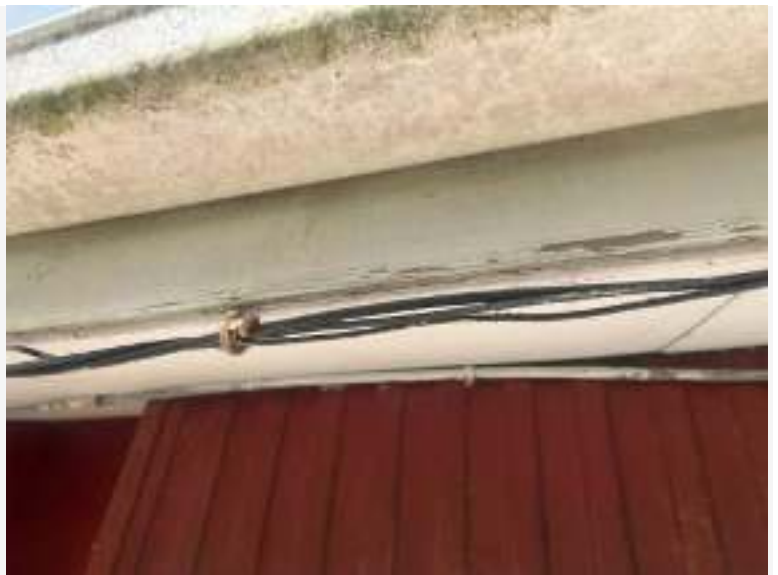
The fascia paintwork was observed to be aged with areas of peeling/flaking at the time of inspection.

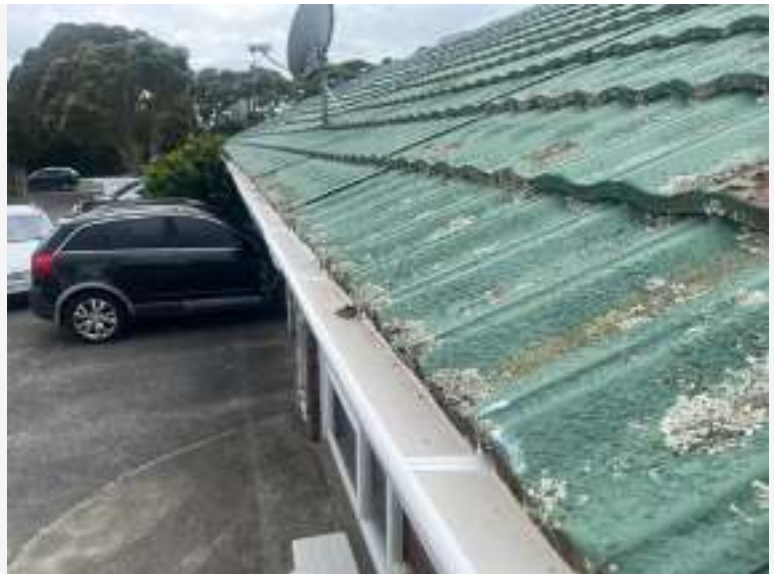
A blockage/build-up of debris was observed in the rear guttering at the time of inspection.

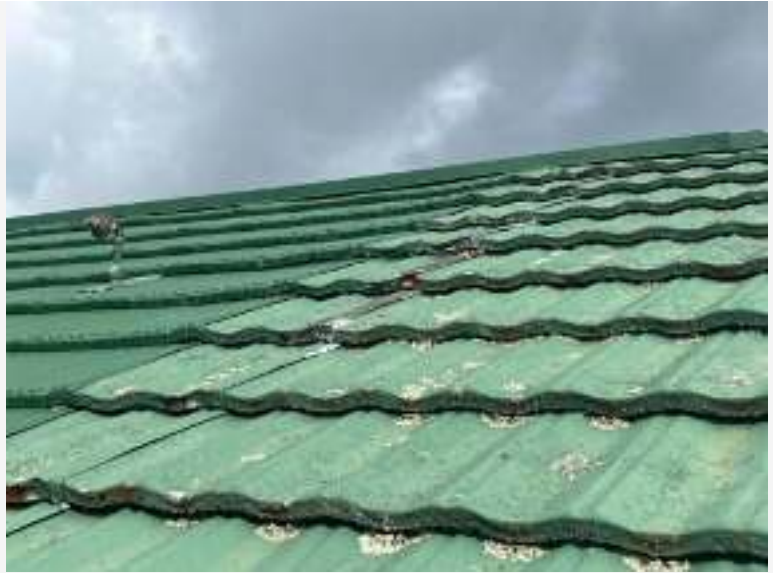
Lichen growth was observed on the roof surfaces at the time of inspection.

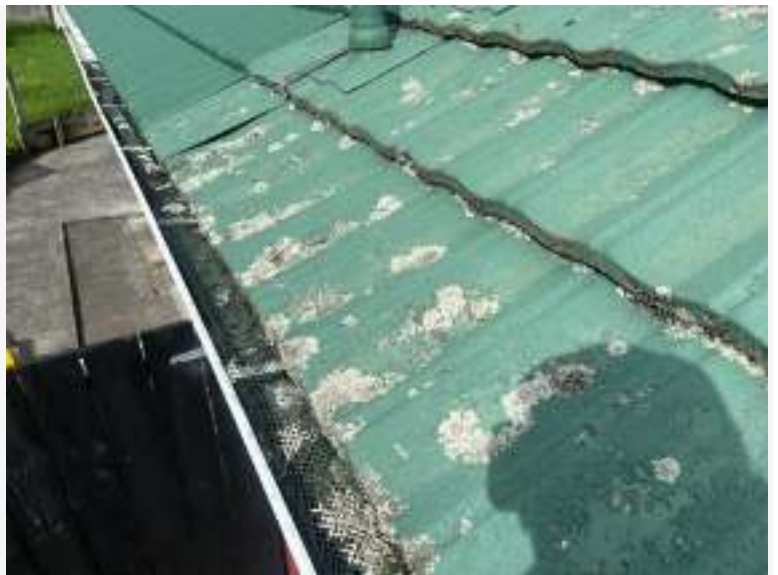
Lichen growth was observed on the roof surfaces at the time of inspection.

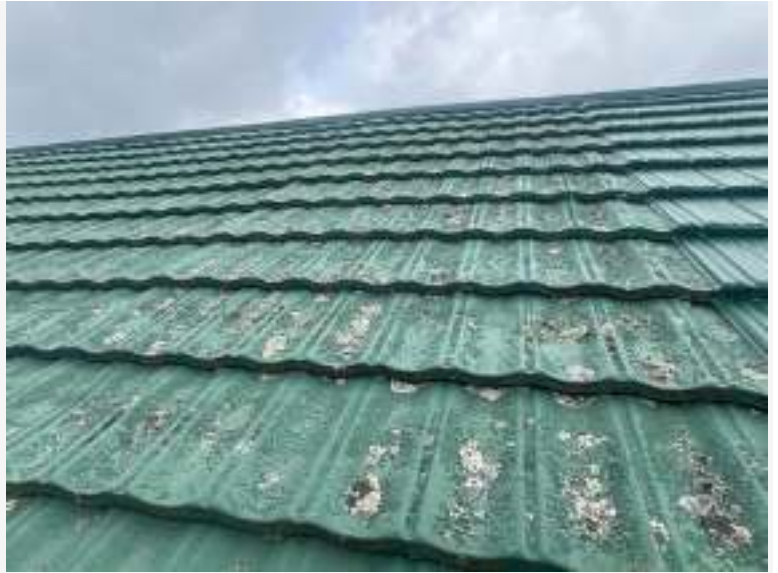
Lichen growth was observed on the roof surfaces at the time of inspection.

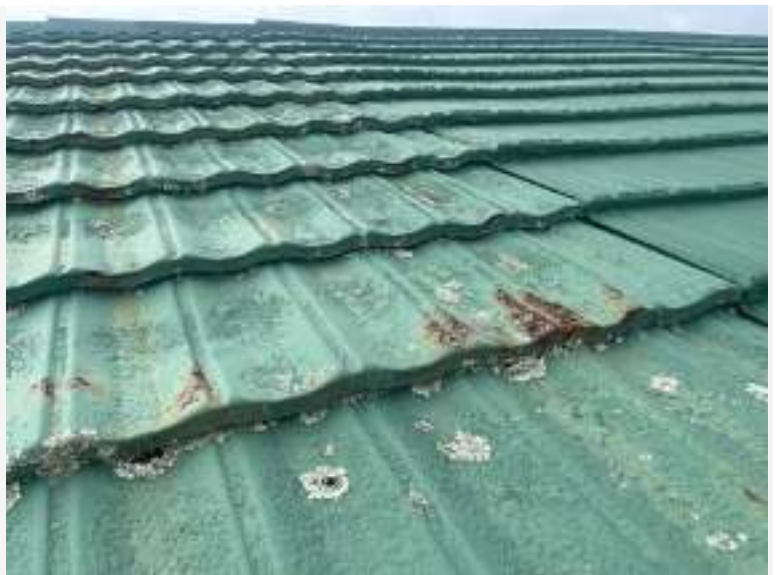
Lichen growth and surface rust was observed on the roof surfaces at the time of inspection.

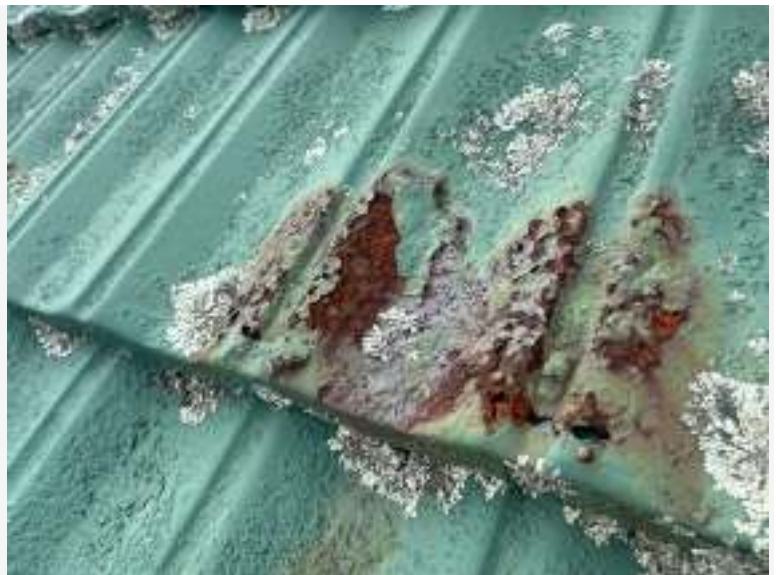
Major rust/corrosion was observed to the roof covering at the time of inspection. This indicates significant breakdown of the protective coating and may reduce the remaining service life of the roof. Advanced corrosion can progress to thinning/perforation, increasing the risk of leaks particularly around fixings, laps, flashings, and low-slope areas where water sits longer.

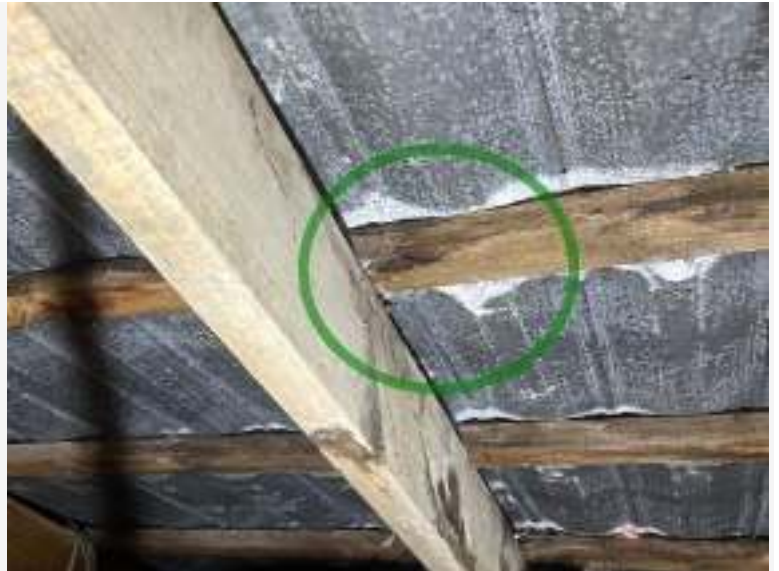
Water staining was observed on a roof purlin (timber member) at the time of inspection.

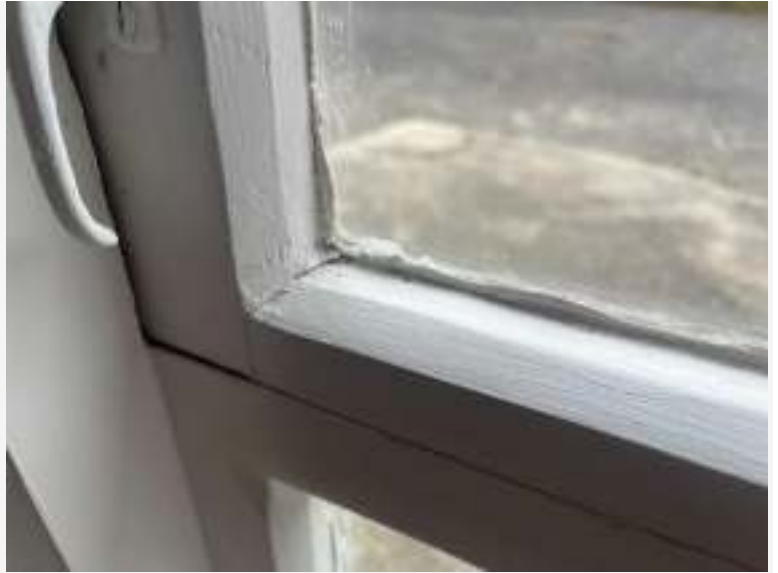
The sealant around the window was observed to be aged/deteriorated at the time of inspection.

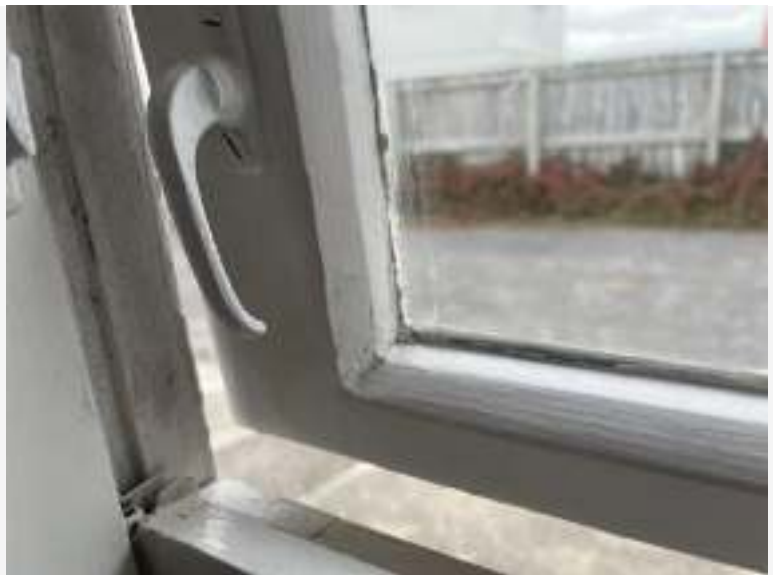
The sealant around the window was observed to be aged/deteriorated at the time of inspection.

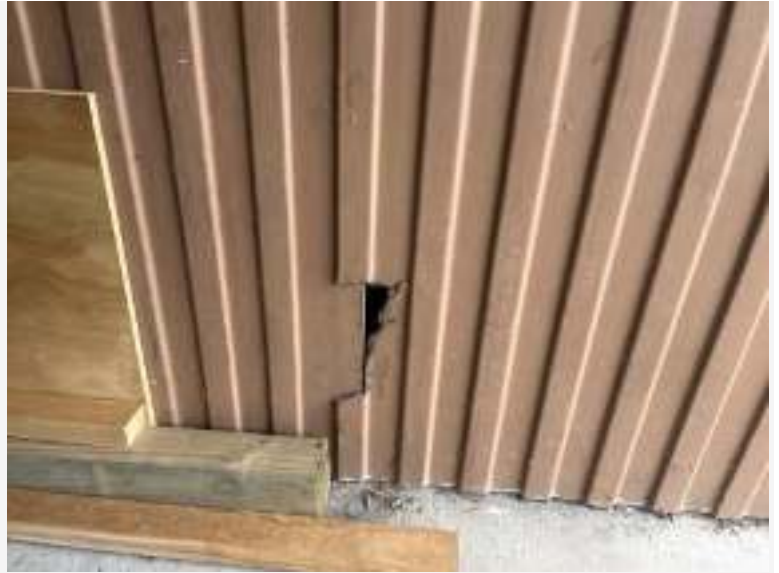
Broken/damaged exterior cladding was observed at the time of inspection.

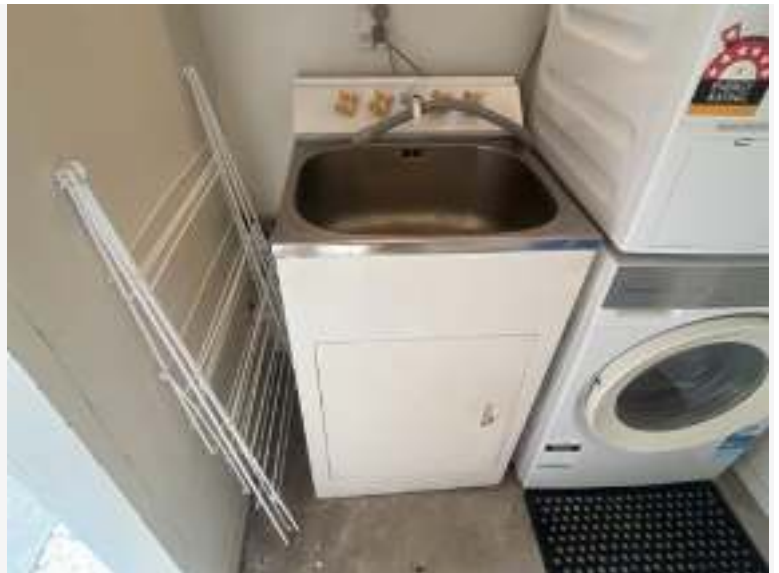
Rust/corrosion was observed at the bottom of the laundry tub at the time of inspection. This may be surface corrosion from prolonged moisture exposure, trapped water, or deterioration of protective coatings/finish.
