# Cozy Building Compliance

# Pre-Purchase House Inspection

| <b>ADDRESS:</b> | New Lynn, Auckland |
| <b>INSPECTION DATE &amp; Weather</b> | 08/02/2026 |

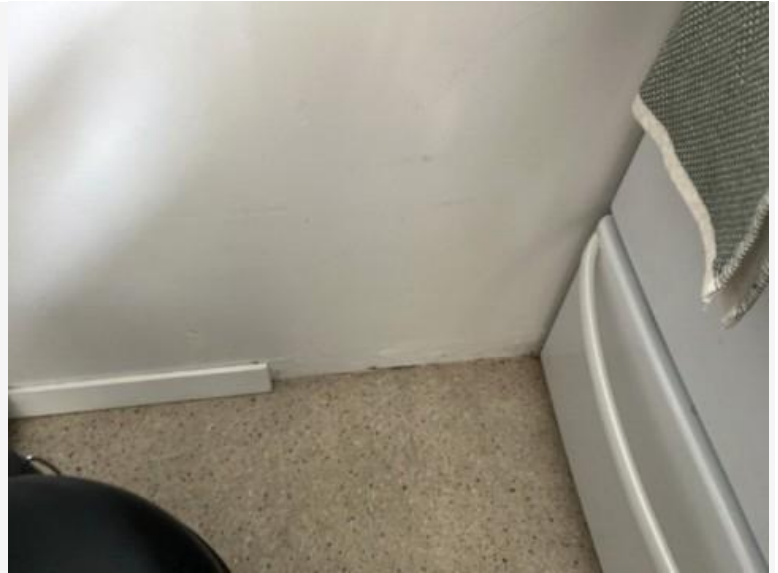
A section of skirting board was observed to be missing at the time of inspection. This is a visible finishing defect and repair is recommended to reinstate the wall lining trim.

Recommendation: Arrange for a qualified builder to repair or replace the missing skirting.

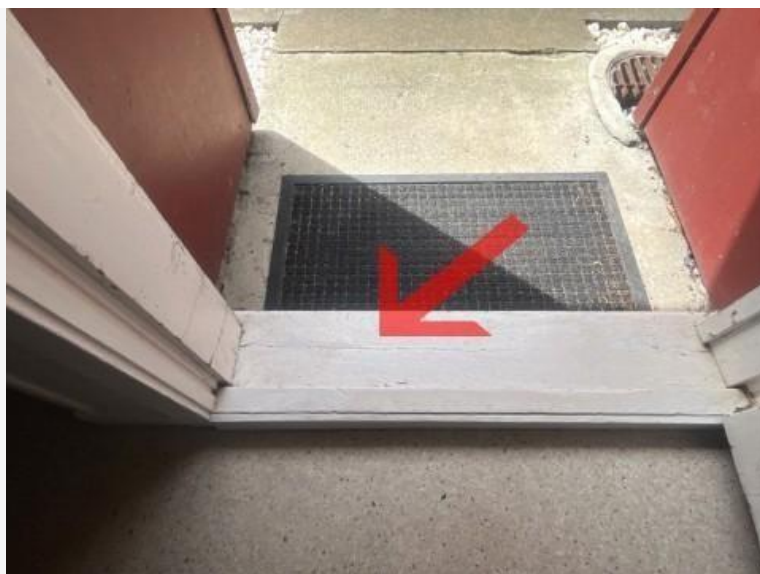
A crack line was observed at the door sill/threshold area at the time of inspection. This is a visible defect and repair is recommended to prevent further deterioration.

Recommendation: Arrange for a qualified builder to assess and repair the affected area.

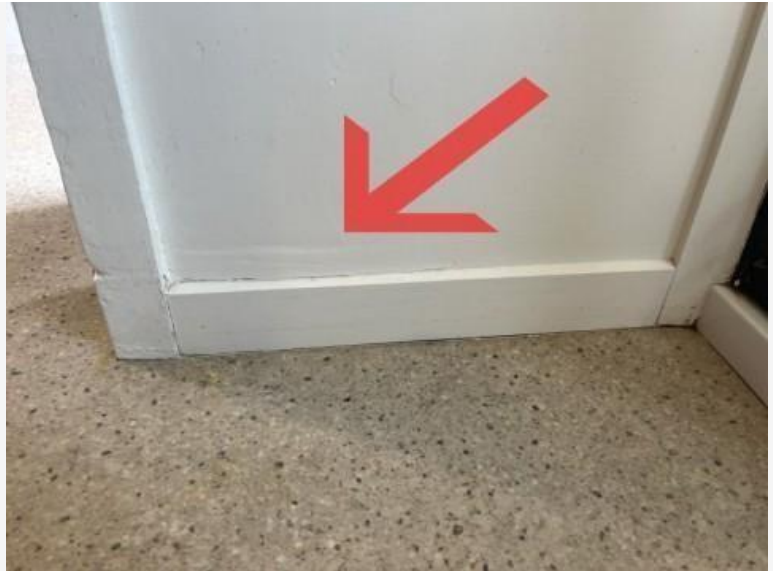
An area of wall lining was observed to be uneven and untidy at the time of inspection. This appears to be a finishing defect, and remedial work is recommended to achieve a neater finish.

Recommendation: Arrange for a suitably qualified builder or painter to repair and make good the affected area.

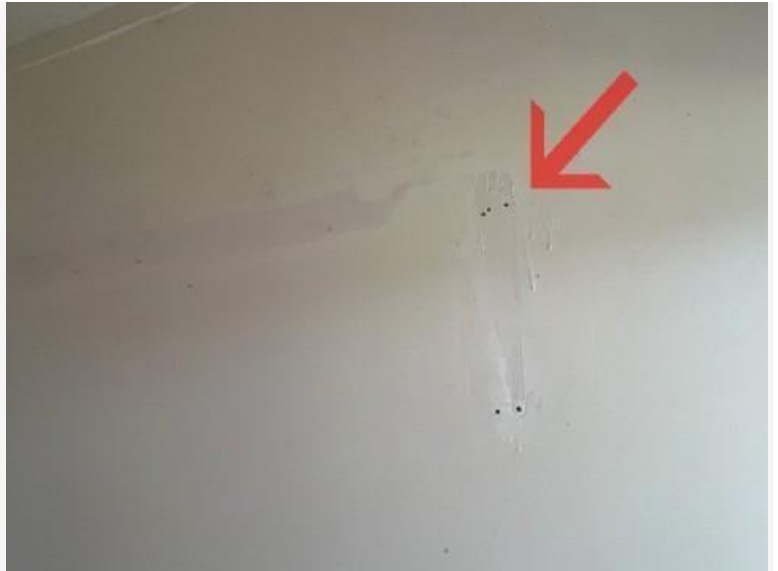
Fixing holes were observed in the wall lining at the time of inspection. This is a visible finishing defect, and repair is recommended to achieve a neat finish.

Recommendation: Arrange for a suitably qualified plasterer or painter to fill, repair, and make good the affected area.

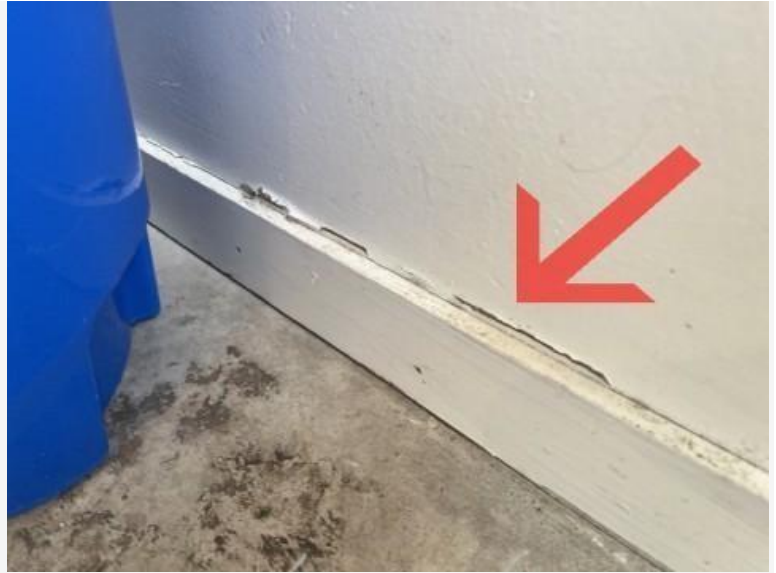
Peeling/flaking paint was observed at the junction of the wall and skirting at the time of inspection.

Recommendation: Arrange for a suitably qualified painter to prepare, repair, and repaint the affected area as required.

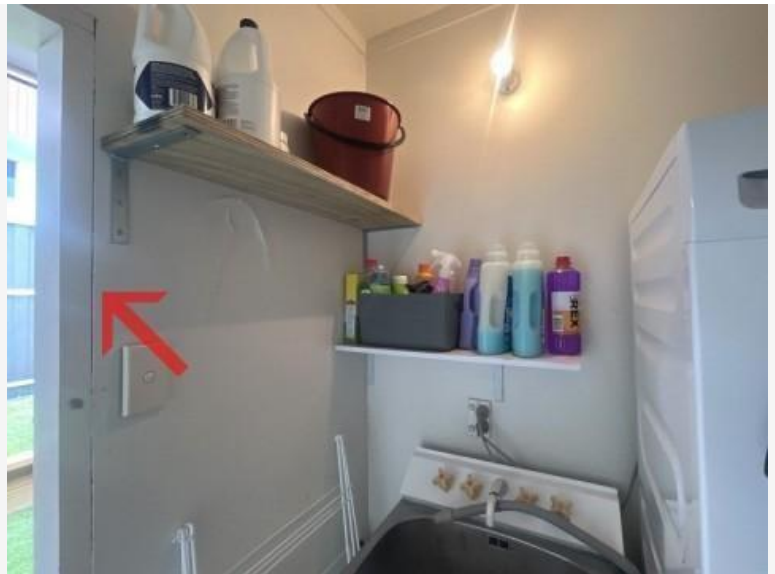
A gap was observed between the door jamb (frame) and the adjacent wall lining/architrave area at the time of inspection. Localised repair is recommended to close the gap and reinstate a neat finish.

Recommendation: Arrange for a suitably qualified builder or painter to make good the affected area.

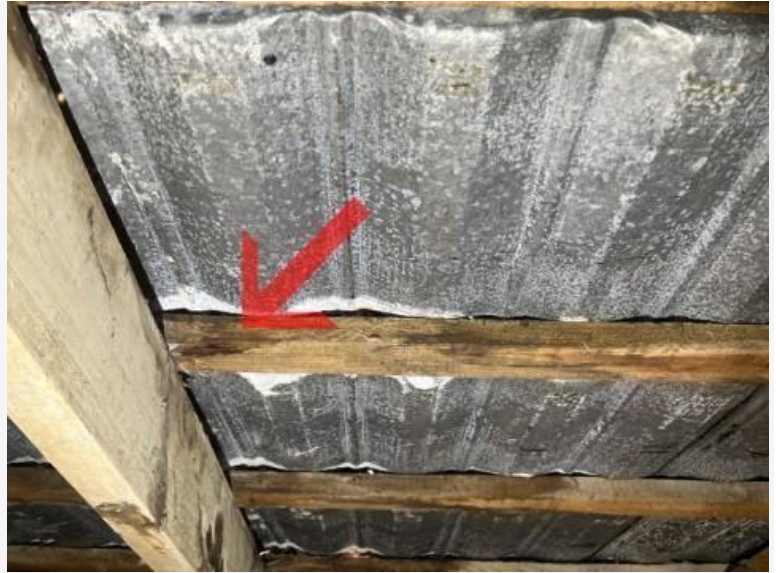
Dry water staining was observed on a roof purlin (timber member) at the time of inspection. This is a moisture-related indicator and may be associated with previous moisture ingress. No active moisture was confirmed at the time of inspection.

Recommendation: Continue to monitor the area, and arrange further assessment by a suitably qualified builder or roofing contractor if any evidence of active leakage or ongoing moisture ingress becomes apparent.

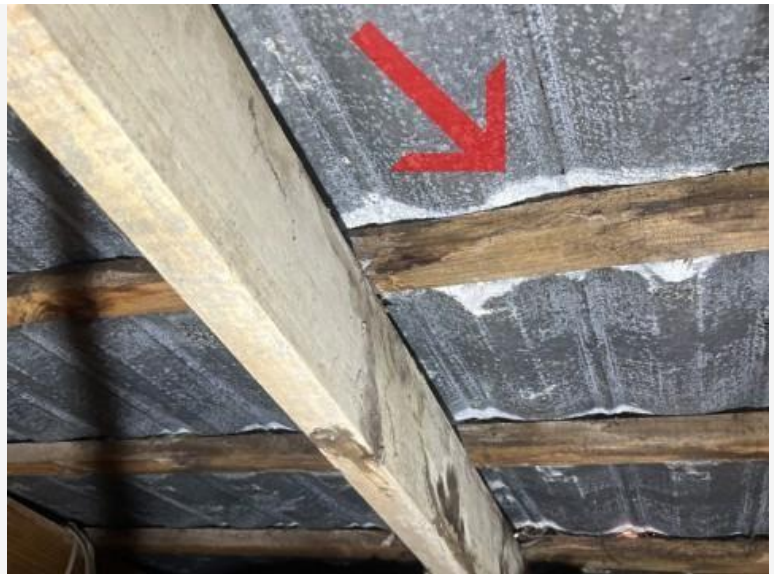
White staining was observed on the galvanised roof surface at the time of inspection. This may be associated with weathering, moisture exposure, or surface deterioration.

Recommendation: Monitor the affected area and arrange further assessment/maintenance by a suitably qualified roofing contractor if deterioration progresses.

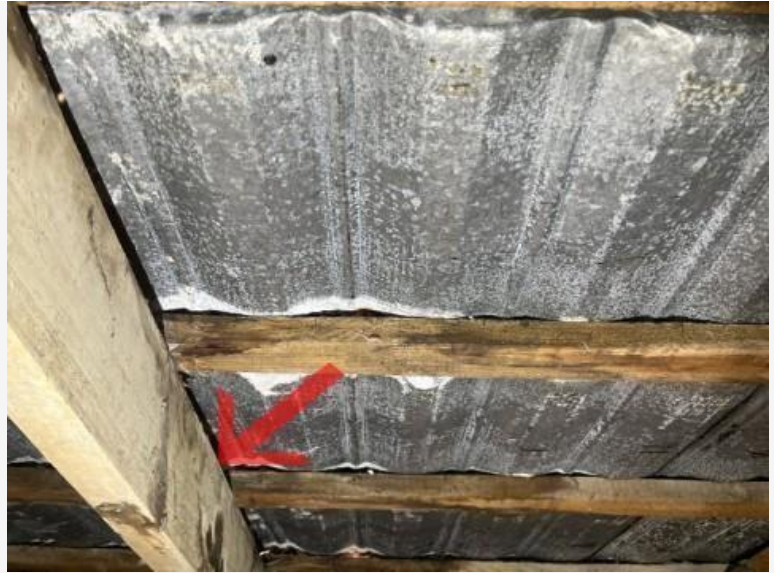
Dry water staining was observed to roof framing at the time of inspection. This is a moisture-related indicator and may be associated with previous moisture ingress. No active moisture was confirmed at the time of inspection.

Recommendation: Monitor the area over time, particularly during and after rainfall. If any evidence of active leakage, dampness, or ongoing moisture ingress becomes apparent, arrange further assessment by a suitably qualified builder or roofing contractor.

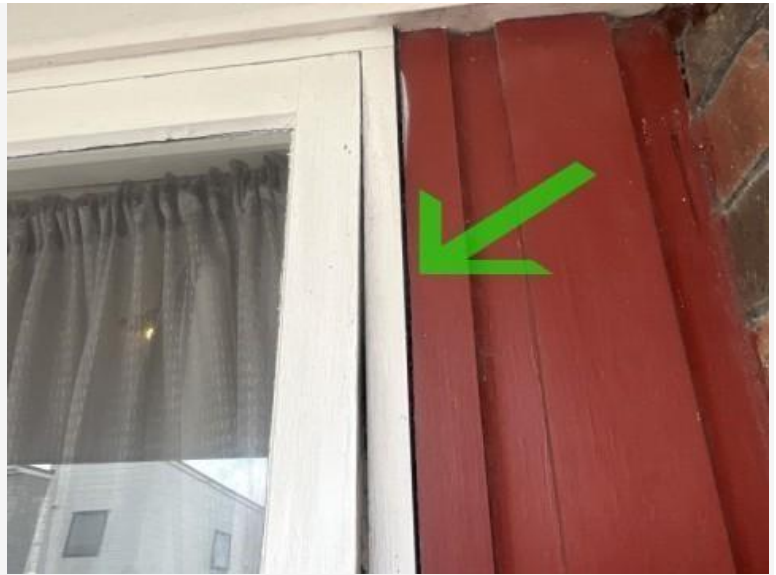
A gap was observed between the exterior cladding and the window frame at the time of inspection. This is a visible defect and may allow moisture ingress at the window junction if left unaddressed.

Recommendation: Arrange for a suitably qualified cladding contractor or LBP builder experienced in cladding / weathertightness remedial work.

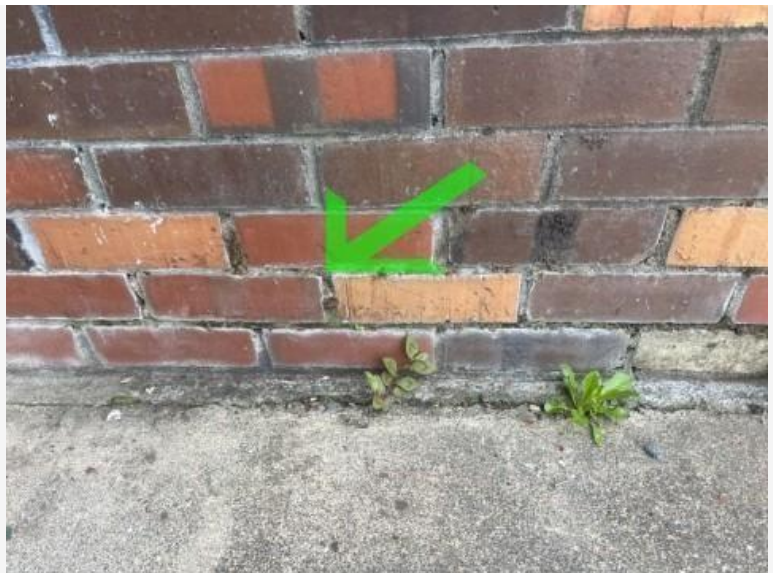
Evidence of efflorescence was observed to the brick wall at the time of inspection. Efflorescence can be associated with moisture movement through the masonry, although it may also relate to salts within the mortar/materials.

Recommendation: Arrange for the affected area to be cleaned and monitored for any ongoing or recurring moisture-related staining.

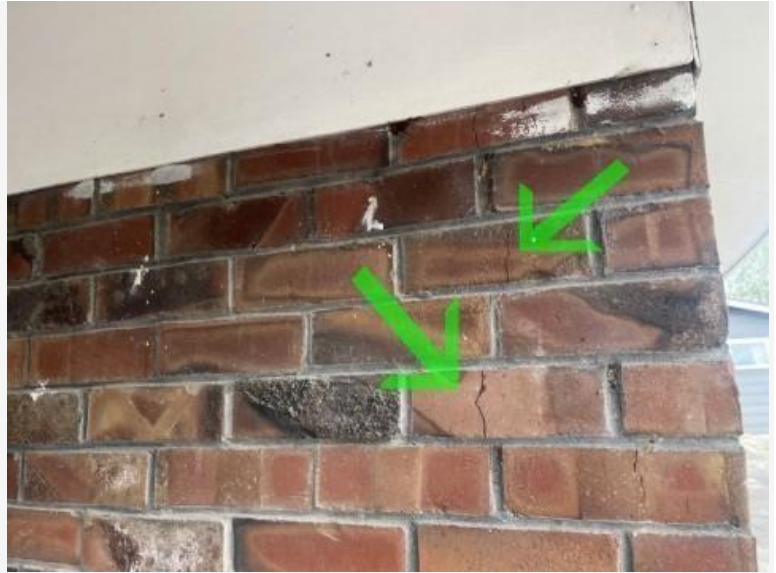
Minor cracking was observed to the brickwork at the time of inspection. This is a visible defect and should be monitored for any further movement or deterioration.

Recommendation: Monitor the affected area over time, and arrange repair/assessment by a suitably qualified builder or bricklayer if cracking worsens.

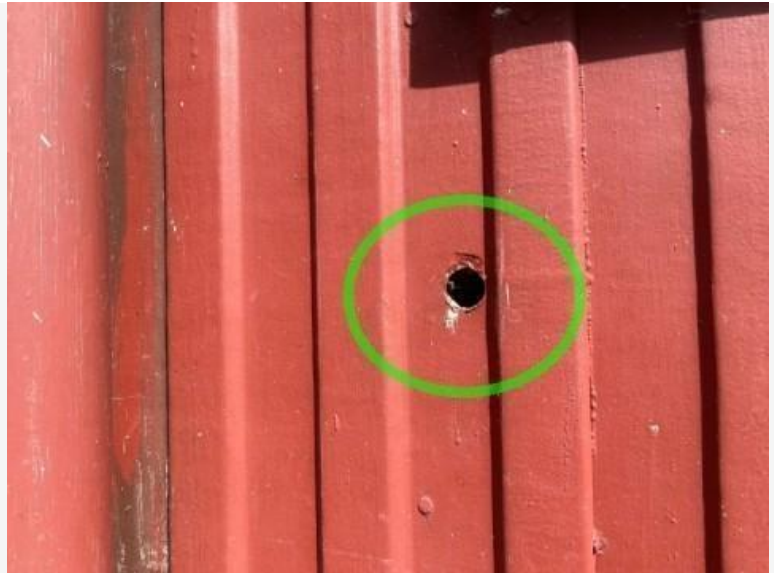
- Multiple exterior cladding defects were observed, including pipe penetrations through cladding, a hole in cladding, an untidy sealed repair to a hole/penetration, broken/damaged cladding, and a gap at a cladding junction. These are considered **evident weathertightness defects**, as they may allow wind-driven rain and moisture to enter behind the cladding and contribute to concealed dampness and deterioration of underlying materials over time.

A hole was observed in the exterior cladding at the time of inspection. Openings in exterior cladding are considered an evident weathertightness defect, as they may allow wind-driven rain and moisture to enter behind the cladding, increasing the risk of concealed dampness and deterioration of underlying materials over time. The condition of any concealed internal timber framing or substrate behind the cladding could not be determined by visual inspection alone.

**Recommendation:** Engage a suitably qualified cladding contractor or LBP builder experienced in cladding / weathertightness remedial work to assess and rectify the affected areas.

Recommendation: Arrange for a suitably qualified cladding contractor or LBP builder experienced in cladding / weathertightness remedial work

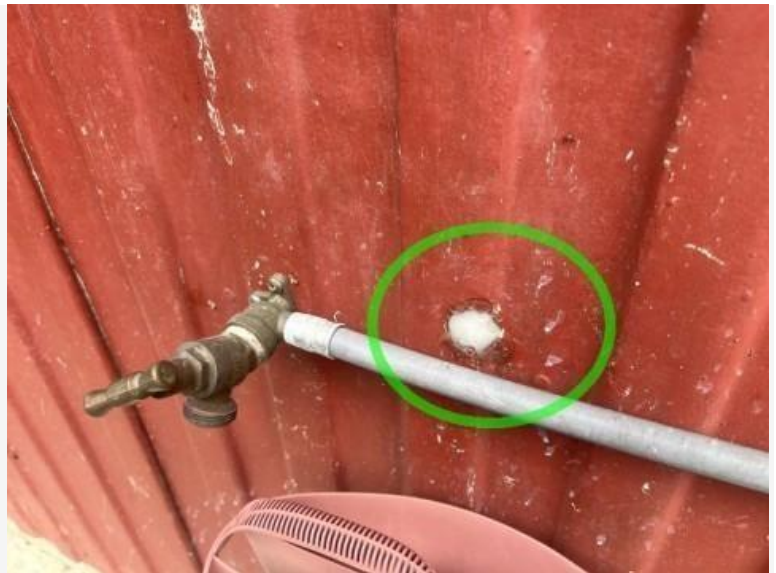
A hole/penetration in the exterior cladding appeared to have been filled/sealed at the time of inspection; however, the repair was untidy and did not present a neat or uniform finish. The adequacy and long-term performance of the repair could not be confirmed by visual inspection alone.

Recommendation: Arrange for a suitably qualified cladding contractor or LBP builder experienced in cladding / weathertightness remedial work

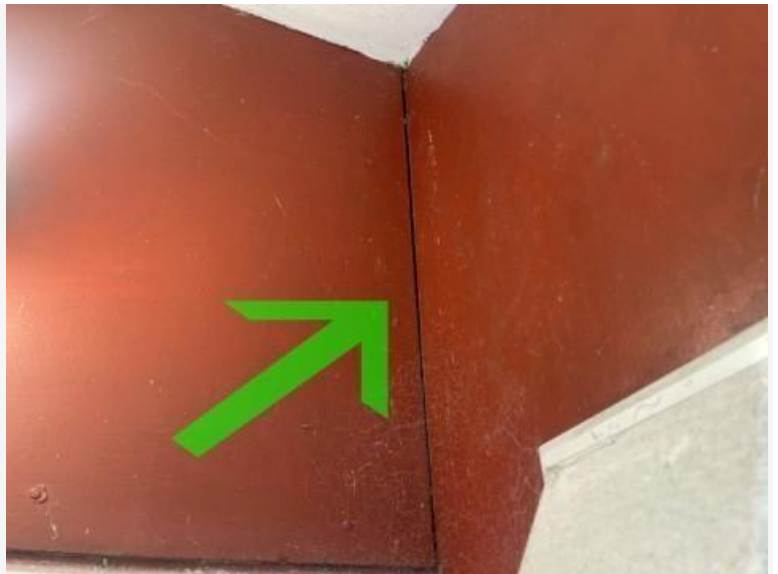
A gap was observed at a cladding junction at the time of inspection. This is a visible defect and may allow moisture ingress if left unaddressed.

Recommendation: Arrange for a suitably qualified cladding contractor or LBP builder experienced in cladding / weathertightness remedial work

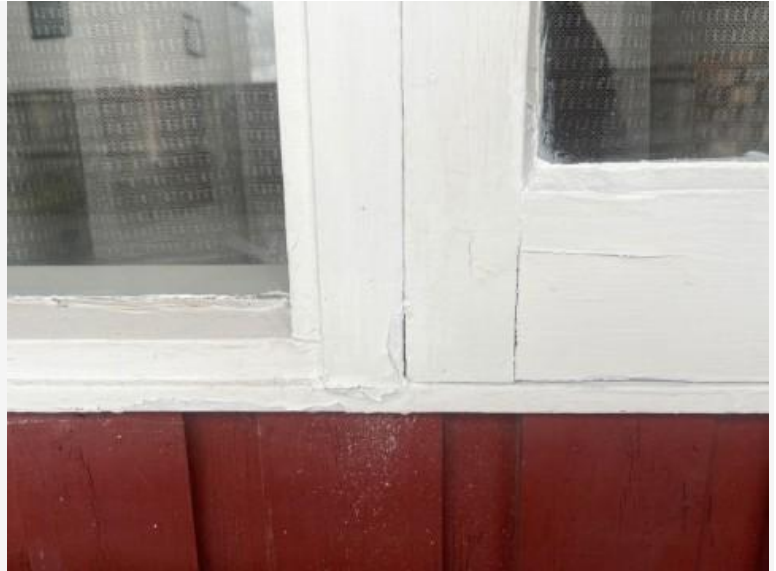
The paint finish to the window frame was observed to be aged and peeling at the time of inspection. This is a visible maintenance defect, and remedial work is recommended to prevent further deterioration and maintain the durability of the frame.

Recommendation: Arrange for a suitably qualified painter to prepare, repair, and repaint the affected window frame as required.

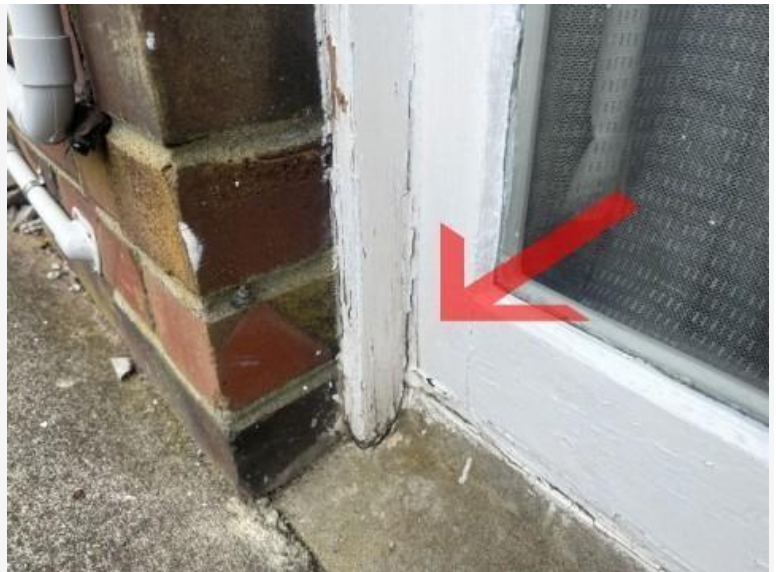
A scribe/trim was present at the joinery at the time of inspection. The paint finish and sealant to this area were observed to be aged/deteriorated. This is a visible maintenance defect and remedial work is recommended to maintain durability and weather resistance.

Recommendation: Arrange for the affected area to be prepared, re-sealed, and repainted as required by a suitably qualified painter or builder.

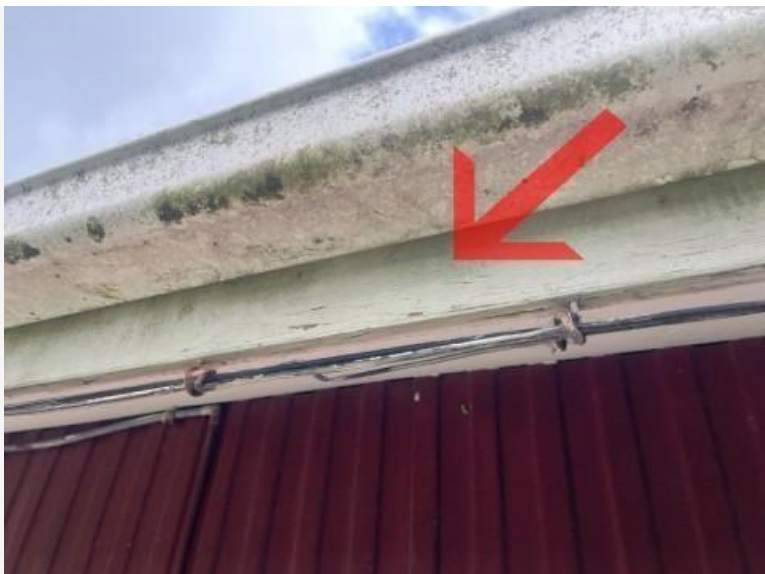
The paint finish to the fascia boards was observed to be aged/deteriorated, with peeling present at the time of inspection.

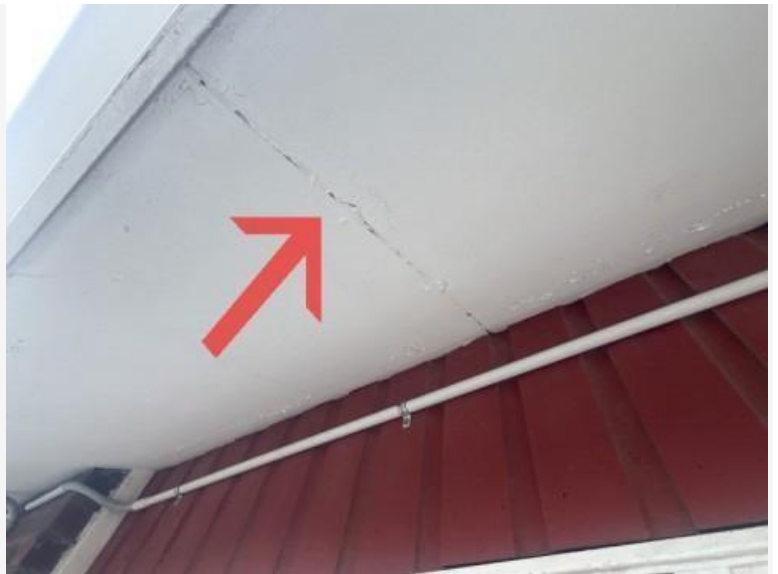
Cracking was observed at the soffit joint at the time of inspection. This is a visible defect and remedial work is recommended to prevent further deterioration and to maintain a neat finish.

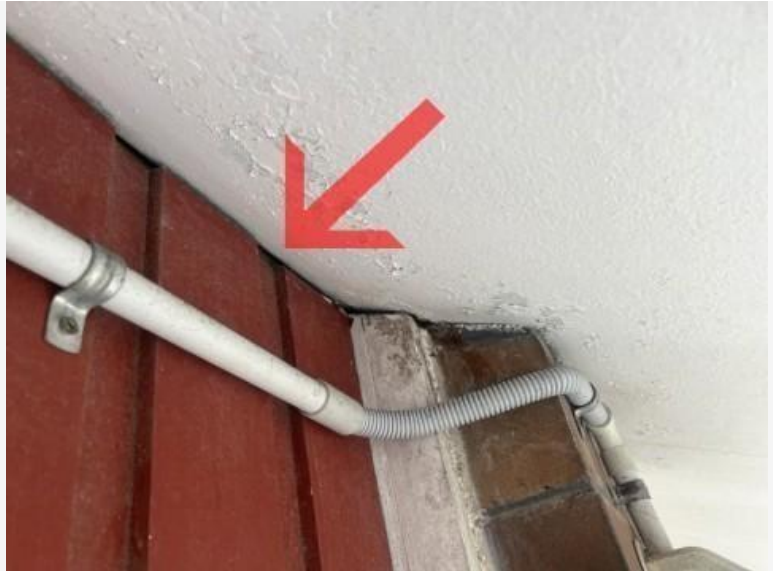
A gap was observed at the junction between the soffit and the cladding at the time of inspection. This is a visible defect and may allow moisture or pest entry if left unaddressed.

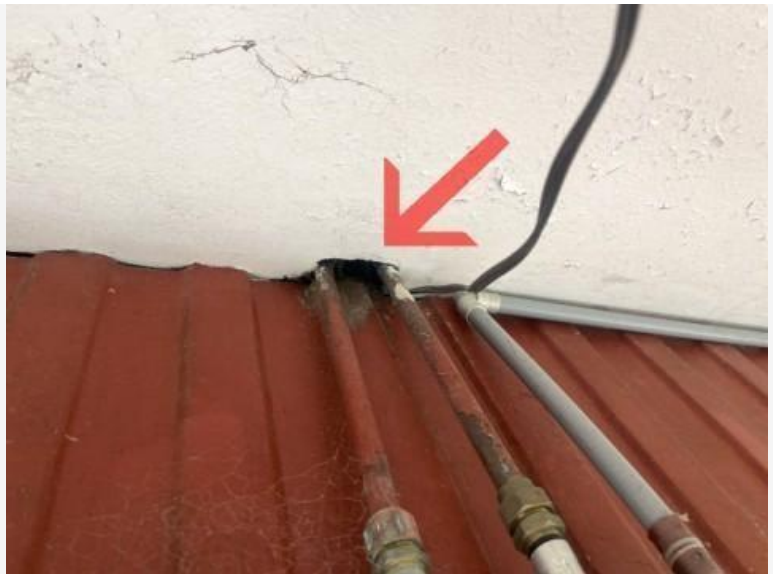
Pipes and/or cables penetrating the soffit were observed at the time of inspection. Any gaps around these penetrations should be sealed to reduce the risk of moisture entry.

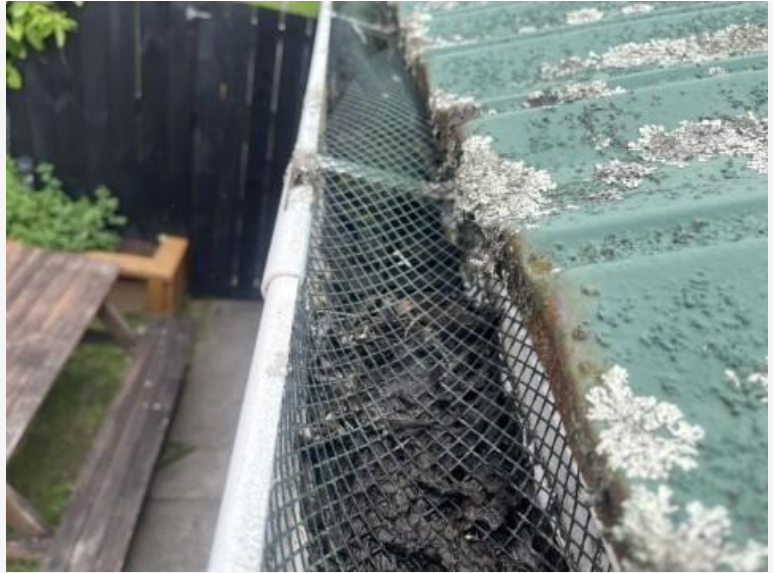
- Water dripping was observed from a gutter joint, and debris build-up was present within the spouting/guttering. These defects may restrict stormwater discharge and increase the likelihood of overflow and moisture discharge to adjacent building elements.

The spouting/guttering was observed to contain a build-up of debris at the time of inspection. This may restrict the free flow of stormwater and increase the risk of overflow during rainfall.

**Recommendation:** Arrange for the leaking gutter joint to be repaired and for the spouting/guttering to be cleaned and cleared by a suitably qualified contractor.

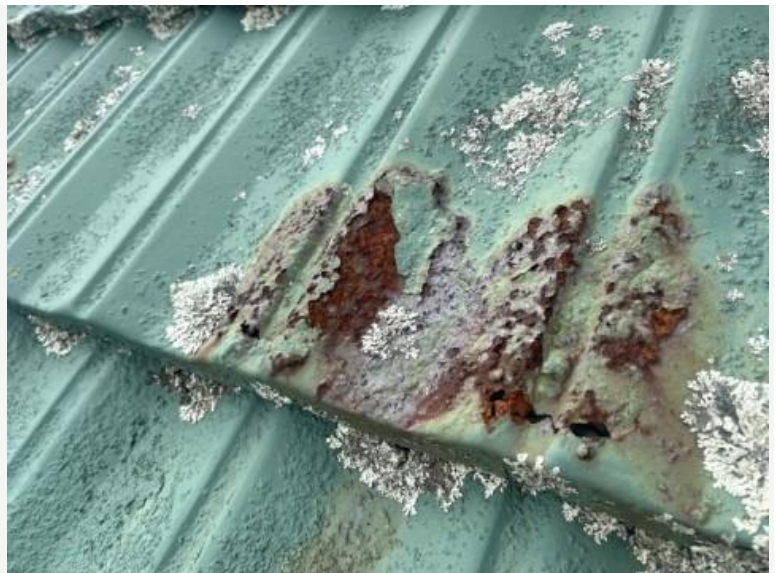
- Significant rust damage and surface corrosion were observed to roof cladding, with lichen growth also noted. A hole/opening to the roof covering has also been recorded. These items are considered **evident weathertightness defects**, as they may reduce the integrity of the roof cladding and increase the risk of moisture ingress if left unaddressed.

A localised hole/opening associated with corrosion was observed to the pressed metal roof cladding at the time of inspection. This is considered an evident weathertightness defect, as openings in the roof covering may allow direct moisture ingress into the roof structure and contribute to concealed deterioration over time.

**Recommendation:** Engage a suitably qualified roofing contractor to assess and repair the affected roof areas promptly. Depending on the extent of corrosion/deterioration, partial repair or replacement may be required.

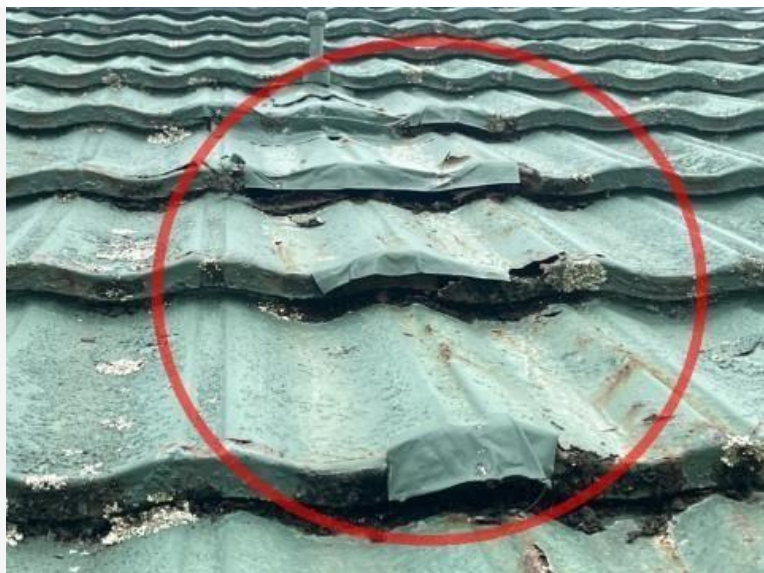
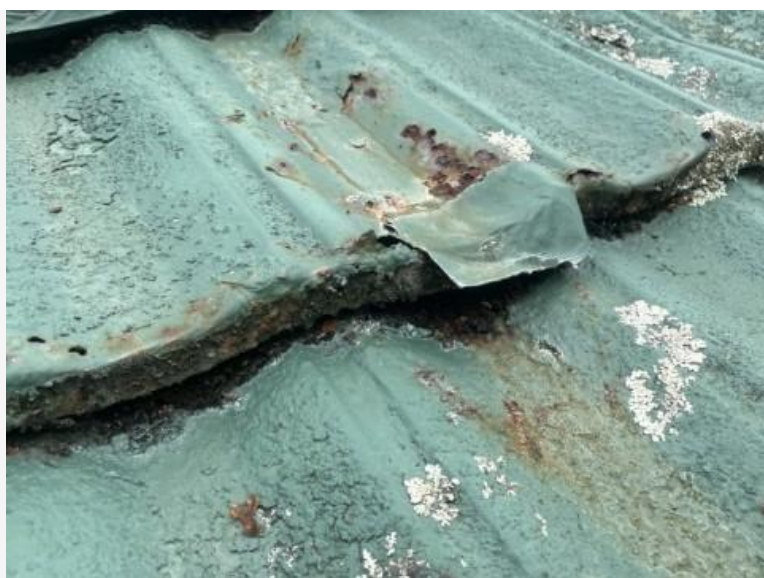
Rust damage and surface corrosion were observed to the back roof area at the time of inspection. This is considered an evident weathertightness defect, as corrosion may reduce the integrity of the roof cladding and increase the risk of moisture ingress if left unaddressed.

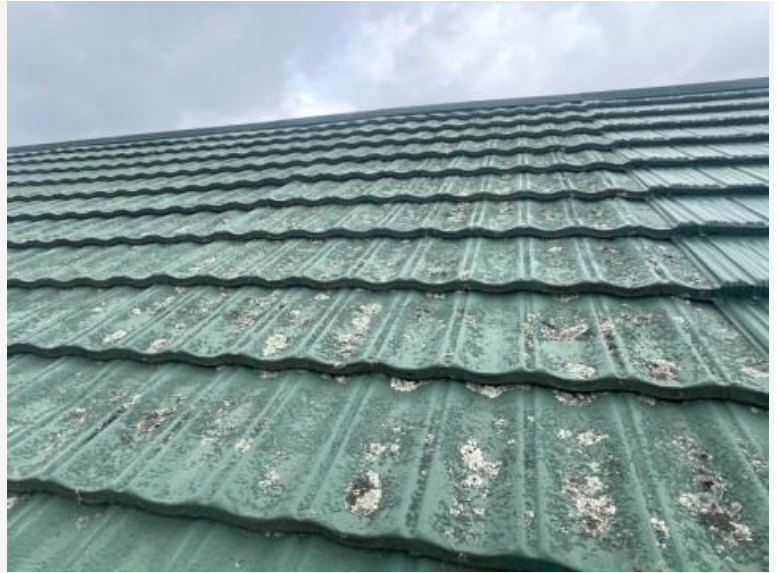
Lichen growth was observed to the back roof area at the time of inspection. This can retain moisture against the roof surface and may contribute to accelerated weathering/deterioration if not maintained.

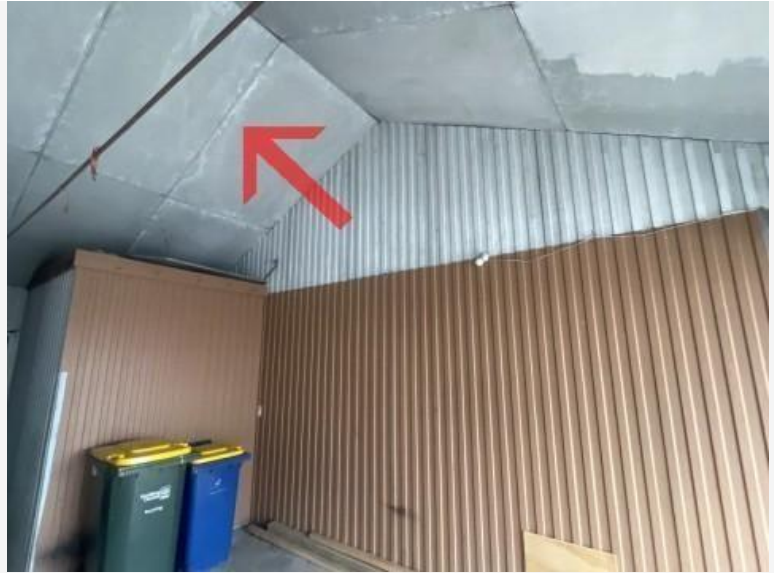
White marking/efflorescence was observed to a fibre-cement sheet at the time of inspection. Due to the height/location, close inspection was not possible, and the cause and extent of the marking could not be confirmed.

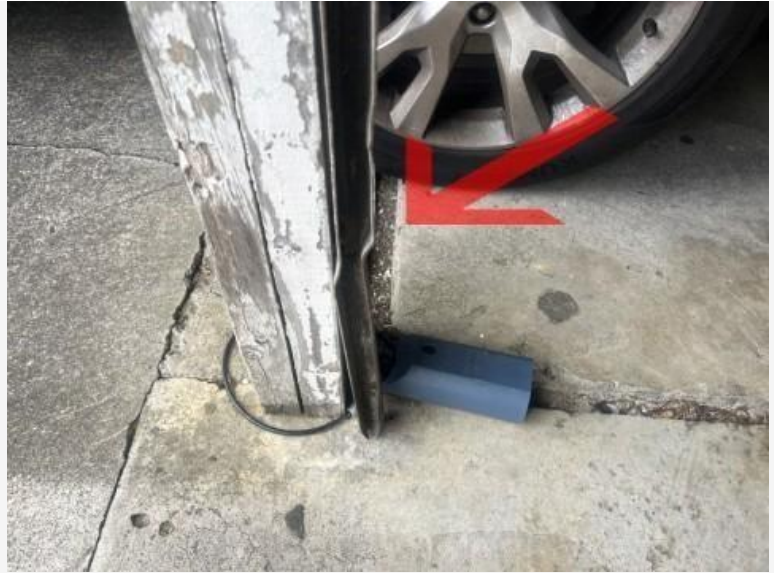
The track to the vehicle door was observed to be bent/damaged at the time of inspection. This may affect the safe and reliable operation of the door.

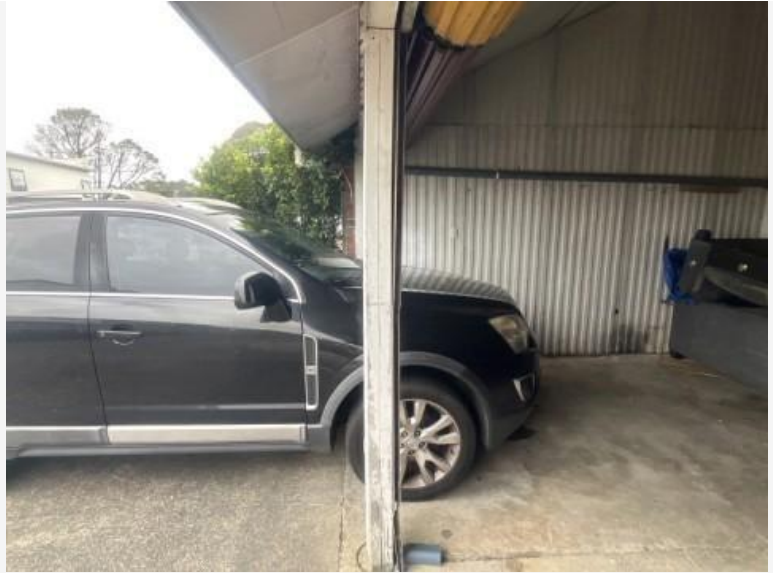
A timber post within the garage was observed to be out of plumb at the time of inspection. This may indicate movement, distortion, or previous impact, and further assessment is recommended.

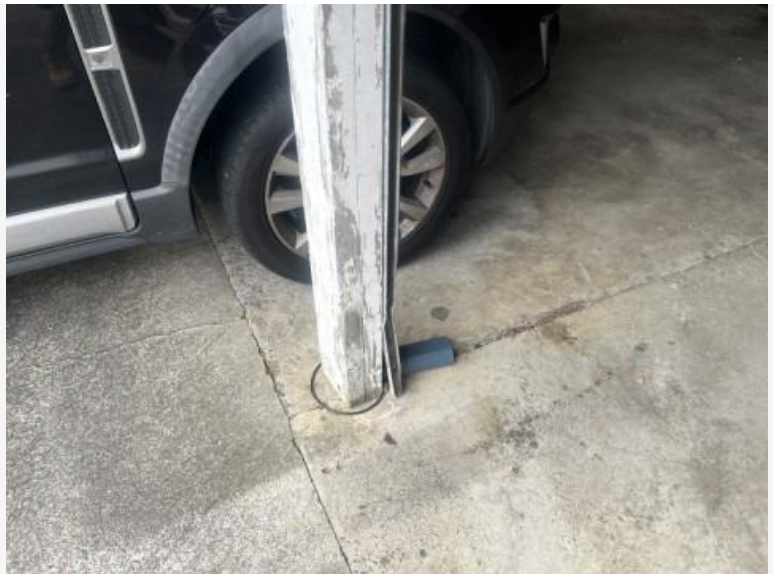
Peeling paint was observed at the time of inspection. This is a visible maintenance defect, and remedial work is recommended to prevent further deterioration and maintain the finish.
