# Cozy Building Compliance

# Pre-Purchase House Inspection

| <b>ADDRESS:</b> | <b>Otahuhu, Auckland</b> |
| <b>INSPECTION DATE &amp; Weather Conditions:</b> | <b>13/12/2025<br/>Sunny</b> |

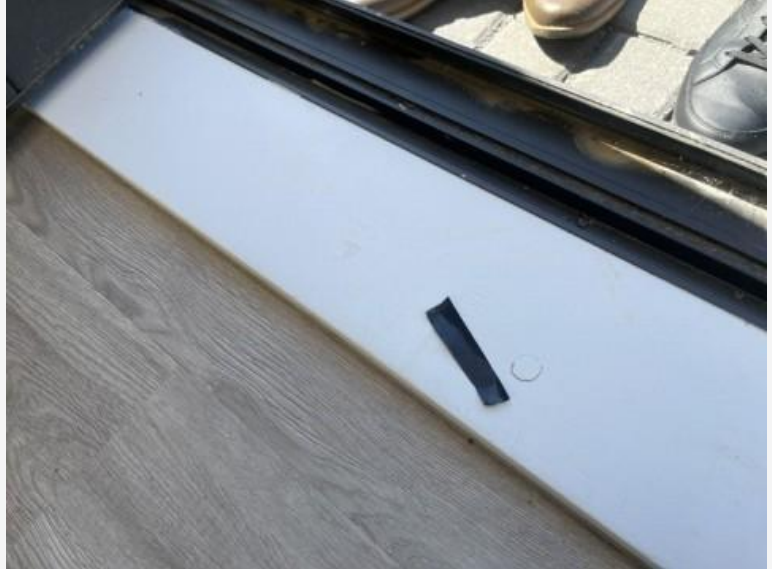
Door sill area: Cracking to filler was observed at the door sill area . This appears consistent with minor movement and is primarily cosmetic at the time of inspection.

Recommendation: Have a qualified painter prepare the are, re-fill as required, sand, prime, and repaint to a suitable finish; monitor for recurrence.

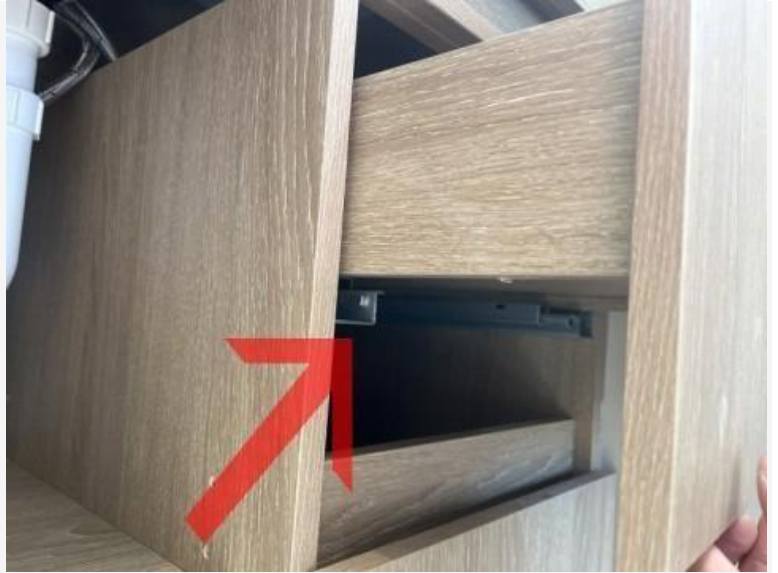
A drawer was observed to be off its runners and did not operate correctly at the time of inspection. Recommendation: Have the drawer runners assessed and repaired/adjusted by a cabinetmaker or competent tradesperson to restore safe and functional operation.

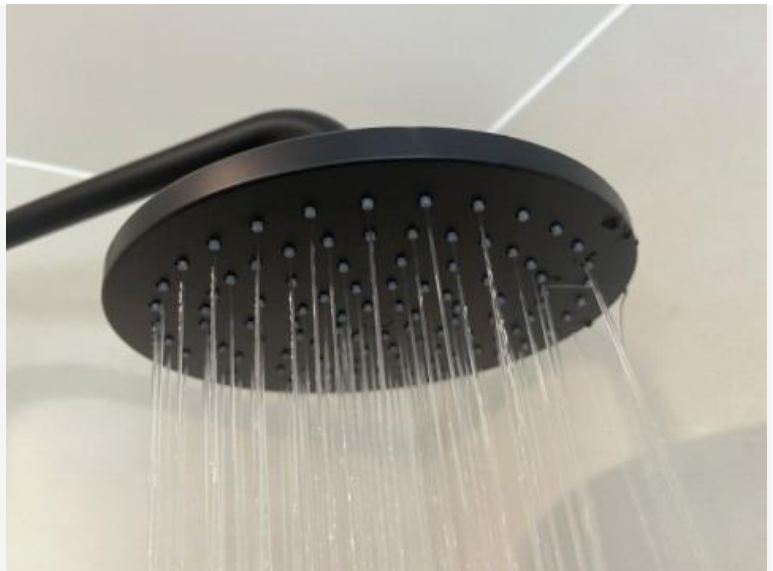
Uneven water discharge was observed from the shower rose, with some spray holes not discharging water at the time of inspection. This may indicate blockage or scaling within the shower rose.  
Recommendation: Clean/descale or replace the shower rose and re-test.  
If the issue persists, engage a qualified plumber to further assess.  
Scope limitation: This assessment is limited to basic functional observation only and does not confirm the internal condition of plumbing components.

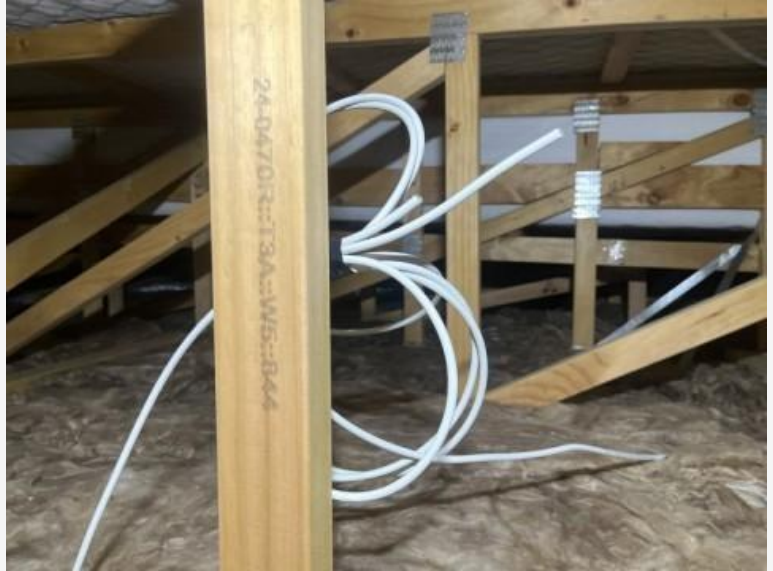
- **Unconnected electrical cable observed** with the termination not suitably covered/protected. This presents a **potential electrical hazard**.  
**Recommendation:** Engage a **registered electrician** to identify the cable, confirm whether it is live/redundant, and make it safe (isolate/terminate and protect as required).
- **Power point with missing cover plate and untidy/exposed cabling** observed (storage room). This presents a **potential electric shock and fire hazard**.  
**Recommendation:** Arrange a **registered electrician** to rectify promptly (reinstate cover plate and secure/protect cabling).

Recommendation: Engage a registered electrician to identify the cable, confirm whether it is live or redundant, and make it safe (e.g., isolate/terminate correctly and cover/protect as required).

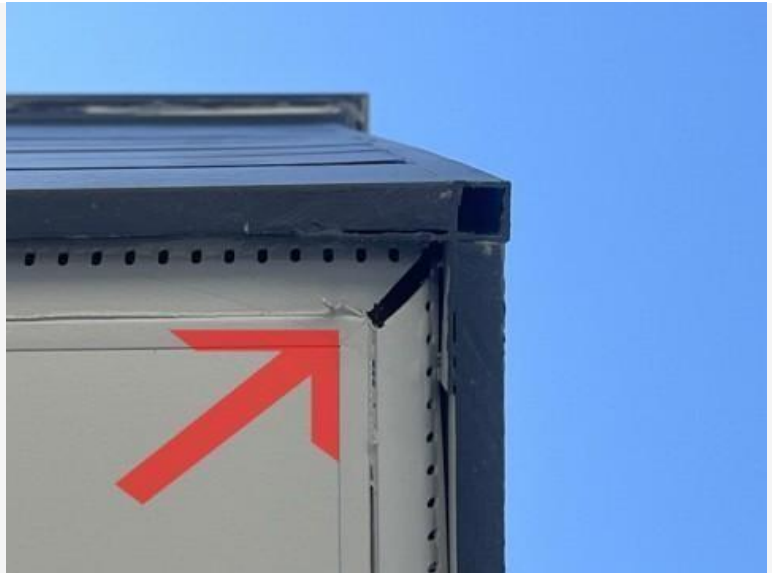
- **Gap observed at the cavity closer** to the exterior wall cladding (south elevation). This may reduce pest control effectiveness and compromise intended cavity performance.

A gap was observed at the cavity closer to the exterior wall cladding (south elevation). This may reduce pest control effectiveness and compromise intended cavity performance.

**Recommendation:** Engage a **qualified cladding contractor / LBP builder (as appropriate)** to tidy the cavity closer and close/seal the gap in accordance with good practice and manufacturer requirements.

Recommendation: Engage a qualified cladding contractor / LBP builder (as appropriate) to tidy the cavity closer and close/seal the gap in accordance with good practice and manufacturer requirements.

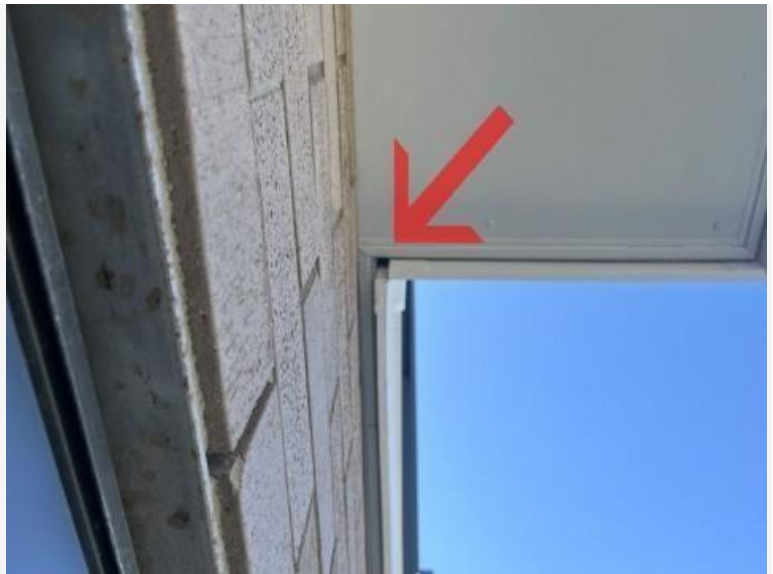
A gap was observed at the cavity closer to the exterior wall cladding (south elevation). This may reduce pest control effectiveness and compromise intended cavity performance.

Recommendation: Engage a qualified cladding contractor / LBP builder (as appropriate) to tidy the cavity closer and close/seal the gap in accordance with good practice and manufacturer requirements.

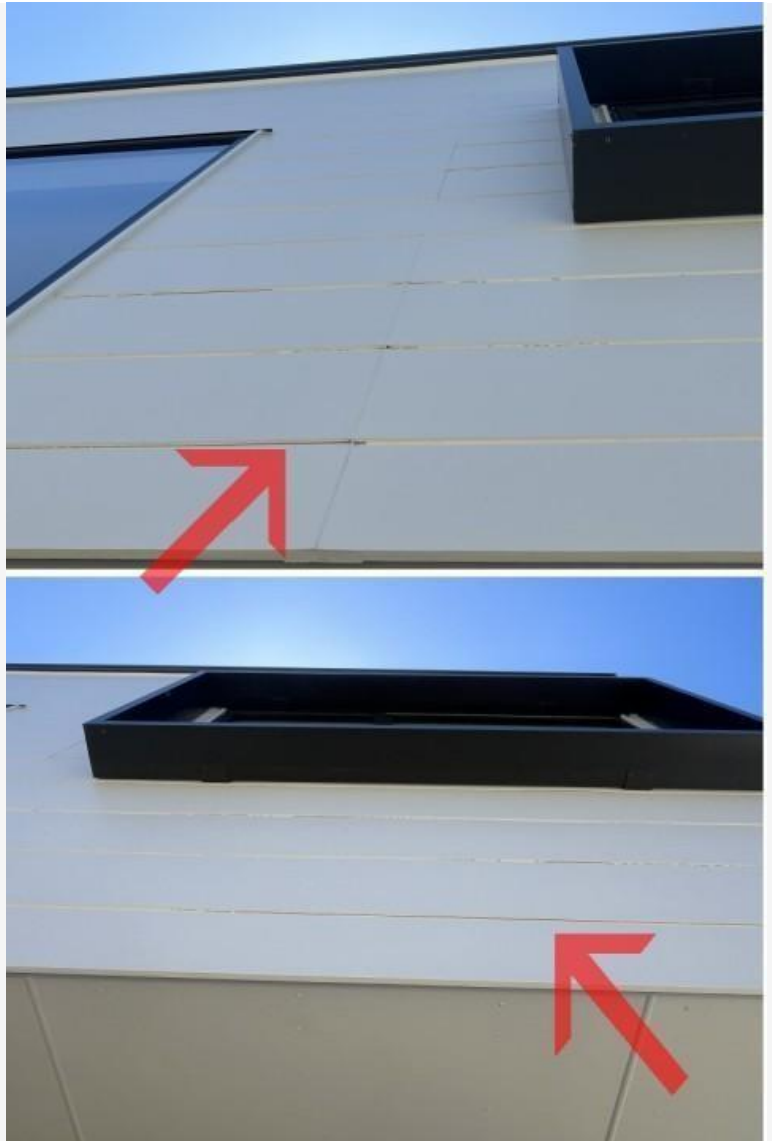
A gap was observed at the bottom edge of the exterior wall cladding on the south elevation. This may allow pest entry and may increase moisture-related risk if the base detail is not performing as intended. Recommendation: Have a competent tradesperson assess the base detail and close/repair the gap as appropriate (including reinstating any required flashings/closures/sealant where applicable).

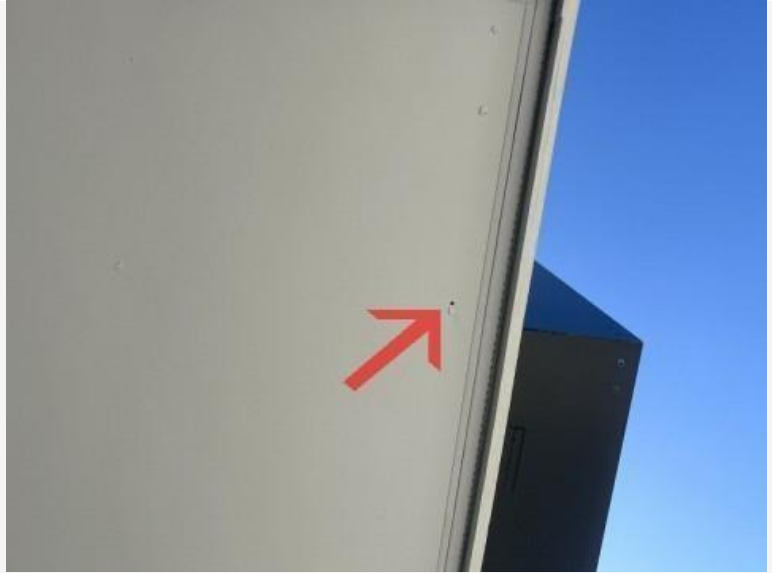
A nail hole was observed to the soffit lining. This may allow moisture entry and contribute to deterioration over time.

Recommendation: Seal and make good the penetration (fill, seal, and repaint) using a suitable exterior-grade system; monitor for any signs of moisture staining.

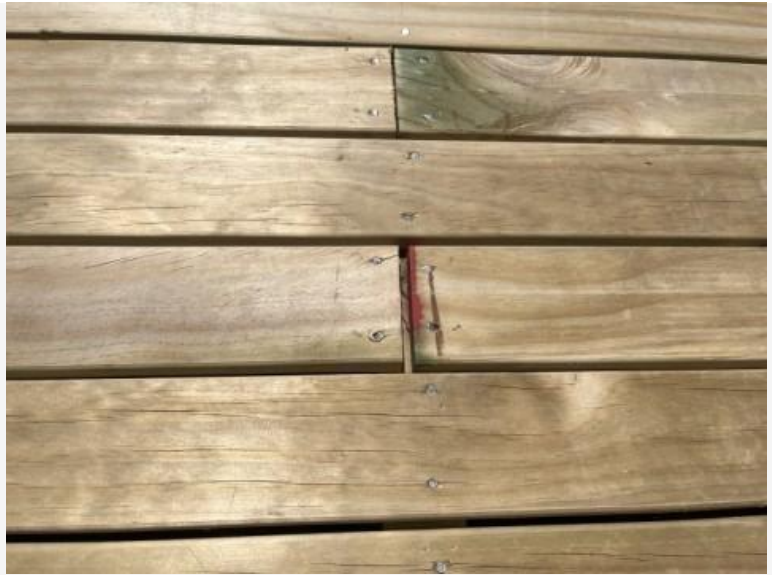
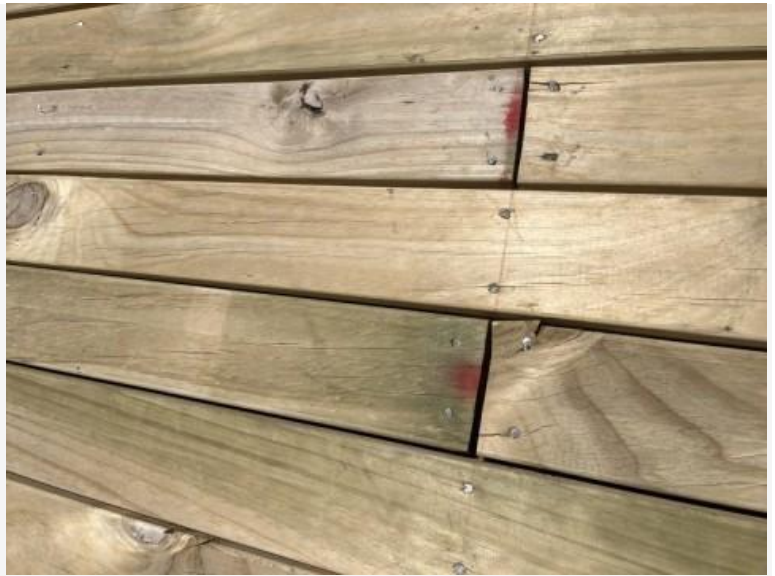
- **Large gap at join between decking boards** (potential trip/snag hazard; may indicate shrinkage/movement/installation issues).

**Recommendation:** LBP/builder to **assess and rectify** (re-fix/replace boards and reinstate suitable spacing).

Recommendation: We recommend you engage a Licensed Building Practitioner (LBP) assess the decking installation and rectify as appropriate (e.g., re-fix/replace boards and reinstate suitable spacing).

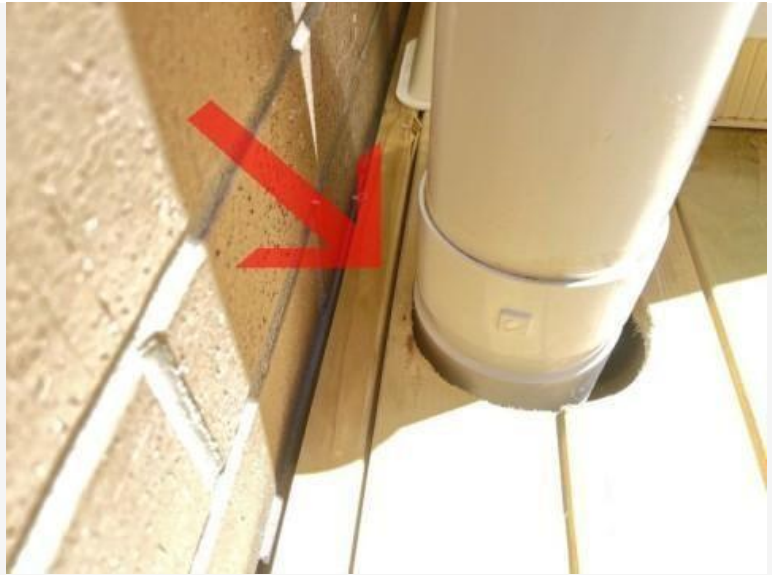
- **Squeaking noted** when walked on; **uneven clearance around a pipe penetration** with sections appearing too close to (or in contact with) the pipe; **localised loose/floating feel** underfoot.

Squeaking was noted from the decking boards when walked on. A decking board also appeared to be in contact with a pipe adjacent to the deck. Uneven clearance was observed around the pipe penetration, with some sections too close to (or in contact with) the pipe. This may contribute to noise, ongoing movement, and potential wear to the decking and/or pipe over time.

**Recommendation:** Engage a **suitably qualified builder** to assess decking structure/fixings and pipe clearance, and carry out repairs/re-fixing as required (concealed fixings/joists/bearers not confirmed due to non-invasive scope).

Recommendation: We recommend you engage a Licensed Building Practitioner (LBP) assess and rectify, including re-fixing boards and trimming/adjusting the penetration to achieve suitable clearance around the pipe and confirm the pipe is not damaged.

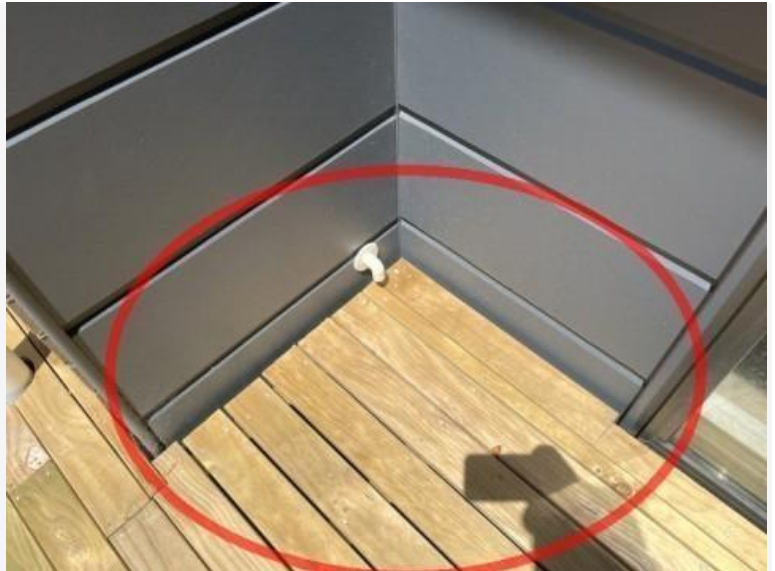
A section of decking felt "floating" at the time of inspection, suggesting inadequate fixing. This may present a safety risk and may worsen over time.

Scope limitation: This inspection is visual and non-invasive; the condition of concealed fixings, joists, and bearers cannot be fully confirmed.

Recommendation: Engage a suitably qualified builder to assess the decking structure and fixings and carry out repairs/re-fixing as required.

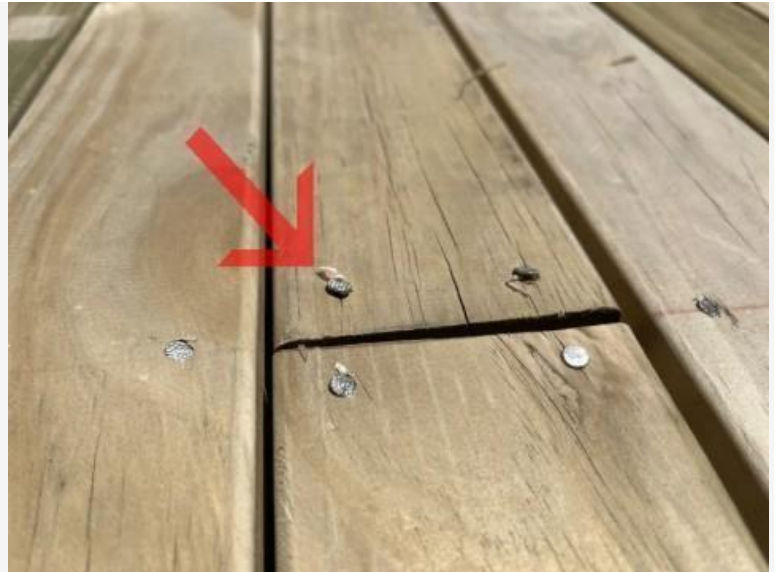
- **Protruding nail (“popped out”)** from decking surface (injury hazard; may indicate board movement/loosening fixings).

**Recommendation:** LBP/builder to **refix/replace the fastening** and check adjacent boards/fixings; resecure as required.

Recommendation: Have a Licensed Building Practitioner (LBP) refix/replace the fastening and check adjacent fixings/boards for movement; resecure as required.
