# Cozy Building Compliance

# Pre-Purchase House Inspection

<b>ADDRESS:</b>	<b>Sample report</b>
<b>CLIENT:</b>	<b>Cozy Building Compliance</b>
<b>AGENT:</b>	<b>Young</b>
<b>INSPECTION DATE &amp; Weather Conditions:</b>	<b>13/12/2025</b> <b>Sunny</b>
<b>INSPECTION INSTRUCTIONS:</b>	<b>Pre-Purchase Visual Non-Invasive Property Inspection</b>
<b>Vendors' INSURANCE:</b>	<b>N/A</b>

**Client Name:** Sample Report  
**Inspection address:**  
**Date of inspection:** 13/12/2025  
**Property Inspector:** Young Tsai  
**Company:** Cozy Building Compliance Ltd  
**Scope of inspection:** The scope of the inspection is as set out in our Terms and Conditions and is limited to a visual Pre-Purchase, or Pre-Sale inspection, carried out in accordance with NZS4306:2005  
**Report number:** 13122025-003

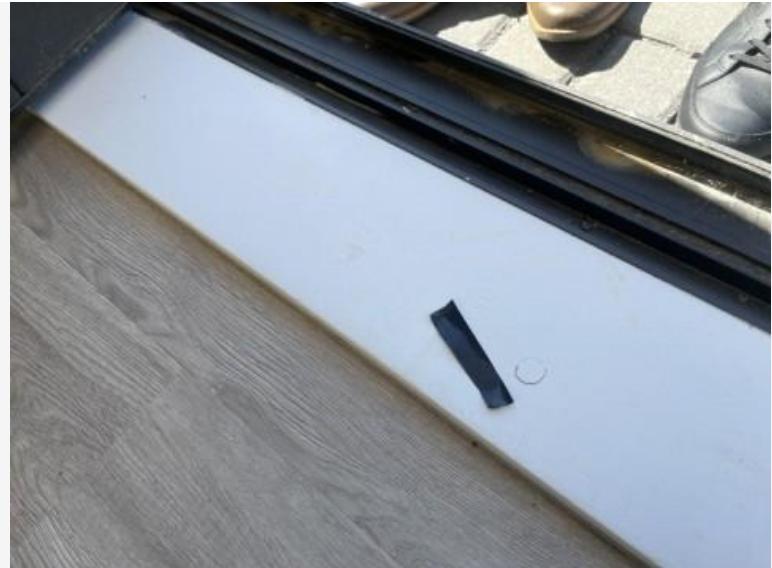
Door sill area: Cracking to filler was observed at the door sill area. This appears consistent with minor movement and is primarily cosmetic at the time of inspection.

Recommendation: Have a qualified painter prepare the area, re-fill as required, sand, prime, and repaint to a suitable finish; monitor for recurrence.

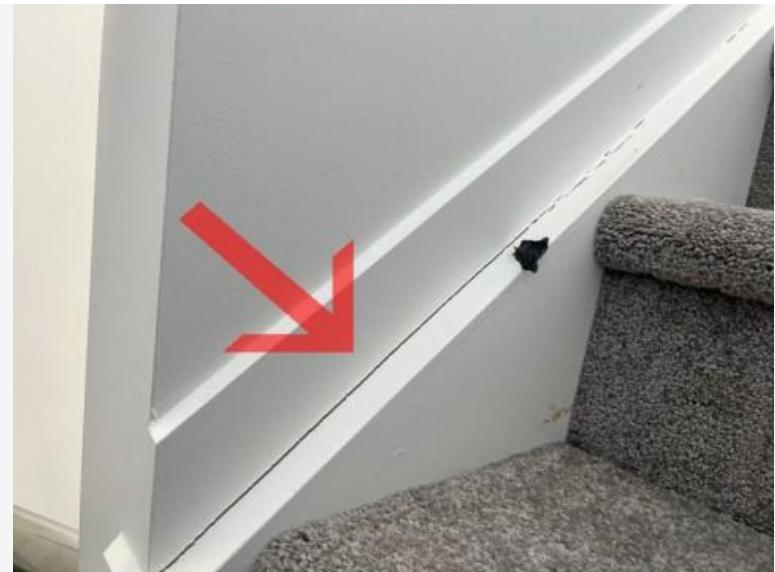
Paint cracking was observed at the junction between the bottom of the skirting and the stair stringer. This appears consistent with minor movement/shrinkage and is primarily cosmetic.

Recommendation: Monitor for progression; repair and repaint as required by a qualified painter.

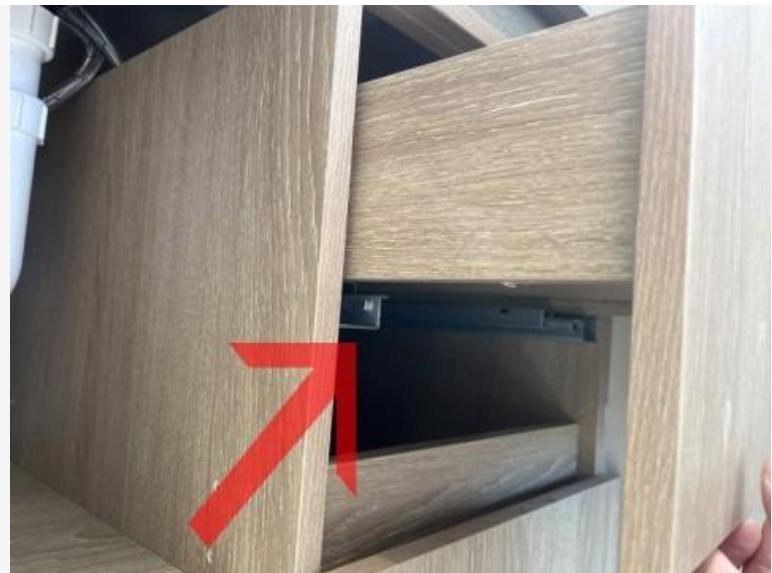
A drawer was observed to be off its runners and did not operate correctly at the time of inspection. Recommendation: Have the drawer runners assessed and repaired/adjusted by a cabinetmaker or competent tradesperson to restore safe and functional operation.

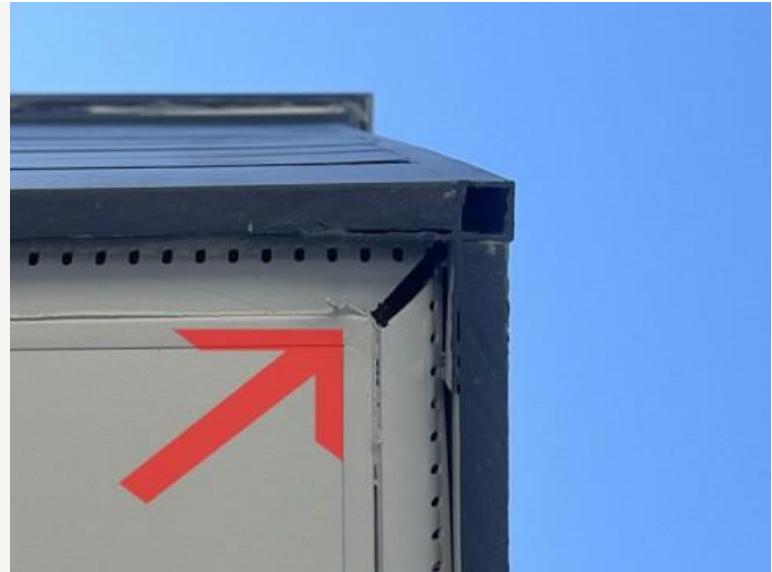
A gap was observed at the cavity closer to the exterior wall cladding (south elevation). This may reduce pest control effectiveness and compromise intended cavity performance.

Recommendation: Engage a qualified cladding contractor / LBP builder (as appropriate) to tidy the cavity closer and close/seal the gap in accordance with good practice and manufacturer requirements.

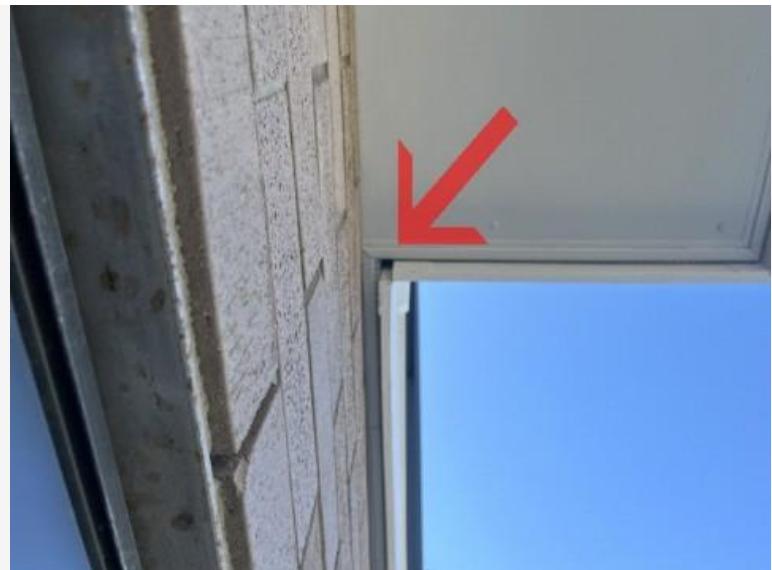
A gap was observed at the cavity closer to the exterior wall cladding (south elevation). This may reduce pest control effectiveness and compromise intended cavity performance.

Recommendation: Engage a qualified cladding contractor / LBP builder (as appropriate) to tidy the cavity closer and close/seal the gap in accordance with good practice and manufacturer requirements.

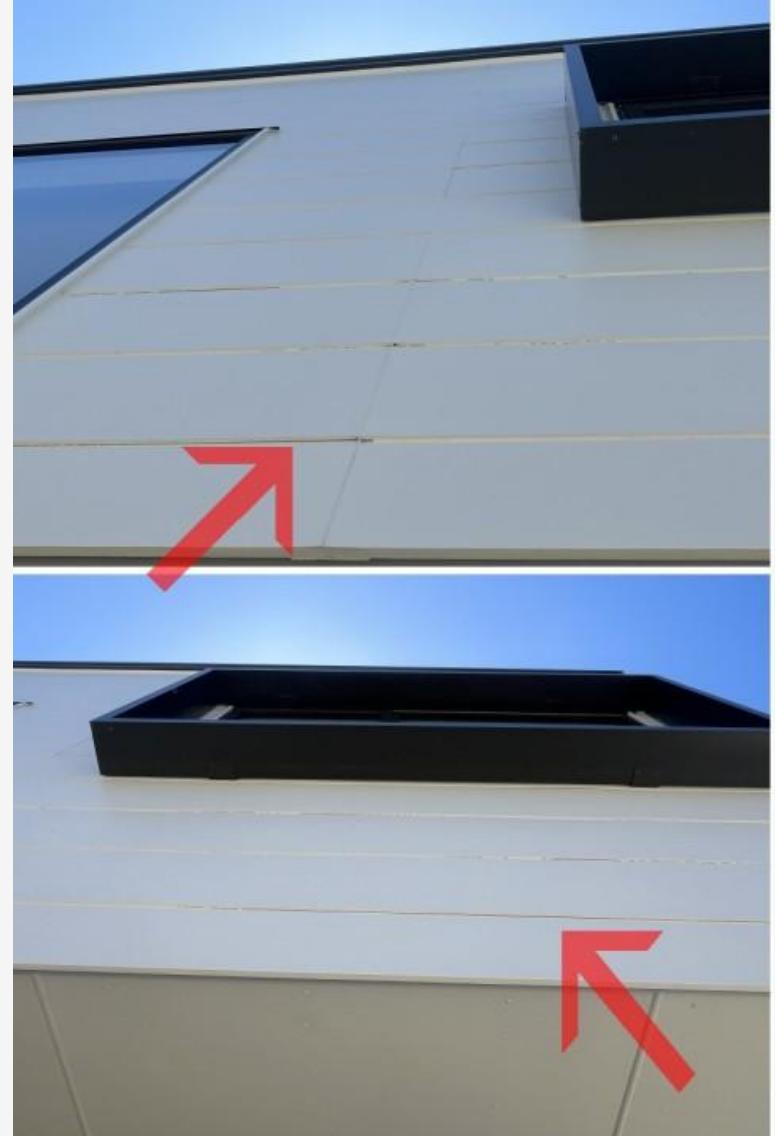
A gap was observed at the bottom edge of the exterior wall cladding on the south elevation. This may allow pest entry and may increase moisture-related risk if the base detail is not performing as intended. Recommendation: Have a competent tradesperson assess the base detail and close/repair the gap as appropriate (including reinstating any required flashings/closures/sealant where applicable).

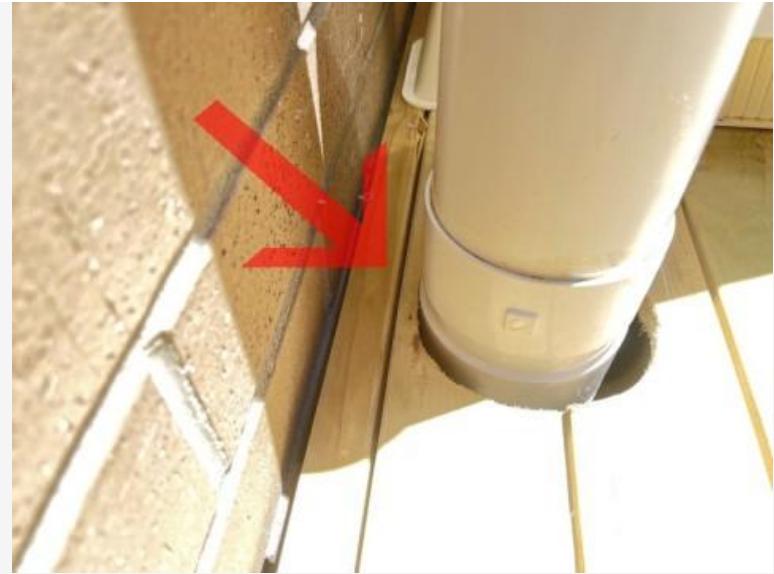
Squeaking was noted from the decking boards when walked on. A decking board also appeared to be in contact with a pipe adjacent to the deck. Uneven clearance was observed around the pipe penetration, with some sections too close to (or in contact with) the pipe. This may contribute to noise, ongoing movement, and potential wear to the decking and/or pipe over time.

**Recommendation:** Engage a suitably qualified builder to assess the decking structure and fixings and carry out repairs/re-fixing as required.

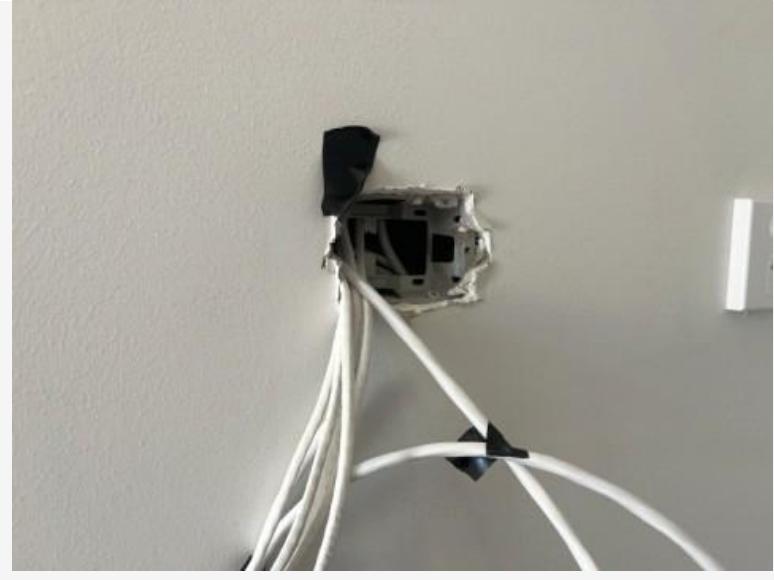
A power point was observed with a missing cover plate, with untidy/exposed cabling noted adjacent. This presents a potential electric shock and fire hazard. Recommendation: Arrange for a registered electrician to assess and rectify promptly, including reinstating an appropriate cover plate and securing/protecting cabling.
