Cozy Building Compliance

Pre-Purchase House Inspection

ADDRESS:	Sample report
CLIENT:	Young
AGENT:	Sample
INSPECTION DATE & Weather Conditions:	
PEOPLE PRESENT:	Buyer
TENANTS DETAILS:	The property was vacant at time of inspection.

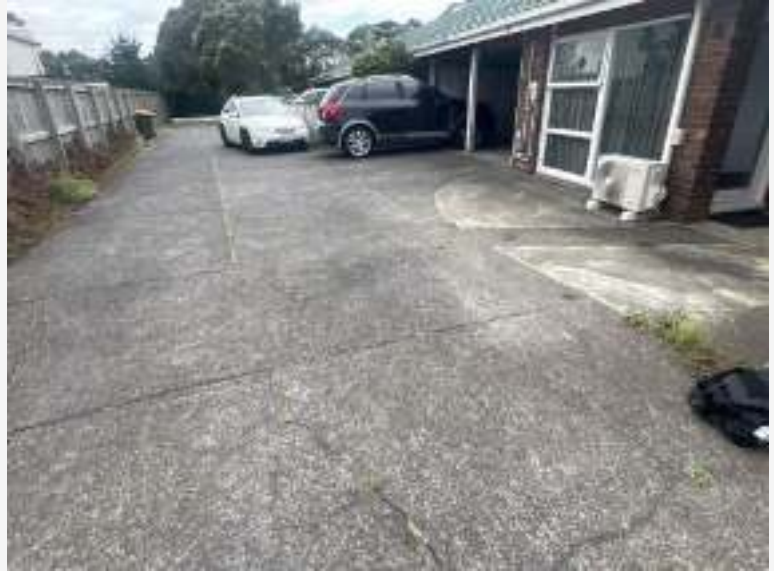
Minor cracking was observed to the concrete driveway at the time of inspection. This type of cracking is common and can occur due to normal concrete shrinkage, temperature changes, and minor ground movement/settlement over time.

Monitor the cracks for any changes such as widening, new cracking, or uneven "stepping" across the crack. Consider sealing/filling the crack(s) to reduce water entry and slow further deterioration.

If cracking worsens, becomes uneven, or creates a trip hazard, engage a suitably qualified builder or concrete contractor to assess and carry out repairs (e.g., crack repair/sealing, localised patching, or replacement if required).

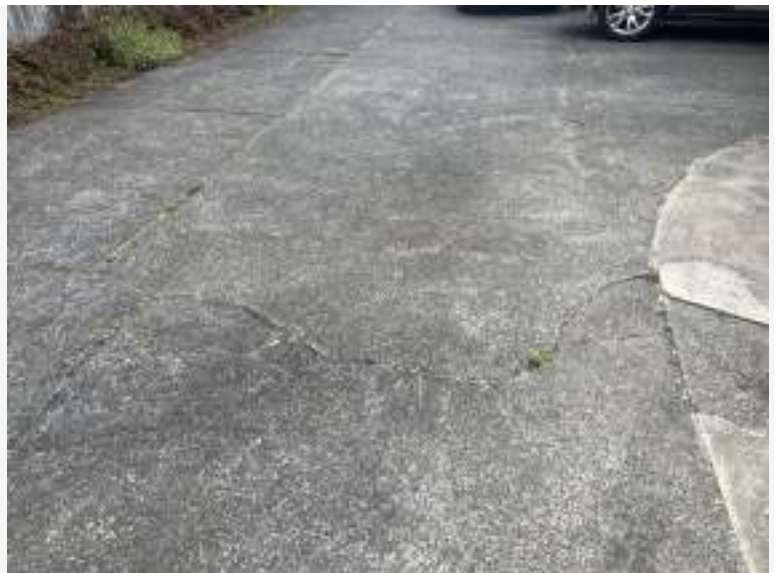
Cracking to the concrete/grouting was observed at the driveway. As a result, a cable is visible/exposed at the affected area. This may indicate localised movement or deterioration of the concrete surface, and the cable may be at risk of physical damage

Engage a concrete contractor or builder to repair the cracked area after the cable has been made safe and correctly protected (e.g., reinstate concrete/grouting and ensure the cable is not left exposed). In the meantime, avoid disturbing the cable and consider temporarily restricting access over the affected area (especially for vehicles), if practical.

Trades to engage: Registered electrician (first), then builder / concrete contractor (repair and reinstatement).

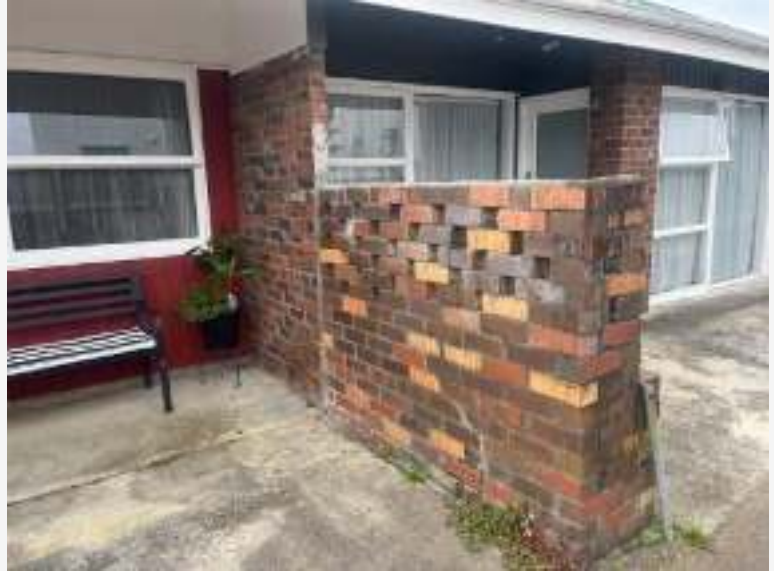
Vegetation growth was observed at the bottom of the brick wall. This typically indicates the area is staying damp and/or debris/soil has built up against the wall, allowing plants to take hold.

Vegetation against a wall can trap moisture and reduce drying, and over time may contribute to deterioration of mortar joints, staining, and moisture-related issues at lower wall areas. If soil or mulch is high against the wall, it can also reduce clearance and increase the risk of dampness

Remove the vegetation and clear any debris from the base of the wall.

Monitor for ongoing regrowth, damp staining, moss/algae, or deterioration of mortar joints.

If dampness persists or mortar is deteriorating, engage a suitably qualified builder to assess, and a landscaper/drainlayer if ground levels/drainage need improvement.

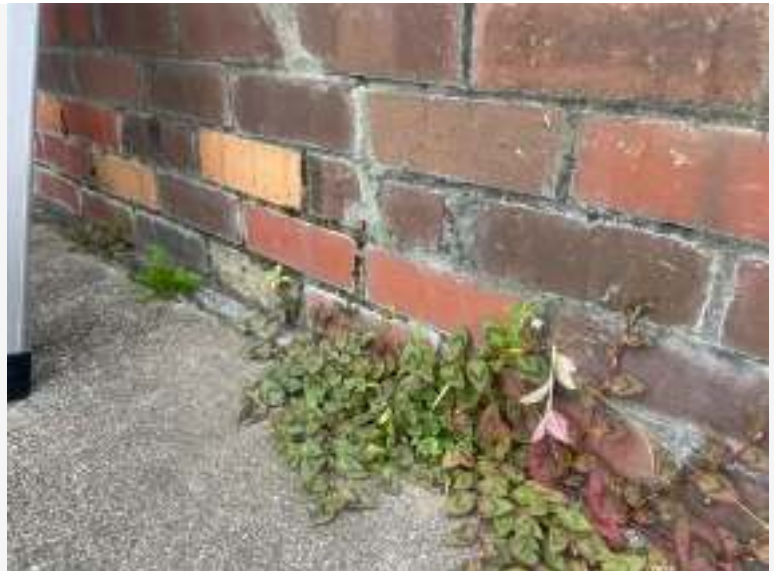
A vertical crack was observed at the brick wall mortar joint area at the time of inspection. This can occur due to minor movement/settlement, thermal expansion/contraction, shrinkage of mortar, or age-related deterioration.

Monitor the crack for changes (widening, lengthening, stepping cracks through bricks, or new cracks nearby).

If the crack is stable and minor, arrange masonry repair/repointing (remove loose mortar and repoint/reseal) to reduce water ingress.

If the crack is widening, there is visible displacement, or multiple cracks are present, engage a suitably qualified builder to assess further. An engineer may be required if significant movement is suspected.

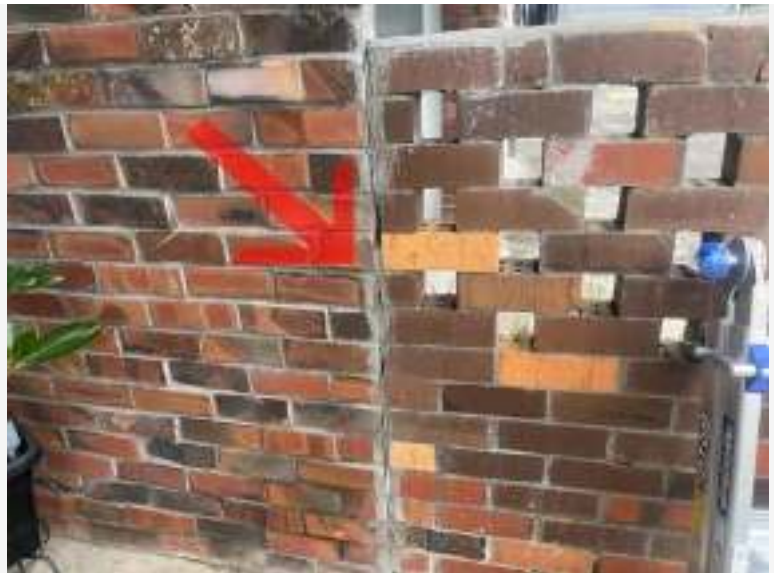
Moss growth was observed on/along the brick wall at the time of inspection. Moss typically forms where surfaces stay damp and shaded, and it can indicate limited sunlight, poor drying, water splash-back, or moisture being retained by debris/soil near the wall.

Clean and treat the affected area to remove moss (gentle wash/soft treatment suitable for masonry/avoid aggressive high-pressure washing that can damage mortar). Keep the base of the wall clear of soil, mulch, and debris and maintain reasonable clearance where practicable to improve drying. Monitor for recurrence and for signs of moisture-related deterioration (e.g., persistent damp staining, crumbling mortar, or efflorescence/white salts).

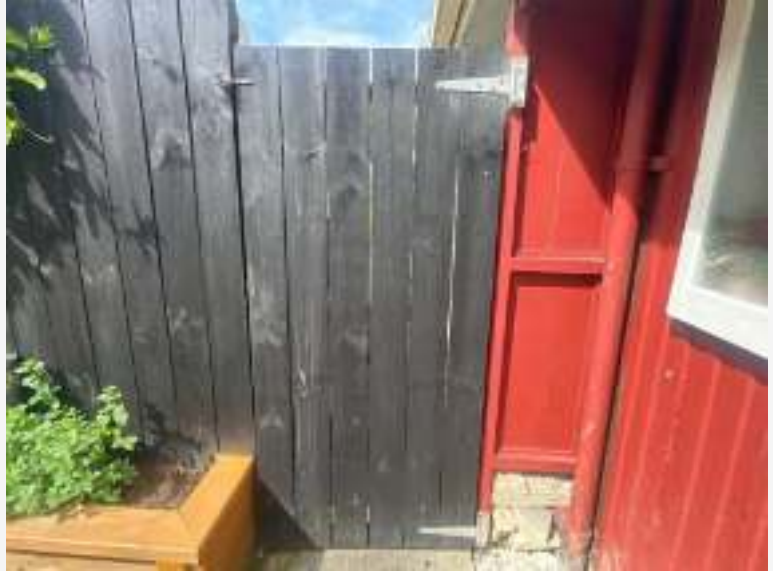
Rust/corrosion was observed to the gate lock/latch hardware at the fence gate at the time of inspection.

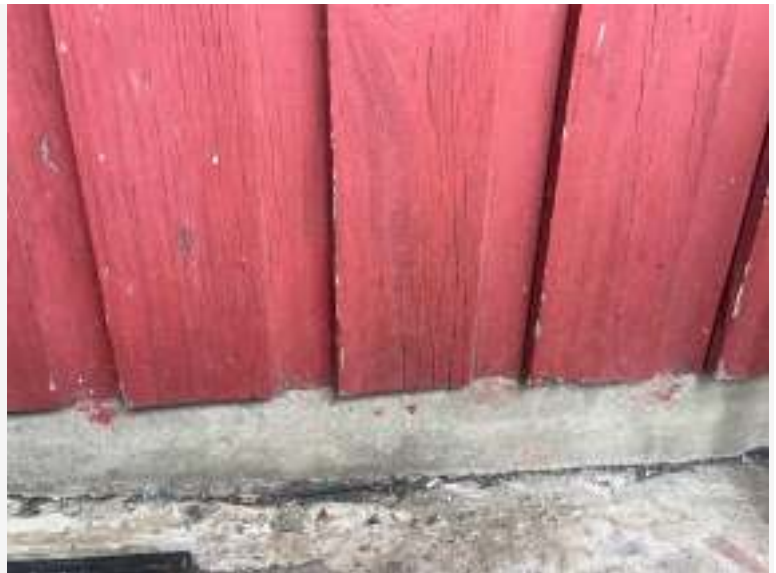
The timber cladding appears aged, and crack lines/hairline splits were observed to some boards at the time of inspection. This is commonly caused by long-term weather exposure, timber shrinkage/expansion, and ageing of paint/coating systems.

Fill/seal small cracks/splits and check/open up any failed joints or gaps before repainting (use suitable exterior-grade filler/sealant).

Monitor areas for soft timber, swelling, staining, or persistent dampness if present, arrange further assessment.

If cracking is significant, boards are deteriorated, or there are signs of rot, engage a suitably qualified builder (LBP recommended) to assess and repair/replace affected cladding sections.

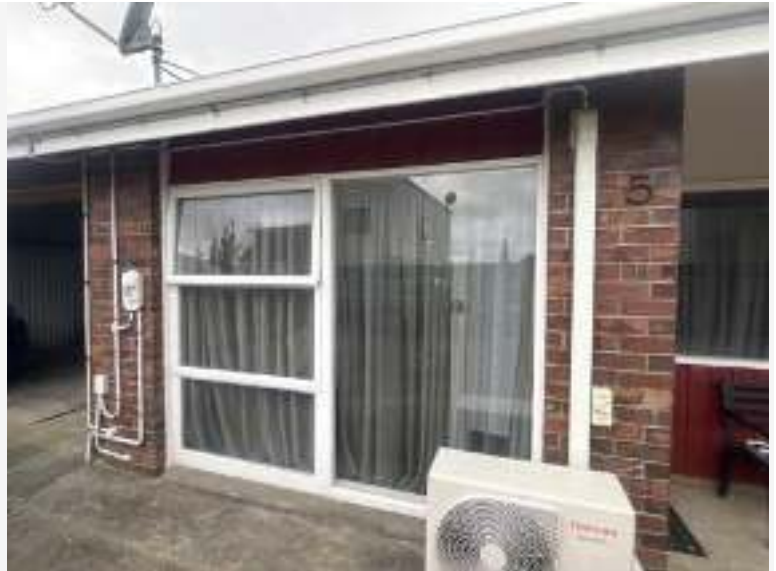
No weep holes were observed to the brick wall at the time of inspection. Weep holes are typically provided at the base of brick veneer walls (and above openings) to allow any moisture that gets behind the brick to drain out and to assist ventilation of the cavity.

Where weep holes are missing or blocked, moisture can remain trapped within the cavity, which may increase the risk of dampness, efflorescence (white staining), and deterioration of timber framing or wall components over time.

Confirm the wall type and weep-hole requirements by engaging a suitably qualified builder (LBP recommended) or bricklayer/mason. If the wall is confirmed as brick veneer, install appropriate weep holes (or proprietary weep vents) at the base of the veneer and other required locations, in accordance with good building practice and applicable detailing.

Check for signs of moisture-related issues (damp staining, mouldy smell, swollen/skirting damage internally, efflorescence on brickwork). If present, treat as a higher priority and consider further investigation.

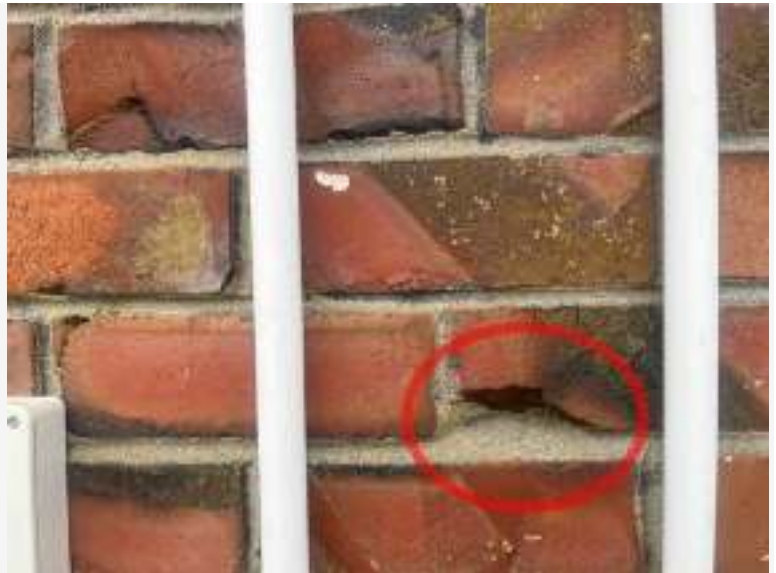
Minor cracking was observed to the brick wall/brickwork at the time of inspection (including small cracks to bricks and/or mortar joints). Minor cracking can occur due to normal building movement, mortar shrinkage, thermal expansion/contraction, and age-related wear.

Recommendation
Monitor the cracking for any changes (widening, lengthening, "stepping" cracks, or new cracks developing). Where appropriate, arrange repointing/sealing of affected mortar joints to reduce water ingress. If cracking worsens, appears widespread, or there is visible displacement, engage a suitably qualified builder for further assessment. A structural engineer may be required if significant movement is suspected.

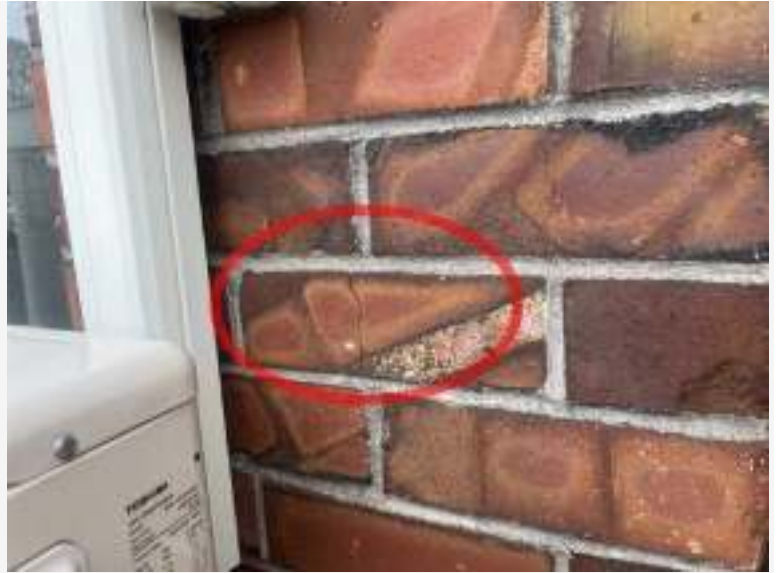
Minor cracking was observed to the brick wall/brickwork at the time of inspection.

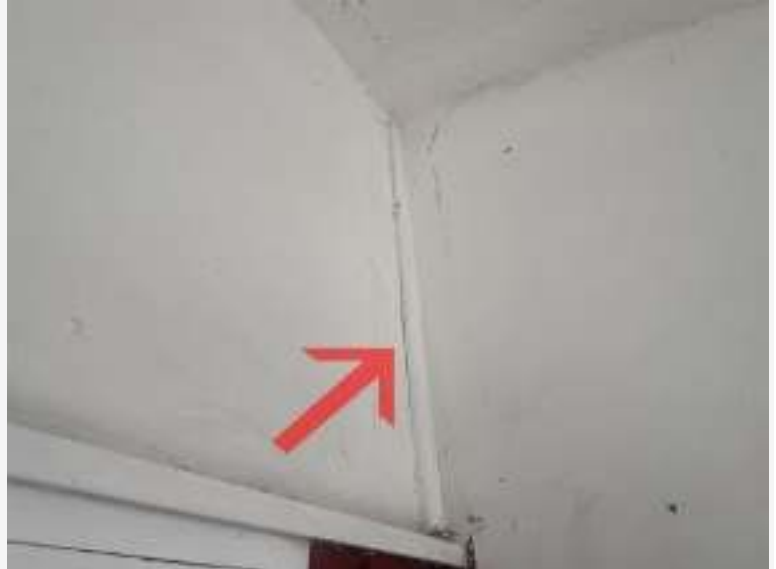
Pipe penetrations through the exterior cladding were observed. Any gaps around penetrations can allow wind-driven rain and moisture to track behind the cladding, increasing the risk of concealed dampness, staining, and (over time) timber deterioration.

This inspection is visual only. The condition of concealed flashings, building wrap, and the extent of any moisture impact behind the cladding cannot be confirmed without further investigation.

All pipe penetrations through the exterior cladding should be sealed and made weathertight, using appropriate exterior-grade sealing/flashings (e.g., compatible flexible sealant and/or proprietary pipe flashing). Ensure sealant is continuous and neatly finished, and maintain adequate fall/drip points where applicable.

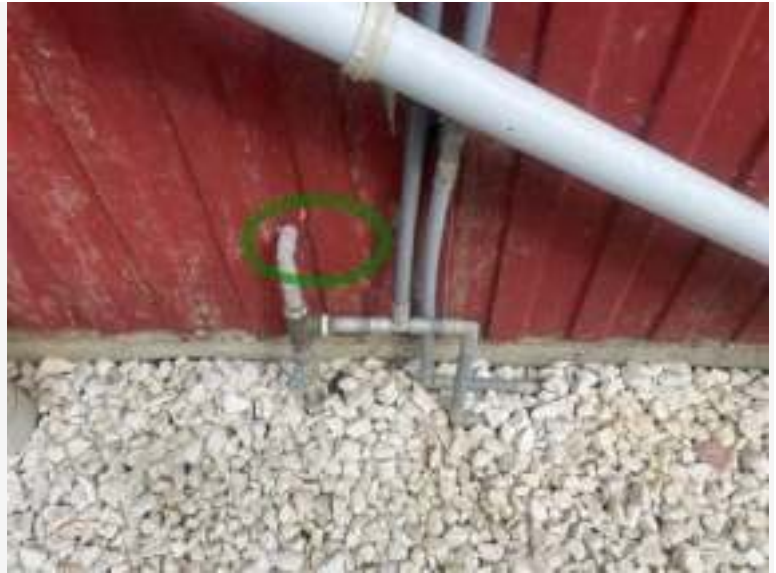
A section of exterior cladding was observed to be broken/damaged at the time of inspection. This inspection is visual only. The condition of concealed framing/building wrap and any moisture impact behind the damaged area cannot be confirmed without invasive investigation.

Repair or replace the damaged cladding section to reinstate weather-tightness and durability. The correct repair method will depend on the cladding material. Ensure repairs are properly sealed and finished (primed/repainted) to maintain protection and appearance. Monitor for signs of moisture ingress around the damaged area (staining, swelling, softening, mould, bubbling paint).

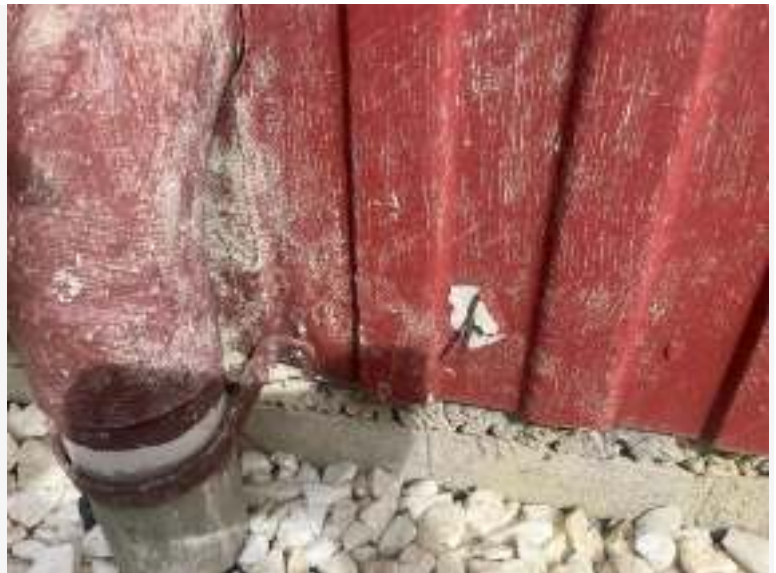
A nail was observed protruding through the exterior cladding from the inside to the outside. This presents a safety hazard (sharp projection) and has also damaged/broken the cladding at the penetration point. The penetration creates a pathway for moisture entry, increasing the risk of water ingress behind the cladding and potential deterioration of underlying materials over time.

This inspection is visual only. We could not confirm the extent of concealed damage, the condition of underlying framing/wrap, or whether moisture has entered behind the cladding at this location without further investigation.

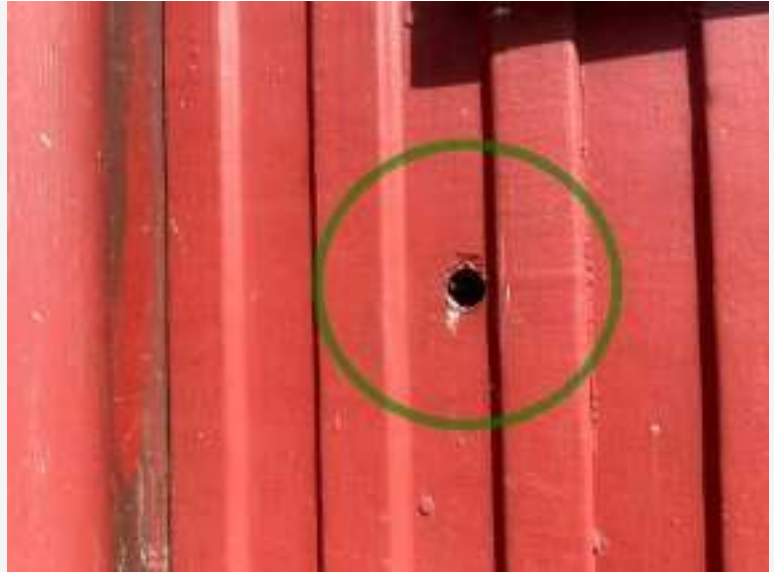
A hole was observed in the exterior cladding at the time of inspection. Openings in cladding can allow wind-driven rain and moisture to enter behind the cladding, increasing the risk of concealed dampness and potential deterioration of underlying materials over time.

This inspection is visual only. The condition of framing/building wrap behind the cladding and any hidden moisture impact cannot be confirmed without further investigation.

Treat as a priority maintenance item and repair the hole promptly to reinstate weather-tightness.

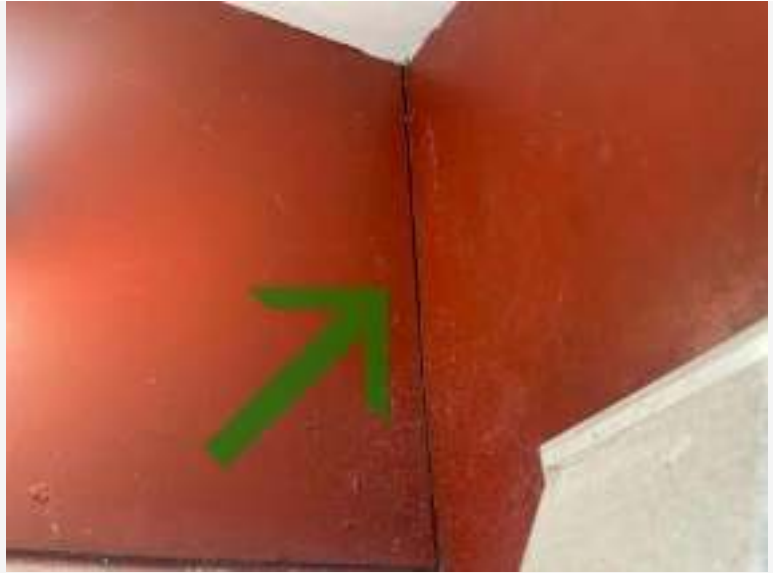
A section of exterior cladding was observed to be broken/damaged at the time of inspection.

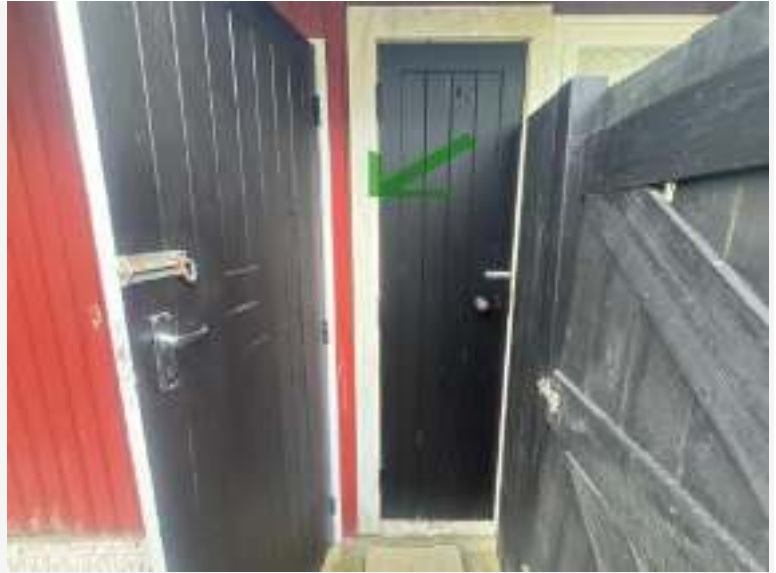
The paint finish was observed to be aged with areas of peeling/flaking at the time of inspection. Paint failure can occur due to normal ageing, poor surface preparation, moisture exposure, heat/sun (UV), or movement/cracking of the underlying substrate.

Peeling paint reduces surface protection and may allow moisture ingress (particularly externally) and can lead to further deterioration of the underlying material if not maintained.

Treat as a maintenance item: scrape/remove loose paint, properly prepare the surface, prime, and repaint with a suitable paint system. Where paint is peeling due to moisture (e.g., bathrooms, wet areas, exterior walls), identify and address

the moisture source before repainting.

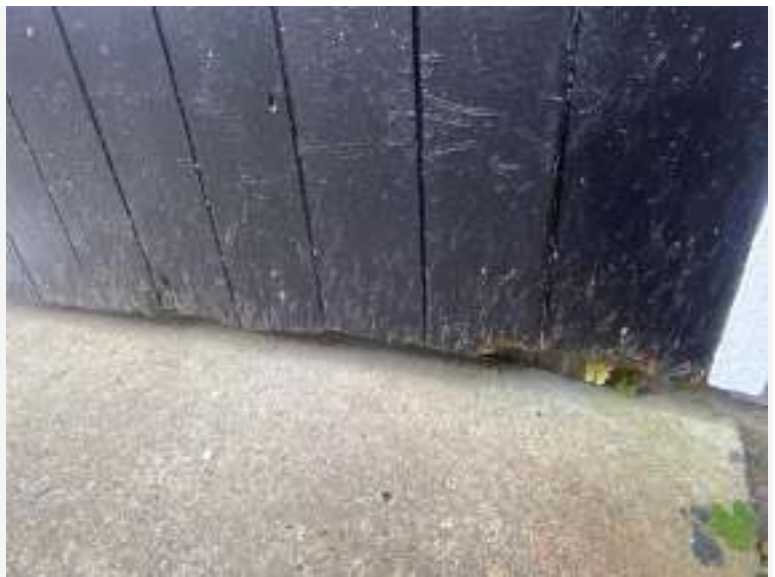
A gap was observed between the exterior cladding and the door jamb/trim at the time of inspection. Gaps at door junctions are a weathertightness risk, as wind-driven rain can enter behind the cladding and track into the wall assembly. This inspection is visual only. The condition of concealed flashings, air seal, and building wrap behind the junction cannot be confirmed without invasive investigation.

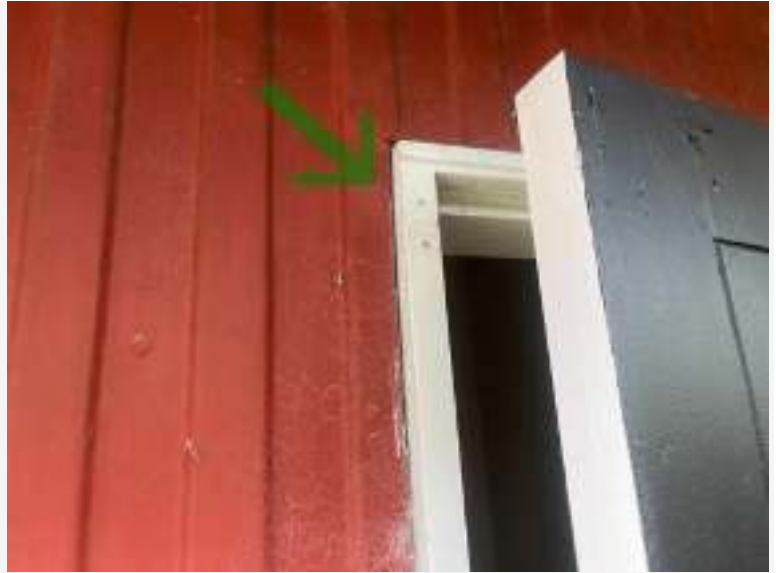
A gap was observed between the exterior cladding and the door jamb/trim at the time of inspection.

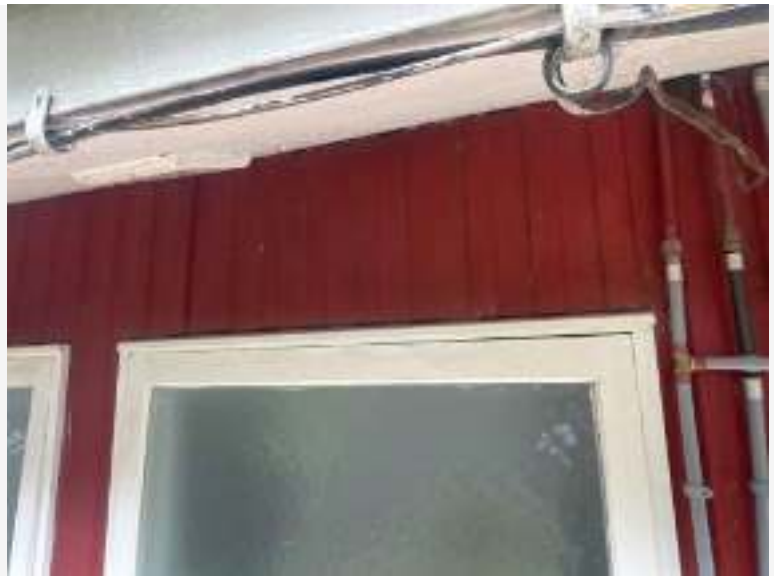
At the time of inspection, there appeared to be no sufficient gap/clearance between the head flashing and the cladding at the top of the opening.

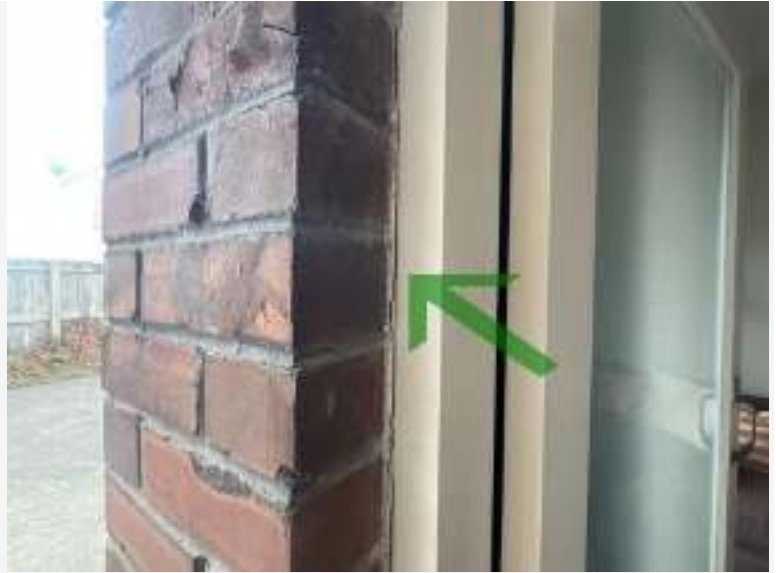
A gap was observed between the exterior cladding and the door jamb/trim at the time of inspection.

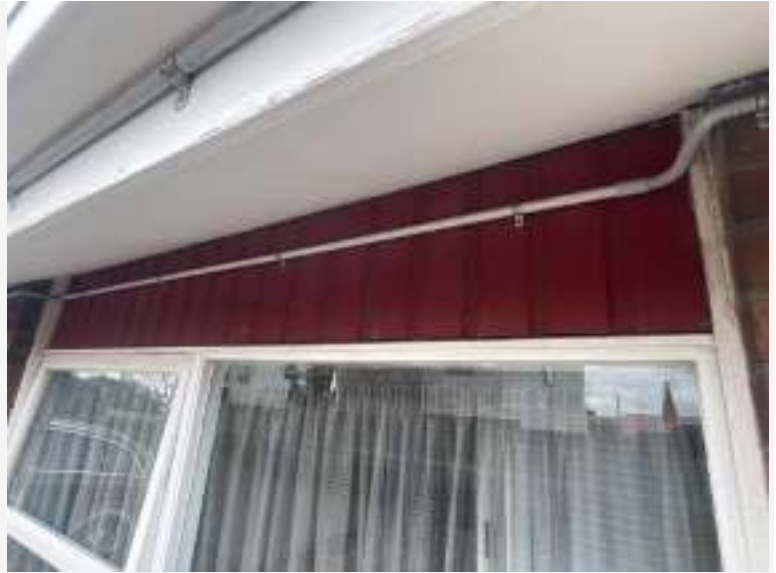
At the time of inspection, there appeared to be no sufficient gap/clearance between the head flashing and the cladding at the top of the opening.

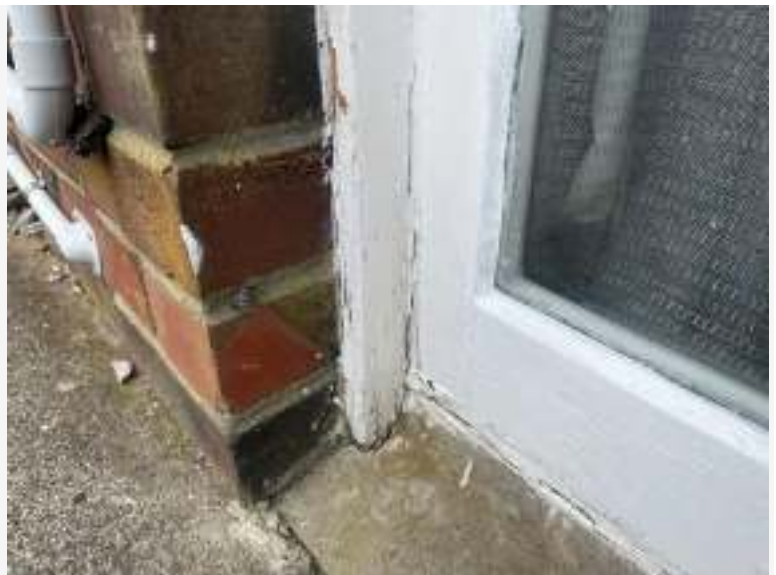
Peeling paint was observed to the window jamb, and minor timber rot/decay was noted at the affected area at the time of inspection. This commonly occurs where moisture has been able to enter timber due to failed paint coating, gaps in sealant, poor drainage, or prolonged wetting/condensation.

If not addressed, timber decay can progress and may affect the durability of the window surround and the ability to maintain a weathertight seal.

This inspection is visual only. The full extent of decay and any concealed moisture impact behind the jamb cannot be confirmed without opening up/removing the affected timber.

Engage a suitably qualified builder/joiner (LBP recommended) to assess the jamb and carry out repairs. Typical work may include:
Removing softened/decayed timber

and splicing/patch repairing or replacing affected sections (depending on extent).
Checking and renewing sealant at junctions (jamb to cladding/joinery).
Ensuring water can drain correctly and that detailing does not trap moisture.
After repairs, prime and repaint with a suitable exterior paint system to reinstate protection.
Monitor for ongoing moisture indicators (staining, recurring paint failure, softness, mould).

Trades to engage: Builder/Joiner (repair/replace timber jamb).
Painter (prepare and repaint).

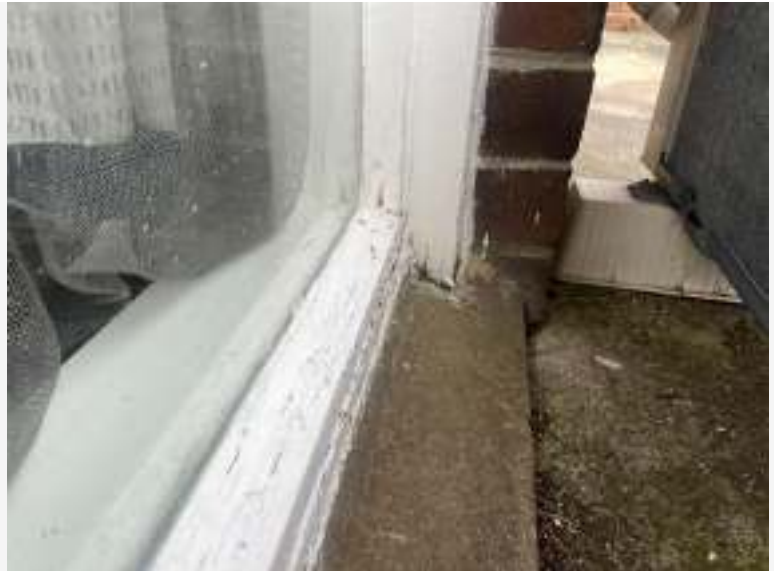
The paint finish was observed to be aged with areas of peeling/flaking at the time of inspection.

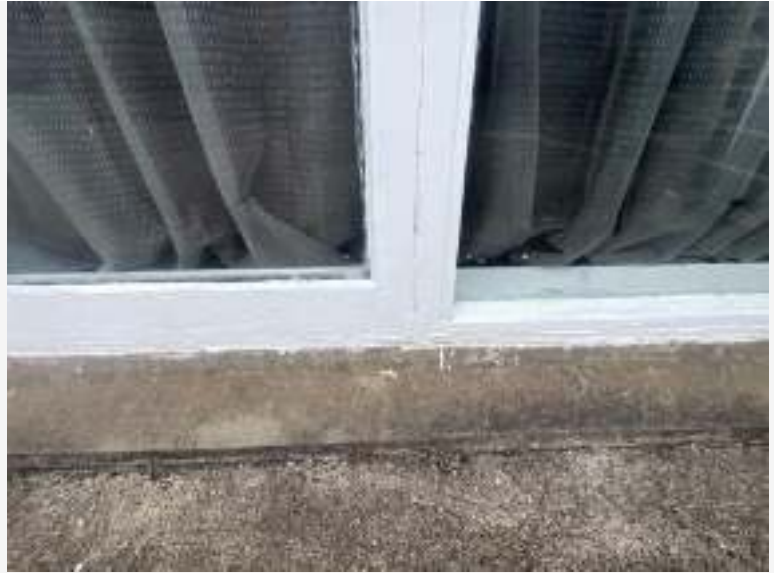
The paint finish was observed to be aged with areas of peeling/flaking at the time of inspection.

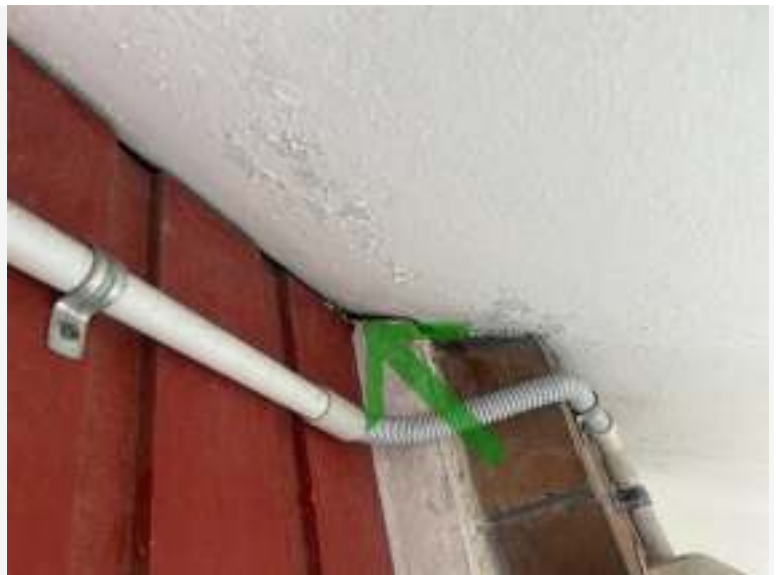
A gap was observed at the junction between the exterior cladding and the soffit/eaves lining at the time of inspection.

Monitor for signs of moisture issues (staining, mould, soft timber, or pest activity) around the eaves line.

If the gap is large, recurring, or suggests loose soffit/cladding components, engage a suitably qualified builder (LBP recommended) to assess and rectify.

Trades to engage: Builder/LBP (repair/refix and sealing/closure).
Painter (finish/touch-up).

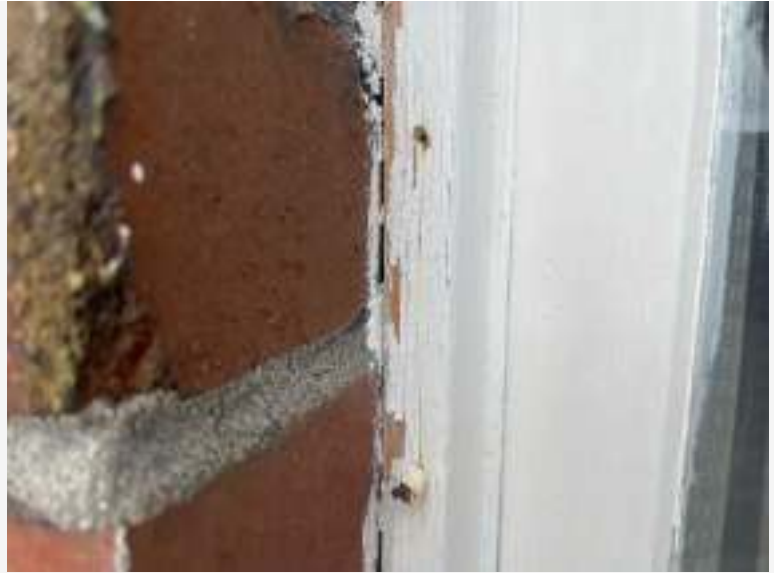
The paint finish was observed to be aged with areas of peeling/flaking at the time of inspection.

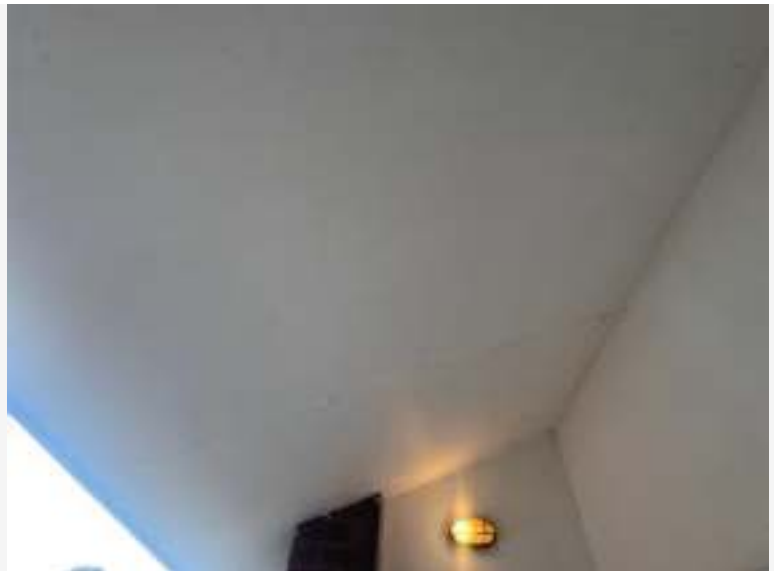
The soffit/eaves lining paintwork was observed to be aged with areas of peeling/flaking at the time of inspection. Paint failure in soffits can occur due to weather exposure at the roof edge, moisture, poor previous preparation, or age-related breakdown of the coating system. Peeling paint reduces protection and may allow moisture to affect the substrate (timber or fibre-cement), potentially leading to further deterioration over time.

This inspection is visual only. The condition of the substrate beneath the paint and any concealed

moisture issues within the eaves area cannot be fully confirmed without preparation work/removal of loose material.

Treat as a maintenance item: remove loose/flaking paint, prepare the surface, apply appropriate primer/sealer, and repaint with an exterior-grade system suitable for soffits.

Check for contributing moisture sources (e.g., leaking gutters, overflow, poor falls, or wind-driven rain) and address these prior to repainting where applicable.

Monitor for ongoing peeling, staining, mould, or softening of the soffit lining present, arrange further assessment.

Trades to engage: Painter/Decorator (prep and repaint). Builder (if soffit lining is damaged/soft or moisture source requires repair).

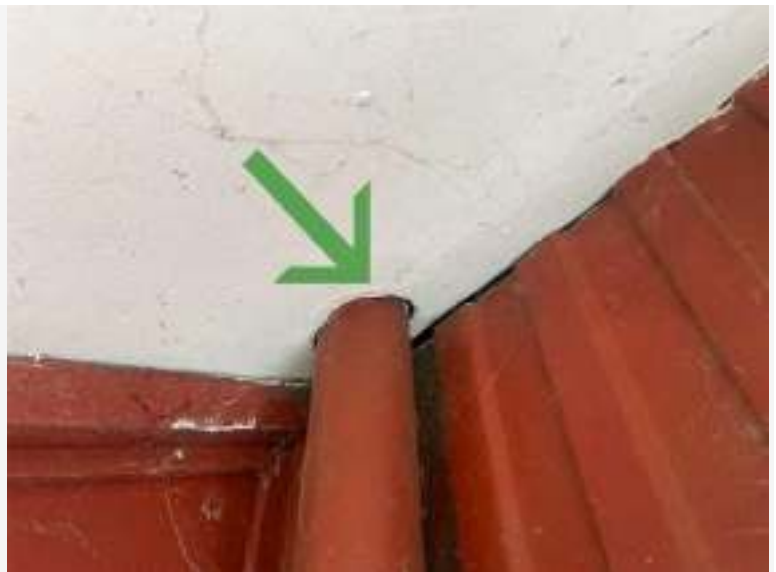
Pipes and/or cables were observed penetrating the soffit/eaves lining. Any gaps around these penetrations can allow wind-driven rain, moisture, insects, and draughts to enter the roof edge/ceiling space. Over time, this may contribute to dampness, staining, mould risk, and deterioration of soffit linings or adjacent framing.

All pipes or cables penetrating the soffits should be sealed and finished neatly using suitable exterior-grade sealant and/or appropriate grommets/penetration covers, ensuring the seal is continuous and compatible with the soffit material.

Trades to engage:
Builder/Handyman or Painter (seal,
repair, and finish).

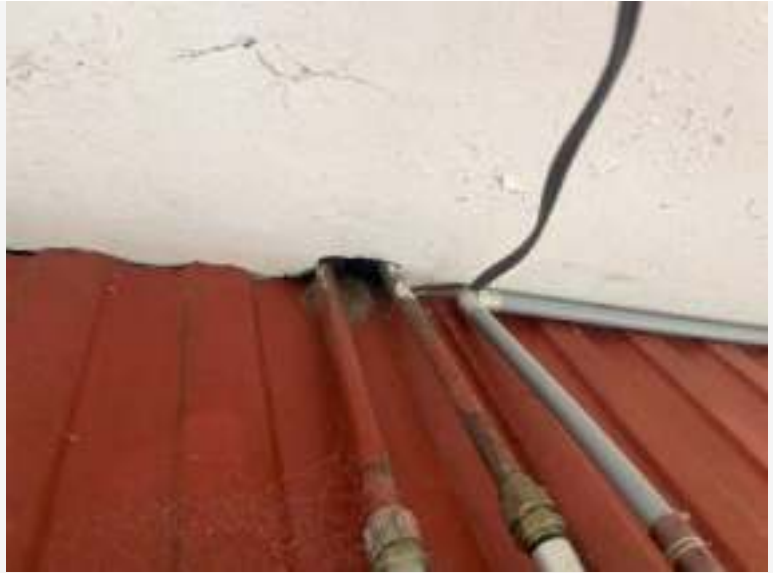
Pipes and/or cables were observed penetrating the soffit/eaves lining.

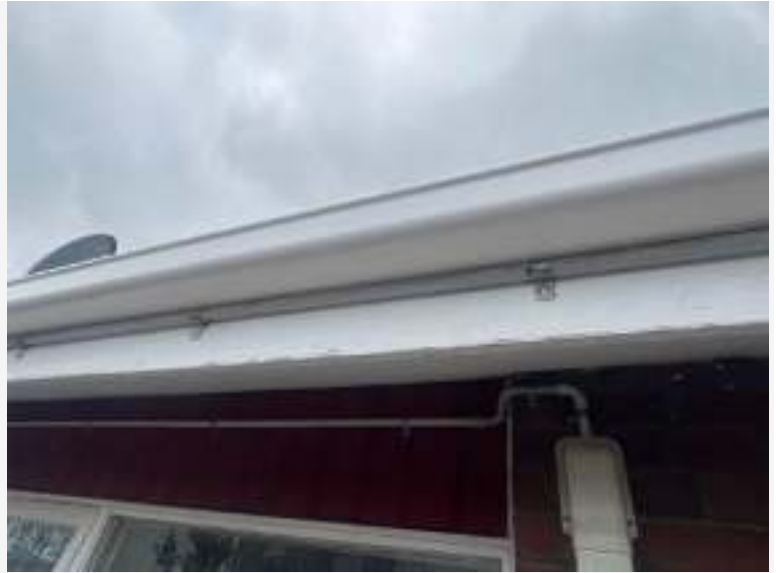
The fascia paintwork was observed to be aged with areas of peeling/flaking at the time of inspection.

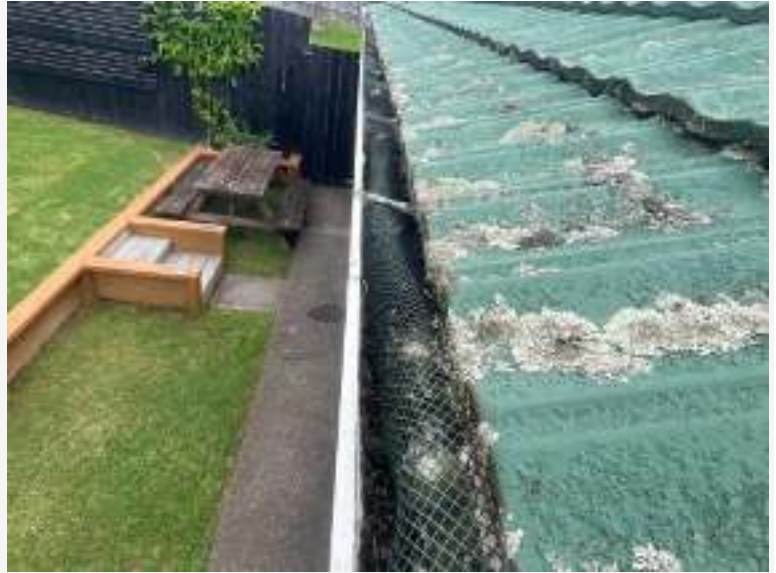
A blockage/build-up of debris was observed in the rear guttering at the time of inspection.

Consider a regular maintenance schedule (especially in autumn/spring) and/or installing gutter guards if debris build-up is frequent.

Monitor during heavy rain for any overflow or slow discharge.

Trades to engage: Gutter cleaning contractor / handyman (cleaning).

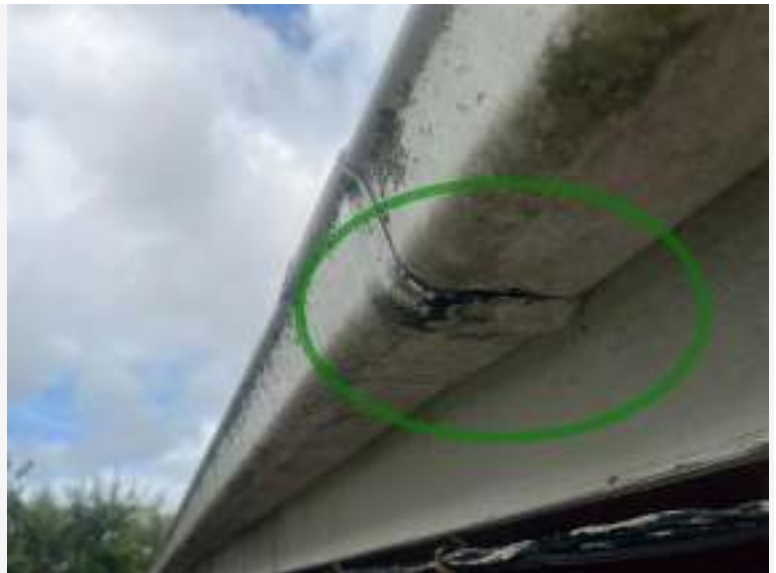
Leakage was observed at joints in the spouting (guttering) at the time of inspection. Leaking joints commonly occur due to ageing sealant, movement, corrosion, poor alignment, or debris build-up causing water to back up.

Arrange for the leaking joints to be repaired and resealed, and confirm gutters are correctly aligned with adequate fall to outlets.

If joints are significantly deteriorated or corrosion is present, consider replacing the affected gutter section/joint.

After repair, monitor during rainfall to confirm there is no ongoing leakage or overflow.

Trades to engage: Gutter specialist / roofing contractor (spouting repairs) or handyman.

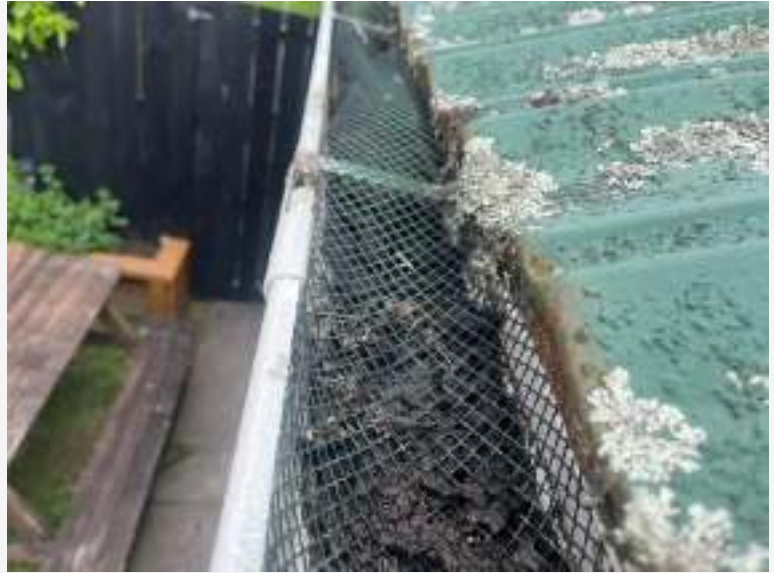
A minor blockage/build-up of debris was observed in the rear guttering at the time of inspection.

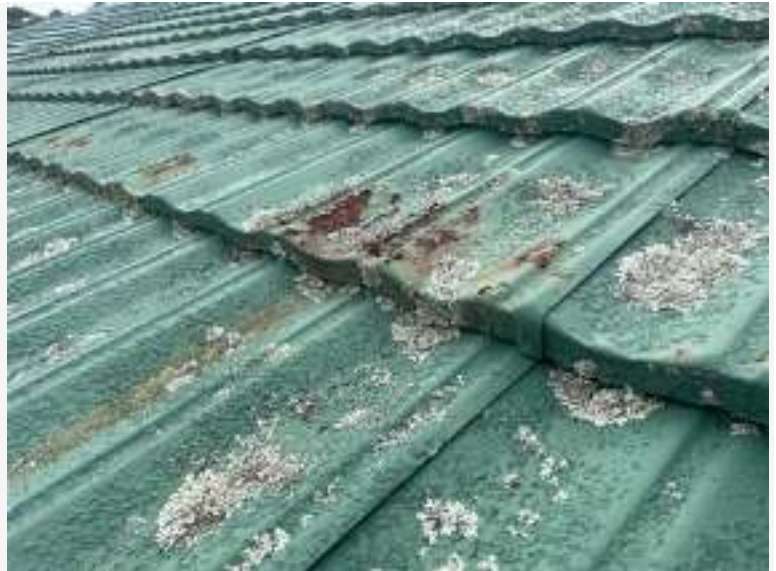
Lichen growth was observed on the roof surfaces at the time of inspection. Lichen commonly develops on roofs that remain damp/shaded and can retain moisture on the surface, which may accelerate coating breakdown and contribute to premature corrosion.

Areas of surface rust were also observed to the roof covering. Rusting typically indicates the protective coating has deteriorated and, if left untreated, corrosion can progress and reduce the service life of the roofing material.

This inspection is visual only. The full condition of roof fixings, laps, underlay, and any concealed corrosion cannot be confirmed without closer inspection and/or roof access.

Arrange for a roof clean and lichen treatment (soft-wash/chemical treatment appropriate for roofing). Avoid aggressive high-pressure water blasting, as it can damage coatings and drive water into laps/penetrations.

Engage a suitably qualified roofing contractor / roof painter to assess the rusted areas and carry out remedial work, which may include:

Rust treatment (remove loose corrosion, apply rust converter/primer), and recoating/painting to reinstate protection; and/or

Replacement of affected sheets/fixings if corrosion is advanced or perforation is present.

Monitor for related issues such as staining to ceilings, drips after rain, or rust bleeding at fixingstreat as higher priority if any leak indicators are present.

Trades to engage: Roof cleaning contractor (lichen treatment), Roofing contractor / Roof painter (rust repair, recoating, or replacement as required).

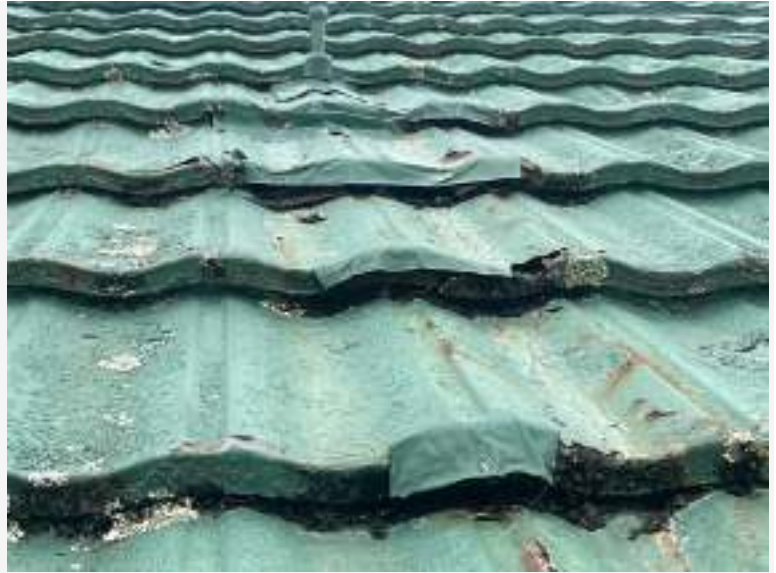
Previous roof repair work appears to have been carried out; however, rust/corrosion is still present on the roof covering at the time of inspection. This suggests the underlying protective coating remains compromised and corrosion may still be active in localised areas (e.g., around fixings, laps, repaired sections, or areas that remain damp).

This inspection is visual only. The extent of corrosion to concealed areas, the condition of fixings/underlay, and whether there is any underlying moisture impact cannot be confirmed without closer inspection and/or roof access.

Engage a suitably qualified roofing contractor / roof painter to assess the remaining rust and determine the most appropriate remediation, which may include:

Proper rust preparation (remove loose corrosion), rust treatment/primer, and recoating/roof painting; and/or Replacement of affected roofing sheets and/or fixings if corrosion is advanced or perforation is present. If the roof has ongoing lichen/moss, have this treated as it can retain moisture and accelerate corrosion. Monitor interior ceilings and roof spaces (where accessible) for any signs of active leaks (staining, dampness), and treat as higher priority if any leak indicators are present.

Trades to engage: Roofing contractor / Roof painter (assessment and remedial work). Roof cleaning

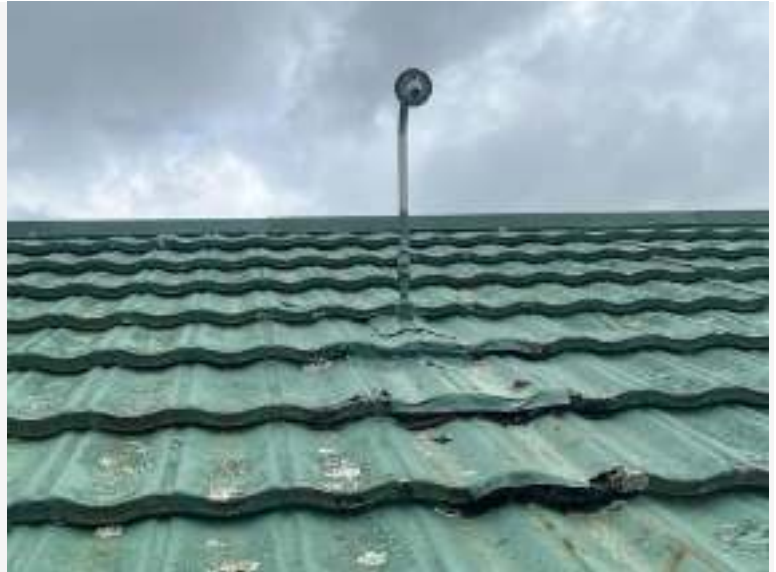
A copper pipe was observed penetrating through the roof at the time of inspection. The purpose/function of this pipe (e.g., plumbing vent, discharge/overflow, or other service) could not be confirmed during a visual inspection.

Roof penetrations are potential weathertightness points. If the pipe is not correctly flashed/sealed, or if its function is not appropriate (e.g., incorrect termination), there is an increased risk of water ingress and moisture-related damage.

Engage a registered plumber to confirm the function of the copper pipe and verify it is correctly connected, terminated, and compliant for its intended purpose. Have the plumber also check the roof flashing/sealing around the penetration and rectify if required to ensure it is watertight.

Monitor for any signs of leaks (ceiling staining, dampness) around the penetration area.

Trade to engage: Registered plumber (and roofer if roof flashing repairs are required).

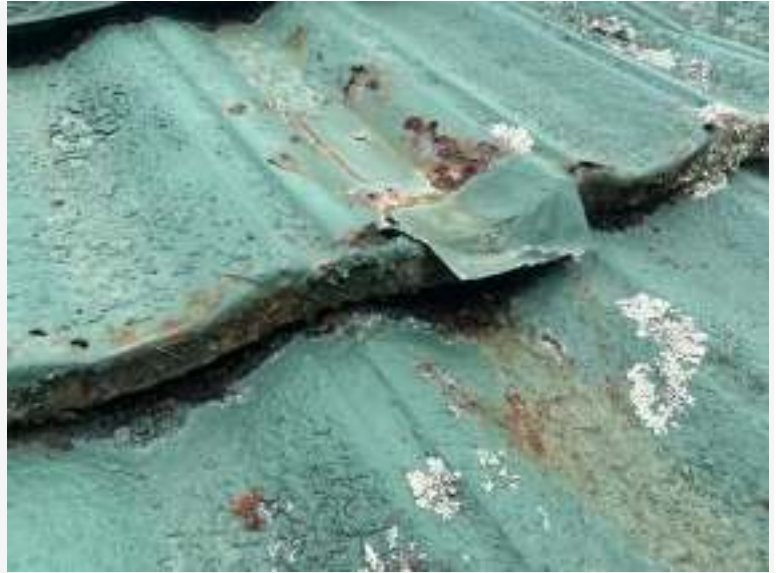
Areas of rust/corrosion were observed to the roof covering at the time of inspection, and a hole/opening was also noted. A hole in the roof is a weathertightness defect and can allow water ingress, which may lead to damage to underlay, framing, insulation, and interior linings if not addressed.

This inspection is visual only. The extent of corrosion, the condition of roof underlay, fixings, and any concealed moisture damage beneath the affected area cannot be confirmed without closer inspection and/or opening up.

Monitor interior ceilings and roof space (where accessible) for signs of leakage (staining, dampness, mould smell) and escalate urgently if leakage is evident.

Trades to engage: Roofing contractor (urgent). Roof painter (if recoating is recommended after repairs).

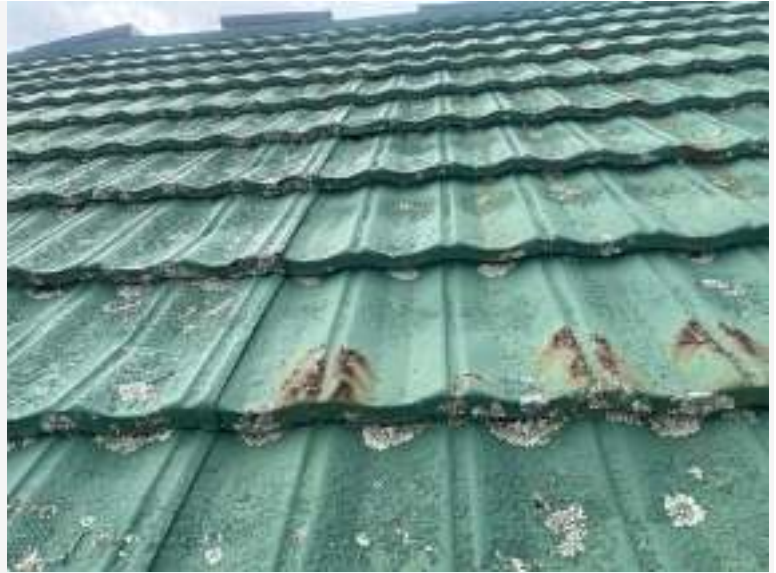
Lichen growth and surface rust was observed on the roof surfaces at the time of inspection.
