Cozy Building Compliance

Pre-Purchase House Inspection

ADDRESS:	Sample report
CLIENT:	Young
AGENT:	Sample
INSPECTION DATE & Weather Conditions:	
PEOPLE PRESENT:	Buyer
TENANTS DETAILS:	The property was vacant at time of inspection.

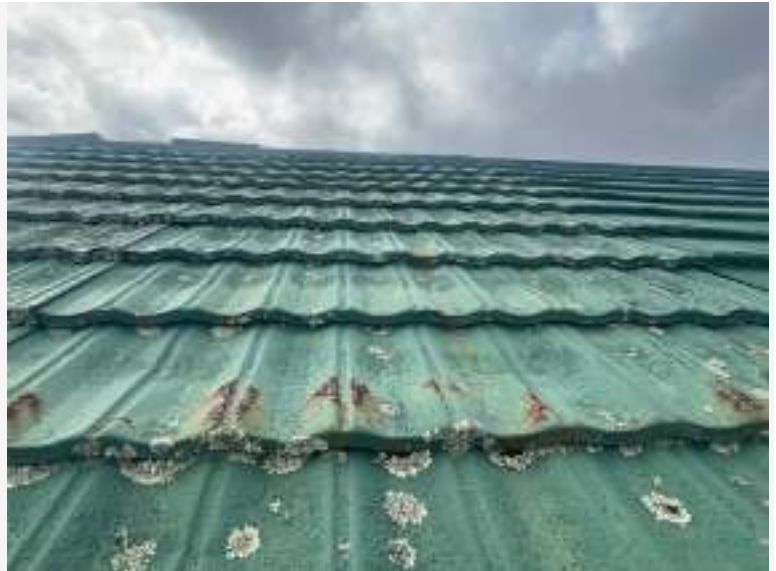
Lichen growth and surface rust was observed on the roof surfaces at the time of inspection.

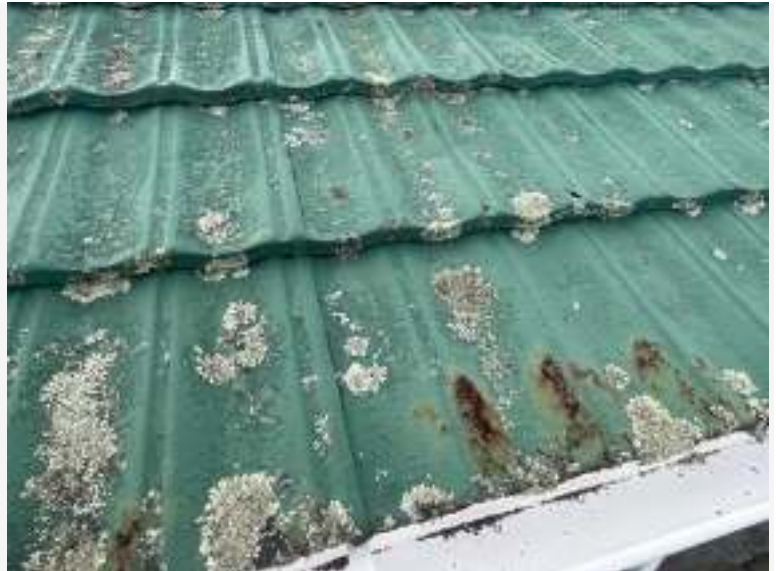
Lichen growth and surface rust was observed on the roof surfaces at the time of inspection.

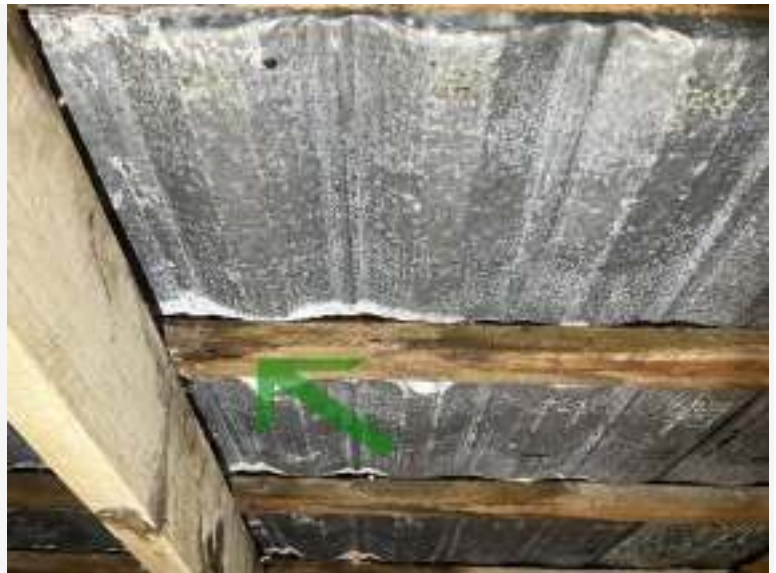
Water staining was observed on a roof purlin (timber member) at the time of inspection. Staining can indicate previous or ongoing moisture entry, commonly from minor roof leaks, flashing issues, or condensation. The staining may be historic; however, active leaks can lead to timber deterioration, mould growth, and damage to insulation/linings over time.

This inspection is visual only. We could not confirm whether the staining is from an active leak, nor confirm moisture content within the timber without further testing. The roof covering and flashings were not tested with water.

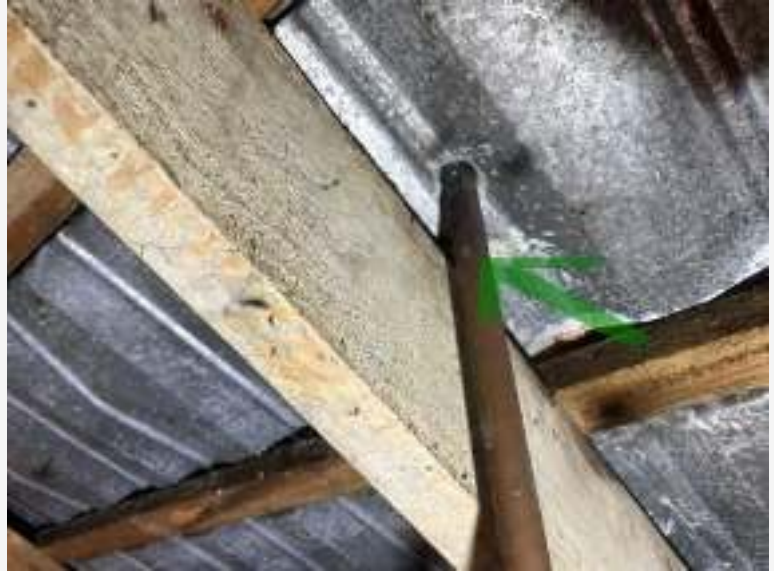
Green staining (verdigris) was observed on copper pipework at the time of inspection. This can occur from normal oxidation over time, however it can also indicate moisture exposure and, in some cases, a slow leak at a joint or fitting.

This inspection is visual only. We could not confirm whether the staining is historic or active, nor confirm the condition of the pipework joints/fittings without further testing.

Recommendation

Monitor the area for signs of an active leak (water droplets, dampness, staining increasing, water marks on nearby surfaces).

If the pipe is part of a water supply line and any moisture is present, engage a registered plumber to check the pipe and joints/fittings, and repair/replace as required.

If the staining is dry and stable, cleaning and periodic monitoring may be sufficient, but treat as a higher priority if located near electrical components or within wall/ceiling cavities.

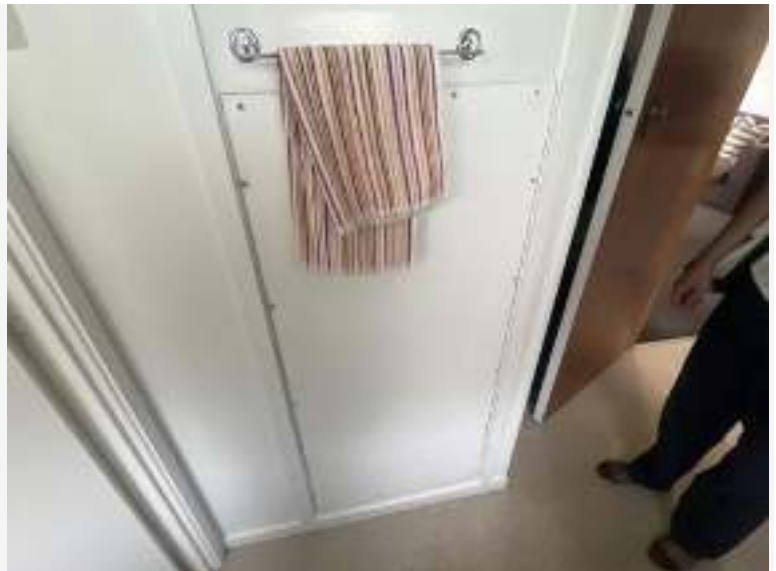
The hot water system is located within an internal wall / enclosed cupboard. At the time of inspection, the access panel/covering appeared securely fixed, and the unit could not be accessed without removal. Therefore, the hot water cylinder and associated valves/pipework could not be inspected.

This inspection is non-invasive and visual only. As access was not available, we could not confirm the condition of the cylinder, connections, relief valve discharge arrangement, evidence of leaks, corrosion, or compliance of the installation.

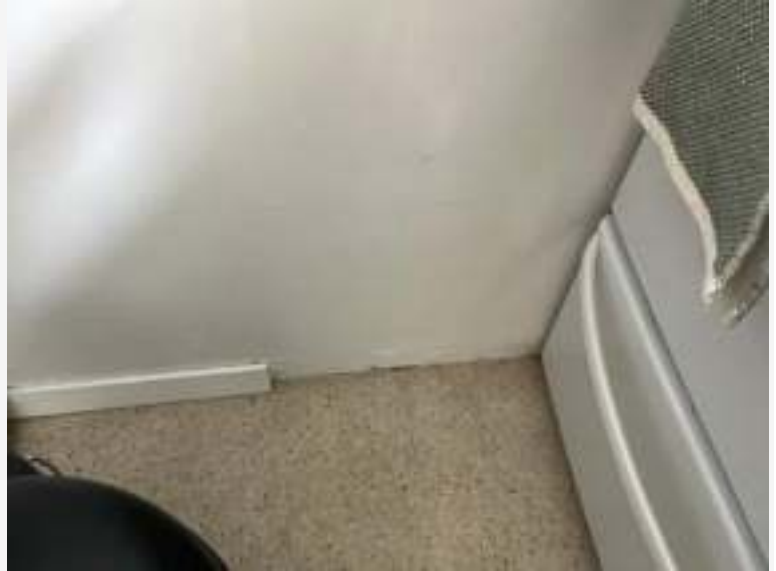
The wall finish in the fridge area was observed to be untidy at the time of inspection.

If the untidy finish is due to previous moisture damage (staining, soft linings, mould), engage a builder to investigate the cause prior to redecorating.

Trades to engage: Painter/Decorator (touch-up/repaint). Plasterer (if re-stopping is required). Builder (if moisture/substrate issues suspected).

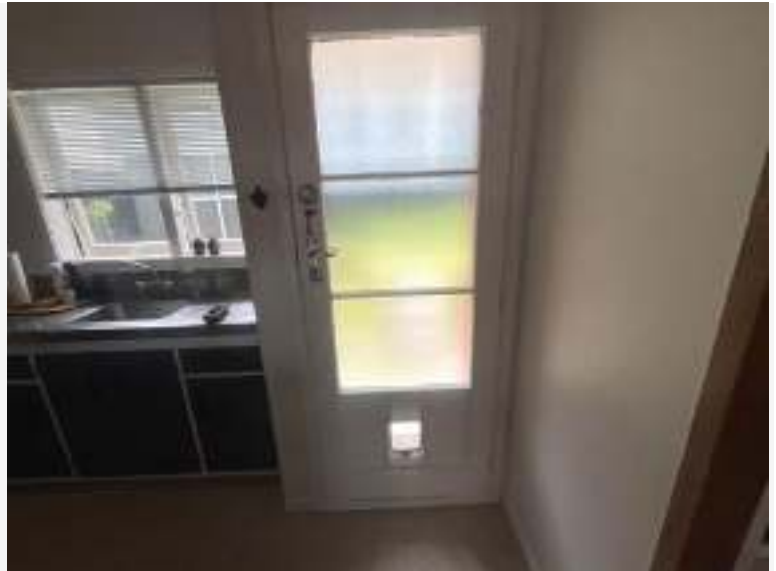
The paint finish to the door was observed to be aged/worn at the time of inspection. Age-related paint deterioration can occur from general use, cleaning, minor impacts, and normal wear over time. Where paint is worn through, the door surface (especially timber) may be less protected and more prone to marking or moisture uptake.

Treat as a maintenance/cosmetic item: prepare the surface (clean, sand, fill minor defects), then prime and repaint for a durable finish. If there are areas of swelling/softness or damage to the door leaf, engage a builder/joiner to assess prior to repainting.

Trades to engage: Painter/Decorator (prep and repaint). Builder/Joiner (if door repair is required).

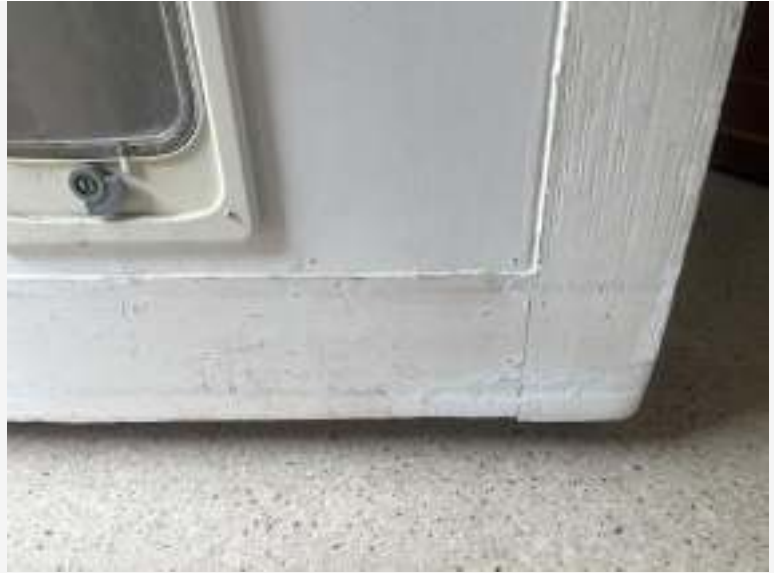
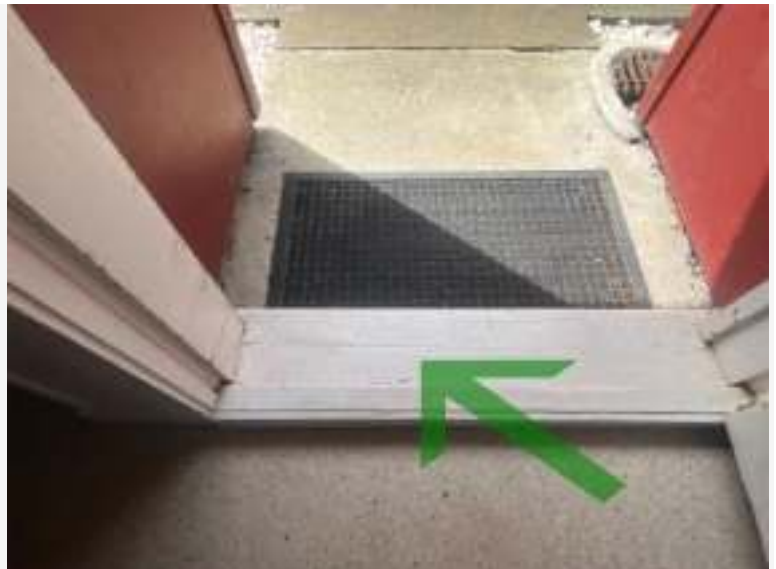
A crack line was observed at the door sill/threshold area at the time of inspection. This can occur due to minor movement, shrinkage of materials, impact wear, or ageing of the sill/finish. Cracks at door sills can allow moisture to enter the junction (particularly at exterior doors), which may contribute to deterioration of adjacent materials over time.

This inspection is visual only. The condition of concealed framing, flashings, and the full extent of the cracking beneath finishes cannot be confirmed without further investigation.

Treat as a maintenance item:
seal/repair the crack using an
appropriate product for the sill
material (e.g., suitable filler/sealant),
then refinish as required.

If this is an external door sill, ensure
the repair is weathertight and
maintains drainage/falls.

Monitor for any signs of water entry
(dampness, swelling/softness to
trims, staining internally). If
movement is evident or cracking
worsens, engage a suitably qualified
builder/joiner to assess and repair.

Trades to engage: Builder/Joiner
(repair and weathertight detailing).
Painter (finishing/recoat if
required).

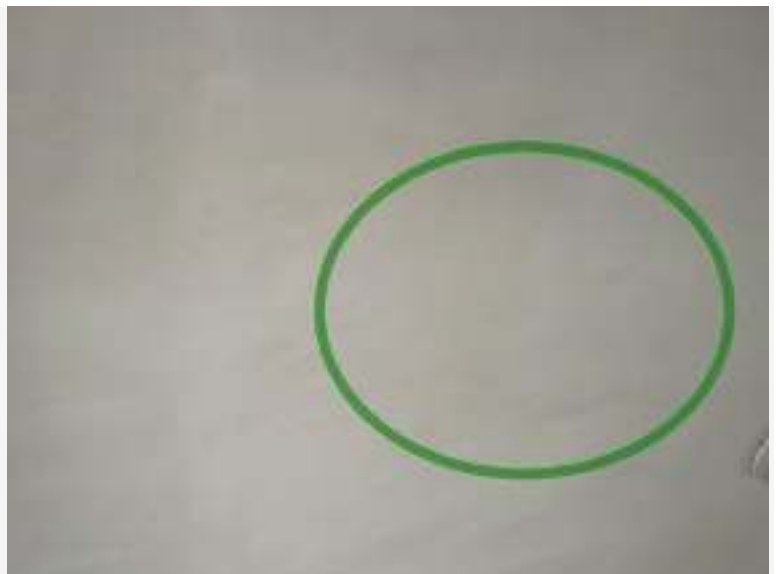
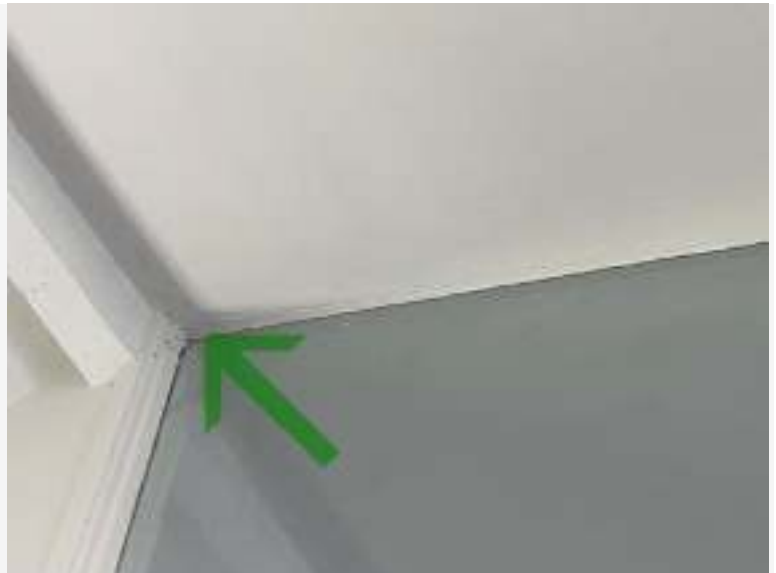
The ceiling paint finish was observed to be aged, with areas of peeling/flaking at the time of inspection. Peeling paint can occur due to normal ageing, poor previous surface preparation, or moisture/condensation (particularly in kitchens, bathrooms, laundries, or near roof leaks).

This inspection is visual only. The condition of the ceiling substrate and whether moisture is contributing to paint failure cannot be fully confirmed without further investigation and surface preparation.

The ceiling paint finish was observed
to be aged, with areas of
peeling/flaking at the time of
inspection.

Treat as a maintenance item:
scrape/remove loose paint, prepare
the surface, apply suitable
primer/sealer, and repaint.

If there are any signs of moisture
(staining, mould, dampness, musty
odour), identify and rectify the
moisture source before repainting
(e.g., improve ventilation, repair
leaks).

Monitor for recurring peeling,
staining, or mould growth if present,
arrange further assessment.

Trades to engage: Painter/Decorator
(prep and repaint). Builder/Rofer
(if leak-related) or Plumber (if
plumbing-related moisture is
suspected).

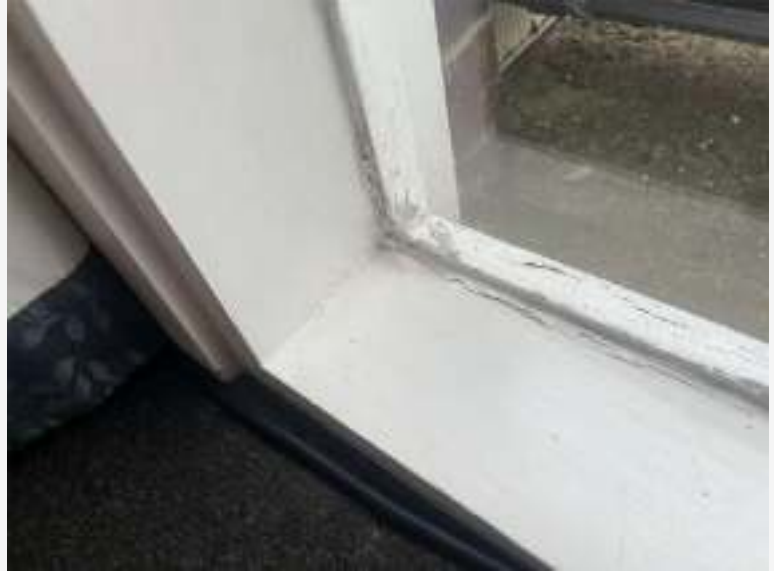
The sealant around the window (at the junction between the window frame and adjacent wall/trim) was observed to be aged/deteriorated at the time of inspection. Aged sealant can crack, shrink, or lose adhesion, which may allow moisture and draughts to enter around the window perimeter.

This inspection is visual only. The condition of concealed flashings, building wrap, and internal air seals cannot be confirmed without further investigation.

Treat as a maintenance item: remove loose/failed sealant, prepare the surfaces, and re-seal using a suitable exterior-grade, paintable, flexible sealant compatible with the cladding/joinery system.

Monitor for signs of water ingress around the window (staining, bubbling paint, mould, softness to trims). If moisture issues are evident, engage a builder (LBP recommended) for further assessment.

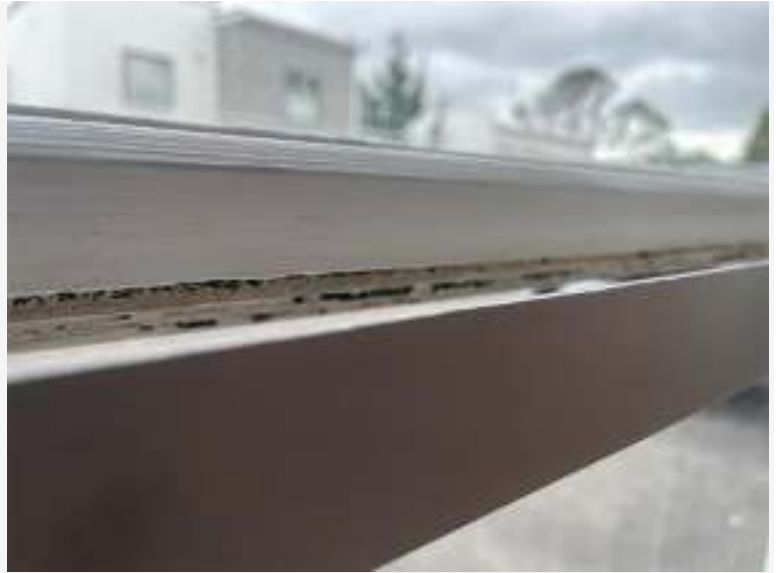
The paint finish to the window frame/surround was observed to be aged/worn at the time of inspection. Ageing paint is common due to UV exposure, weathering, and normal wear. Where paint is thin or failing, the underlying material (particularly timber) can be less protected and more prone to moisture uptake and deterioration over time.

Treat as a maintenance item: prepare the surface (clean, sand, remove loose paint), apply a suitable primer/sealer, and repaint with an appropriate exterior/interior paint system.

Pay particular attention to joints and bottom edges of timber frames where moisture commonly affects paint.

If any timber is soft, swollen, or showing signs of decay, engage a builder/joiner to repair before repainting.

Trades to engage: Painter/Decorator (prep and repaint). Builder/Joiner (if timber repairs are required).

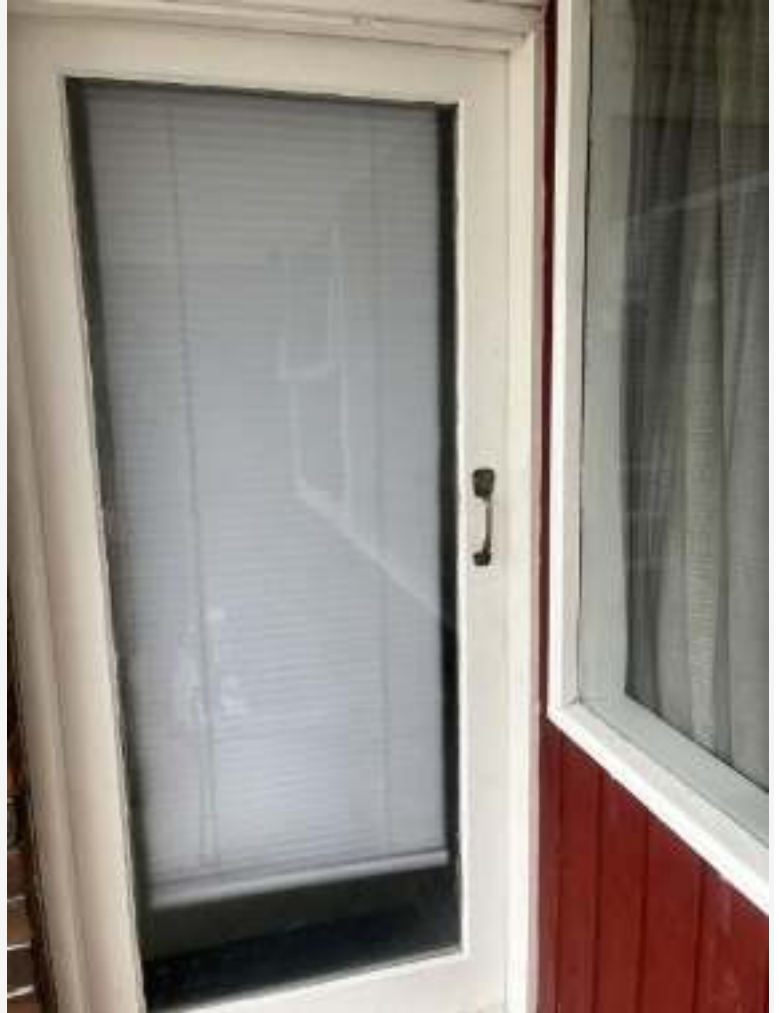
A couple of screws were observed protruding/visible on top of the door head jamb at the time of inspection. This may indicate a prior repair, adjustment, or temporary fixing.

If the door frame is loose or the door is not closing/latching smoothly, engage a suitably qualified builder/joiner to assess alignment and rectify.

Trades to engage: Builder/Carpenter or Joiner (fixing/adjustment).
Painter (patch and repaint).

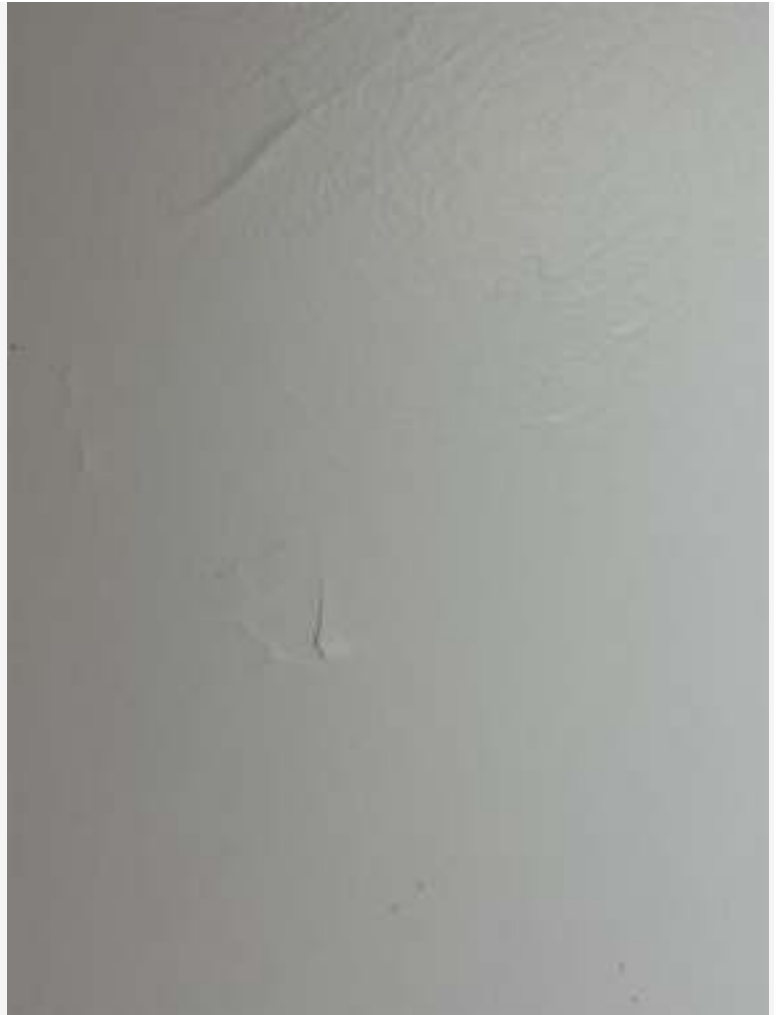
The ceiling paint finish was observed to be aged, with areas of peeling/flaking at the time of inspection.

Treat as a maintenance item: scrape/remove loose paint, prepare the surface, apply a suitable primer/sealer, and repaint
Monitor for recurring peeling, staining, or mould growth if present, arrange further assessment.

Trades to engage: Painter/Decorator (prep and repaint). Builder/Rofer (if roof leak suspected)

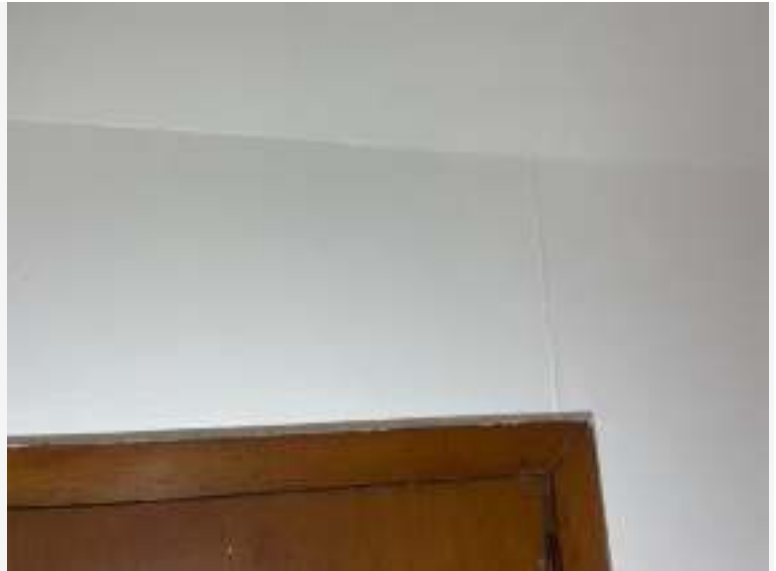
A crack was observed along the wall lining joint at the time of inspection. Joint cracking can occur due to minor building movement/settlement, timber shrinkage, seasonal changes, or ageing of stopping/paint finishes. In many cases this is cosmetic, however larger or progressing cracks may indicate ongoing movement.

This inspection is visual only. The condition of framing behind the lining and the extent of any movement cannot be confirmed without further investigation.

If minor and stable, treat as a cosmetic maintenance item: re-stop/fill the joint crack, sand, seal, and repaint to restore finish.

Monitor the crack over time for widening, lengthening, or reappearing after repair.

If the crack is significant, recurring, or accompanied by doors/windows sticking or other movement signs, engage a suitably qualified builder to assess potential underlying movement.

Trades to engage: Plasterer/Stopper (re-stopping) and Painter/Decorator (repaint). Builder (if movement is suspected).

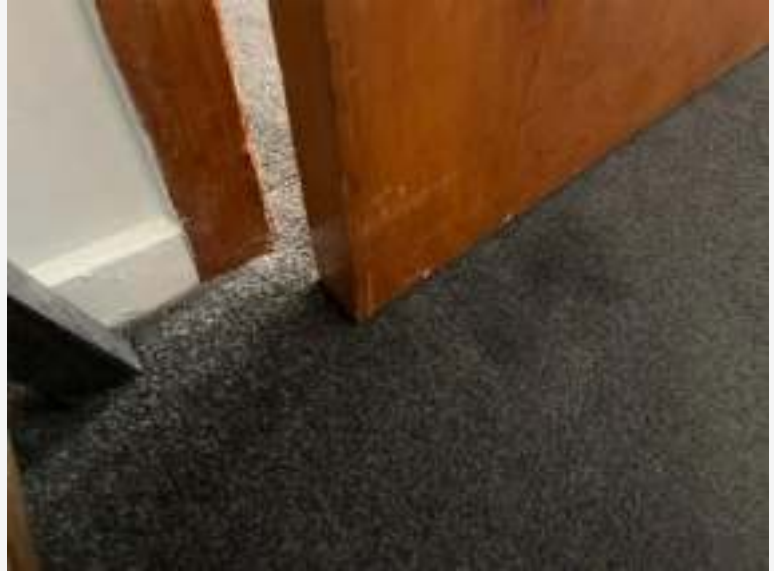
The door was observed to slightly rub/stick on the carpet during operation at the time of inspection.

First check for simple causes: ensure carpet is correctly trimmed at the door swing and that hinges/screws are tight.

If rubbing continues, a builder/joiner can adjust the door (hinge adjustment, re-hanging, or minor planing/trimming of the door bottom as appropriate).

After any trimming, ensure the cut edge is sealed/painted to reduce moisture uptake.

Trades to engage: Builder/Carpenter or Joiner (door adjustment). Carpet layer (if carpet needs trimming/refit).

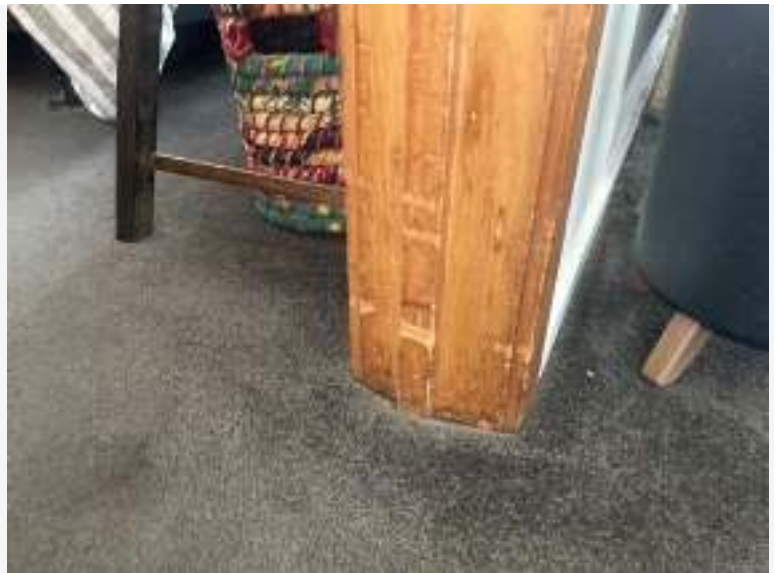
Impact damage was observed at the bottom section of the door jamb at the time of inspection.

Minor/cosmetic: repair by filling and sanding the damaged area, then seal/prime and repaint to protect the timber and restore appearance.

Trades to engage: Builder/Joiner (repair/replace if needed). Painter/Decorator (finish/repaint).

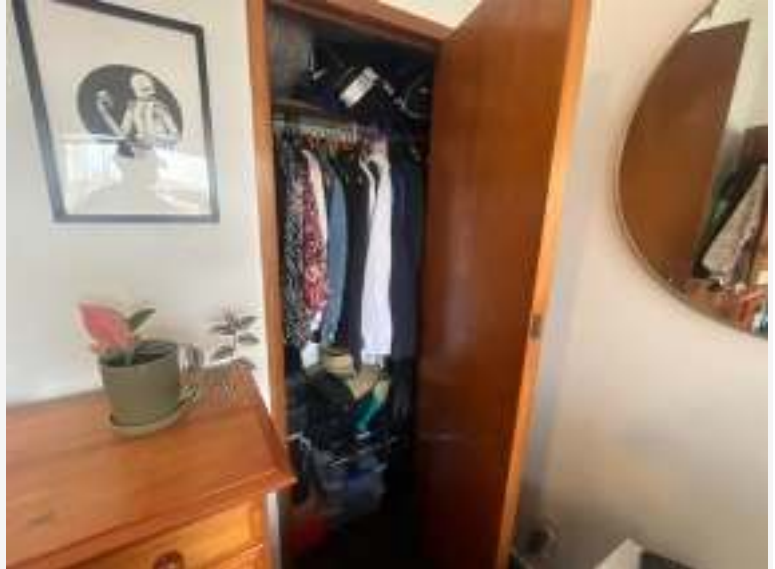
The cupboard was full of stored items and personal belongings, which prevented an inspection of the interior.

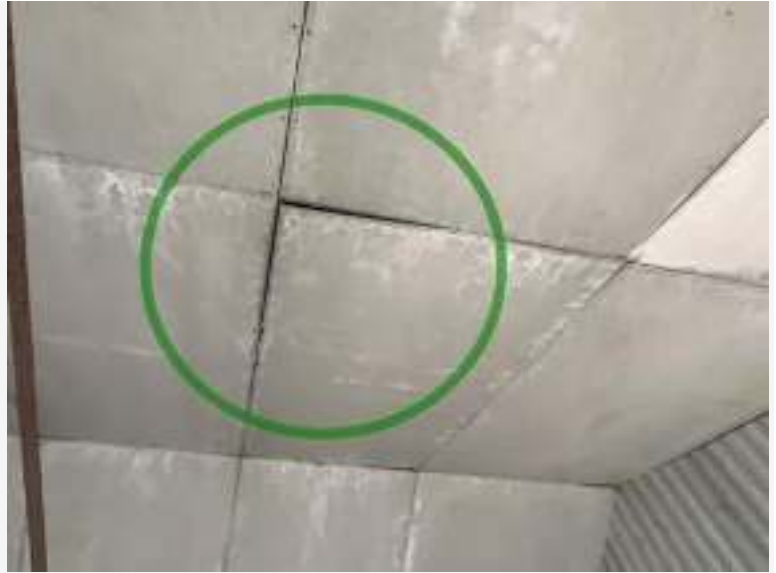
Interior Ceiling (Ceiling Line Dropped / Sagging)

A section of the ceiling lining appeared to have dropped/sagged (uneven ceiling line) at the time of inspection. This can occur due to age-related movement, inadequate fixings, framing movement, previous repairs, or moisture/condensation affecting the ceiling lining and fasteners.

This inspection is visual only. The condition of the ceiling fixings, ceiling framing, and any concealed moisture issues within the roof space could not be confirmed without further investigation/access.

ceiling lining and framing and determine the cause. Remedial work may include refixing the ceiling lining, replacing affected lining sections, and reinstating a level finish.

If there are any signs of moisture (staining, mould, damp smell), have the source investigated and repaired first (e.g., roof leak or plumbing leak) before re-lining/painting.

Monitor for changes such as increasing sag, cracking, or loose lining treat as higher priority if movement is progressing.

Trades to engage: Builder/Carpenter (assessment and refix/reline), Plasterer/Stopper (finish), Painter (repaint). Roofer/Plumber (if moisture source is identified).

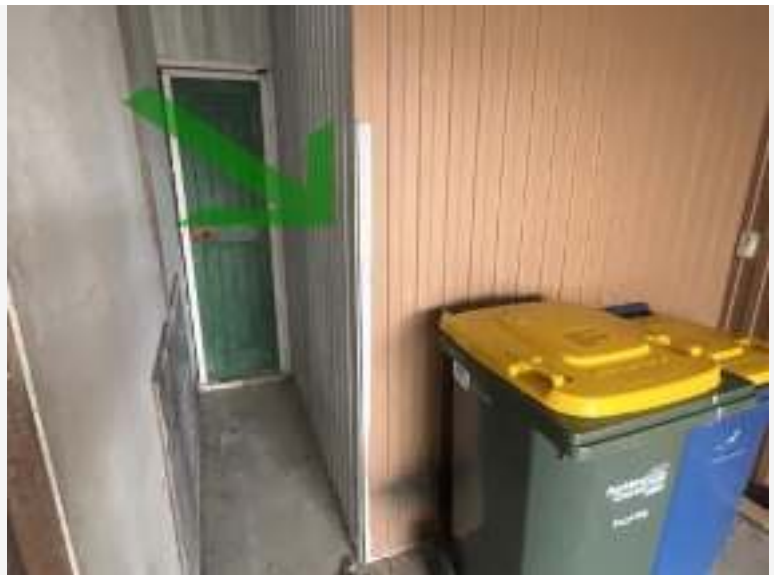
A section of corner boxing / internal cladding within the garage was observed to be broken/damaged at the time of inspection. This may be due to impact damage, vehicle/storage contact, or general wear

Treat as a maintenance item: repair or replace the broken corner boxing/cladding to restore a tidy finish and reduce the risk of further damage.

Trades to engage: Builder/Carpenter or Handyman (repair/replace).
Painter (touch-up/finish if required).

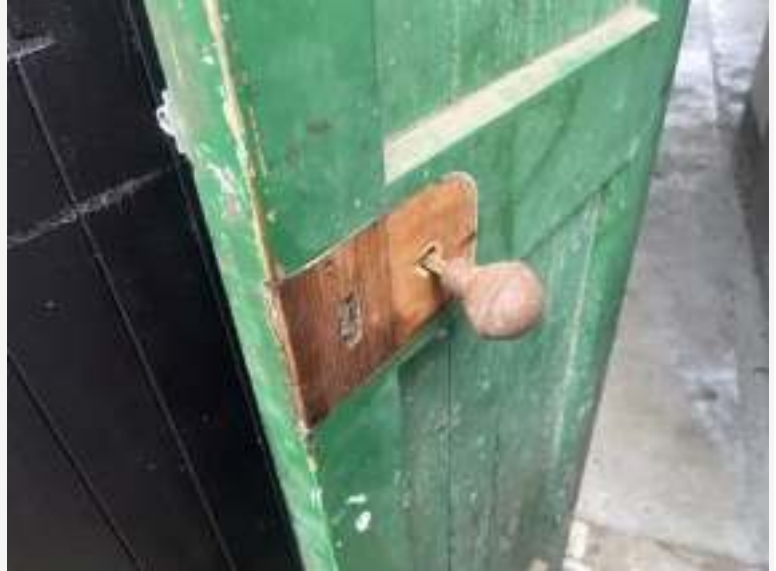
The door handle was observed to be loose at the time of inspection. Loose hardware is commonly due to worn screws, misalignment, or normal use over time.

Tighten and re-secure the handle and fixings. If screw holes are stripped, the fixings may need to be re-seated (e.g., longer screws, plugs, or repair of the timber).

If the handle or latch is worn/damaged, replace the hardware.

Trades to engage: Handyman / Builder / Joiner (adjust or replace hardware). Locksmith (if keyed hardware is involved or replacement is specialised).

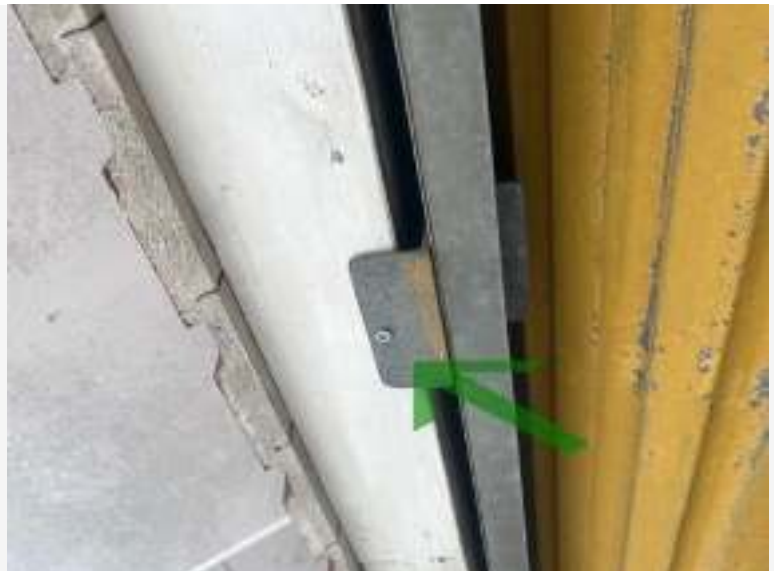
The garage vehicle door was observed to be fixed in place and could not be operated at the time of inspection. The reason for this could not be confirmed.

Engage a garage door specialist to inspect the door, confirm why it has been fixed in place, and repair/restore safe operation (including checking springs, tracks, cables, and motor controls where fitted).

If the door is intended to remain fixed permanently, confirm it is securely braced and weather-tight, and consider alternative

access/egress arrangements if required.

Treat as a priority item if the door is the primary vehicle access or if there is a safety concern (e.g., unstable door or damaged spring system).

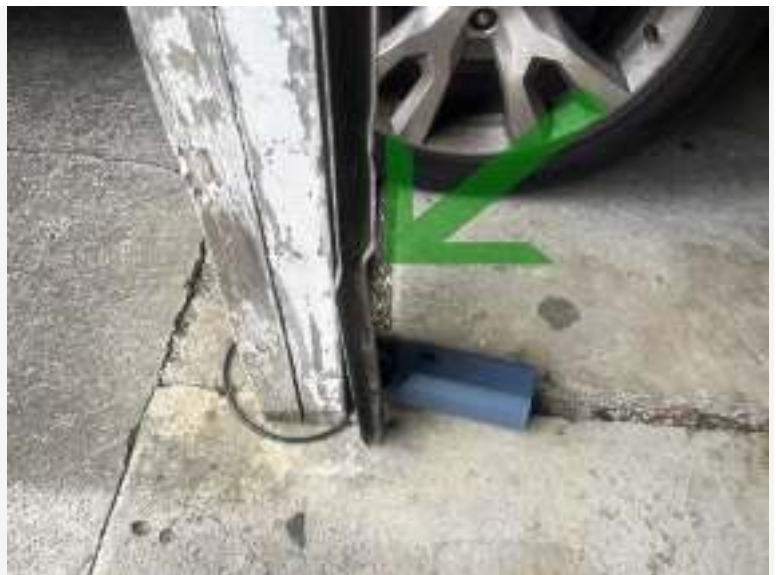
The vehicle/garage door track was observed to be bent at the time of inspection. A bent track can cause the door to bind, run unevenly, or become unsafe to operate.

Treat as a priority safety and functionality item. Engage a garage door specialist/technician to assess the track and door system. Remedial work may include straightening or replacing the bent track, checking/adjusting rollers and brackets, and confirming correct alignment and safe operation. Avoid forcing the door open/closed, as this may worsen damage or create a safety risk (particularly where spring tension systems are involved).

Trades to engage: Garage door specialist/technician (primary).

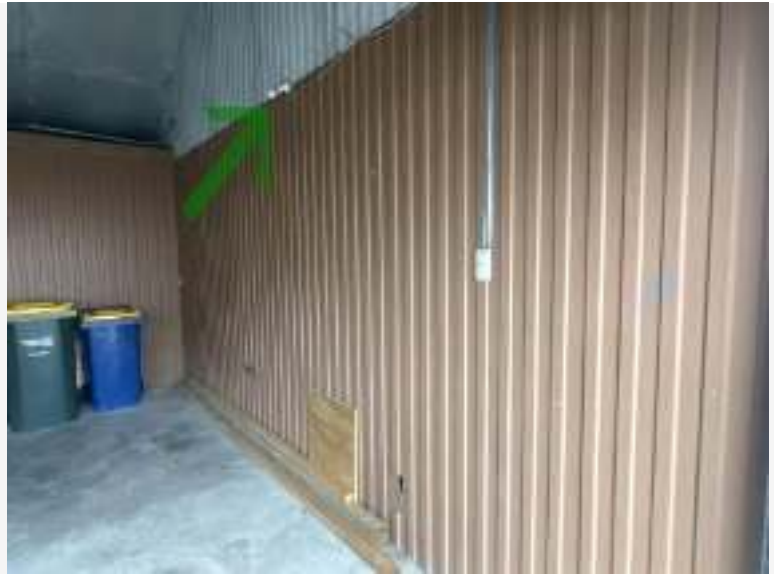
The lights are not working.

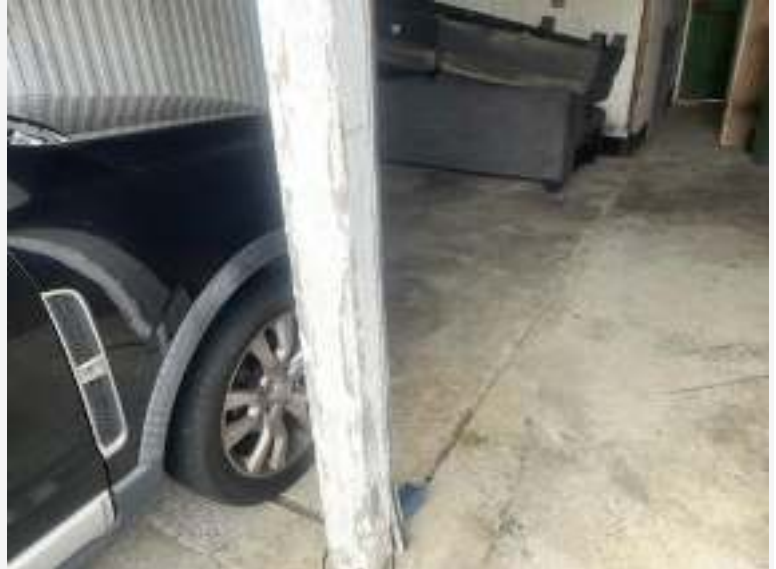
Exterior Post (Out of Plumb & Twisted)

A post was observed to be out of plumb (not vertical) and twisted at the time of inspection. This can occur due to timber shrinkage/warping, inadequate bracing, movement at the footing/base, or age-related movement.

A leaning/twisted post can reduce the stability of the structure it supports (e.g., pergola, deck, porch, fence), and may worsen over time particularly in wind events or if the base remains damp.

This inspection is visual only. The condition of the post below ground/at the footing, concealed fixings, and the adequacy of structural connections could not be confirmed without further investigation.

Engage a suitably qualified builder (LBP Carpentry recommended) to assess the post, base/footing, and bracing requirements.

Remedial work may include re-plumbing and re-fixing, adding bracing/support, and/or replacing the post if it is significantly distorted or if the base is unstable/decayed. Monitor for signs of ongoing movement (increasing lean, cracking at fixings, loosening brackets, or sagging of supported beams). Treat as a higher priority if movement appears active or the post is supporting significant loads.

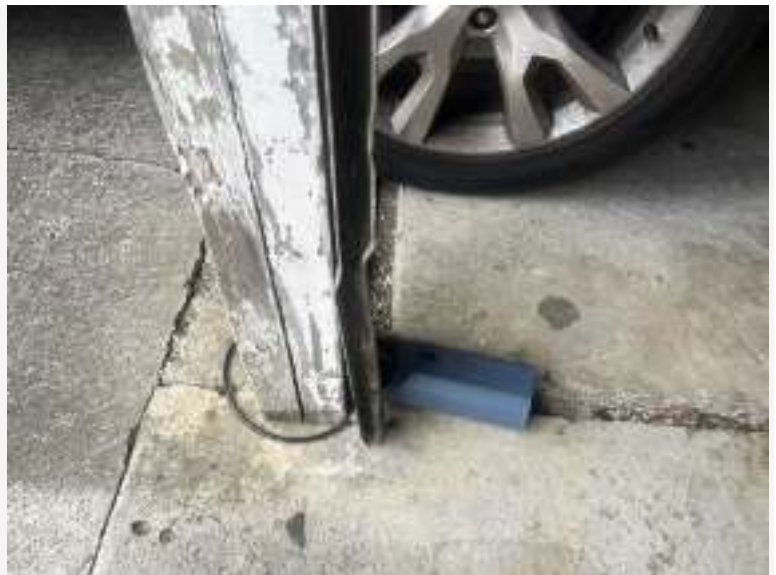
The paint finish to the exterior post was observed to be aged with areas of peeling/flaking at the time of inspection. This is common on exposed posts due to UV and weathering. Where paint has failed, the underlying material (often timber) can be more vulnerable to moisture uptake, which may lead to swelling and timber deterioration over time particularly near the base of the post.

Treat as a maintenance item: remove loose paint, prepare the surface, apply suitable primer/sealer, and repaint with an exterior-grade paint system.

Pay particular attention to the bottom section of the post and any joints where moisture can be trapped.

If any areas are soft, swollen, or

decayed, engage a suitably qualified builder (LBP recommended) to repair/replace affected timber prior to repainting.

Trades to engage: Painter/Decorator (prep and repaint). Builder/LBP (if timber repair/replacement is required).

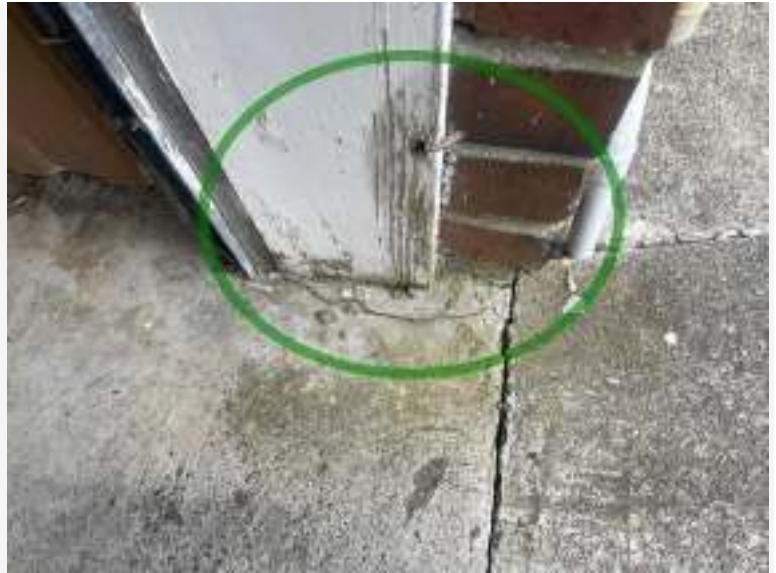
The vehicle (garage) door jamb/trim paintwork was observed to be aged and peeling, and moss growth was present at the time of inspection. Moss typically develops where the surface stays damp and shaded, and it can hold moisture against the jamb material (often timber), accelerating paint breakdown.

This inspection is visual only. We could not confirm whether there is concealed moisture damage behind the jamb/trim or whether water is entering at nearby junctions without further investigation.

Treat as a maintenance item:
Remove and treat the moss (gentle clean and suitable moss treatment avoid aggressive water blasting that may force water into junctions).
Scrape/remove loose paint, prepare the surface, prime/seal, and repaint with an exterior-grade coating system.
Check the surrounding junctions (jamb to cladding/door frame) and renew sealant where required to reduce ongoing moisture entry.
Monitor for signs of deterioration (soft timber, swelling, staining). If timber feels soft or damage is more than minor, engage a builder to repair/replace affected sections

Trades to engage: Painter/Decorator (prep and repaint), Builder/Carpenter (if timber repair is required), Exterior cleaning contractor/handyman (moss treatment/cleaning).

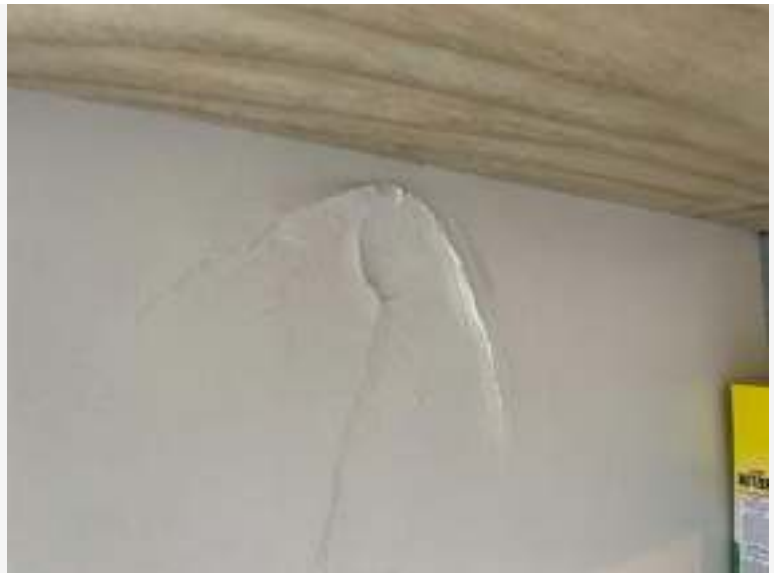
Plaster board.
An area of wall lining/finish was observed to be untidy at the time of inspection (e.g., patchy repairs, scuff marks, uneven paint finish, or minor surface damage). This appears primarily cosmetic.

This inspection is visual only. The quality of any underlying repairs and the condition behind the wall lining cannot be confirmed without opening up.

Treat as a cosmetic maintenance item: clean the surface, carry out minor filling/re-stopping as required, then prepare and repaint for a tidy finish.

If the untidy area is associated with moisture indicators (staining, mould, softness), engage a builder to investigate the cause before redecorating.

Trades to engage: Painter/Decorator (touch-up/repaint).
Plasterer/Stopper (if re-stopping is required). Builder (if moisture/substrate issues suspected).

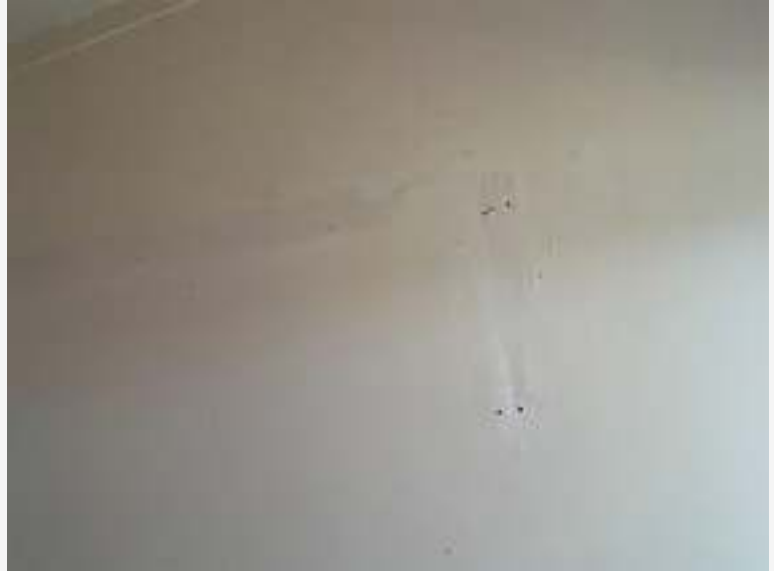
Fixing holes were observed in the wall lining at the time of inspection. This is a common cosmetic issue. Unsealed holes can look untidy and may allow minor dust/air movement through the lining.

Treat as a cosmetic maintenance item: fill the holes with suitable filler/stop, sand smooth, seal/prime, then repaint to match the existing finish.

Trades to engage: Painter/Decorator (fill and repaint). Plasterer/Stopper (for larger patches).

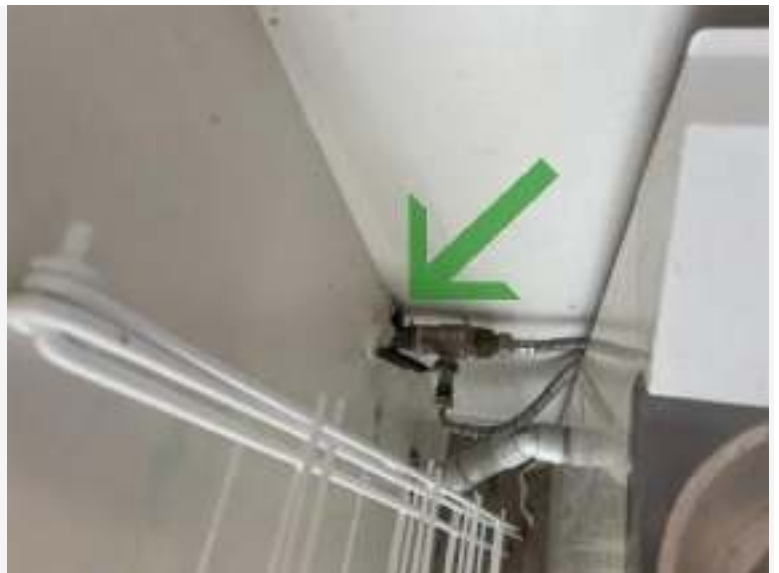
A pipe penetration through the wall was observed to be untidy at the time of inspection.

If the pipe requires repositioning to allow proper sealing/finishing, engage the relevant trade to adjust the pipework first.

Monitor for signs of dampness or staining around the penetration.

Trades to engage: Plumber (if pipework needs adjustment/verification).

Builder/Handyman (finishing, patching, fitting cover plate). Painter (touch-up if required).

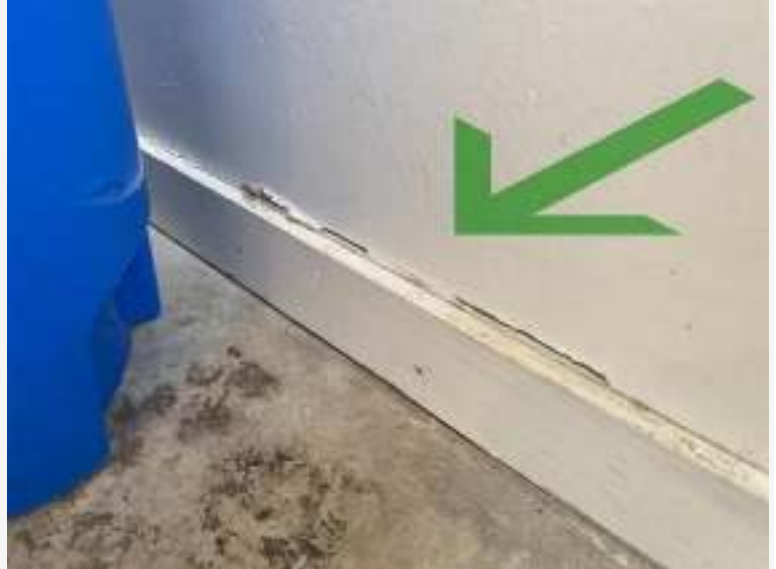
Peeling/flaking paint was observed on the wall at the time of inspection.

Treat as a maintenance item: scrape/remove loose paint, prepare the surface, apply suitable primer/sealer, and repaint.

If there are indicators of moisture (staining, mould, damp smell, soft wall lining), identify and rectify the moisture source before repainting. Monitor for recurring peeling after repair if it returns, engage a builder to investigate underlying causes.

Trades to engage: Painter/Decorator (prep and repaint). Builder (if substrate repair or moisture issues suspected).

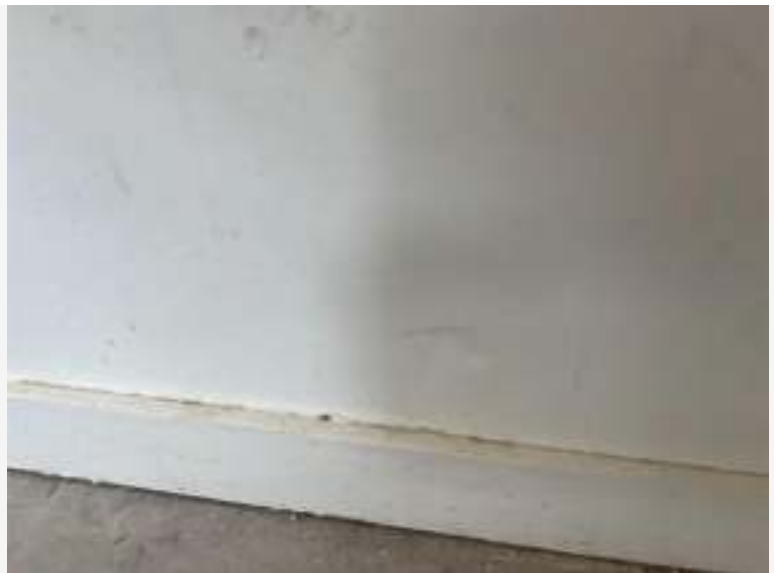
Impact damage was observed to the wall lining at the time of inspection.

Treat as a maintenance/cosmetic item: patch repair the damaged area (fill or replace damaged plasterboard section as required), sand smooth, re-stop, then prime and repaint.

If the damage is significant (hole, loose lining, or cracked joints spreading), engage a builder to assess and repair the lining properly.

Trades to engage: Plasterer/Stopper (patch/re-stopping) and Painter/Decorator (repaint). Builder (if larger repair is required).

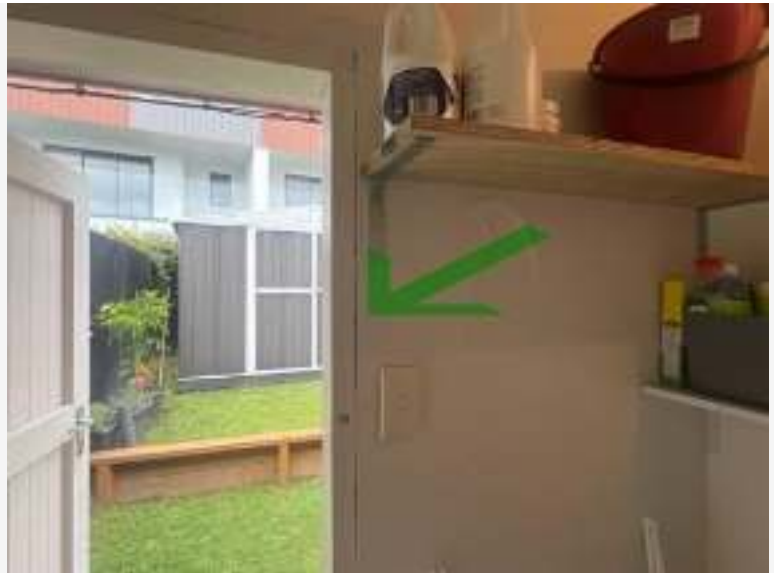
A gap was observed between the door jamb (frame) and the adjacent wall lining/architrave area at the time of inspection.

A gap was observed between the door jamb (frame) and the adjacent wall lining/architrave area at the time of inspection. This can occur due to minor movement, shrinkage, settlement, or incomplete finishing. Gaps can look untidy and may allow draughts and minor pest/dust entry. If this is at an exterior door, it can also increase weathertightness risk at the junction.

This inspection is visual only. The condition of concealed fixings and the full junction detailing behind linings/trim cannot be confirmed without removal.

If the door is external, or if there are signs of moisture staining/softness, engage a builder to check the junction and ensure it is properly sealed and weather-resistant.

Trades to engage: Builder/Joiner (architrave adjustment/refixing),

Painter/Decorator (fill and repaint).

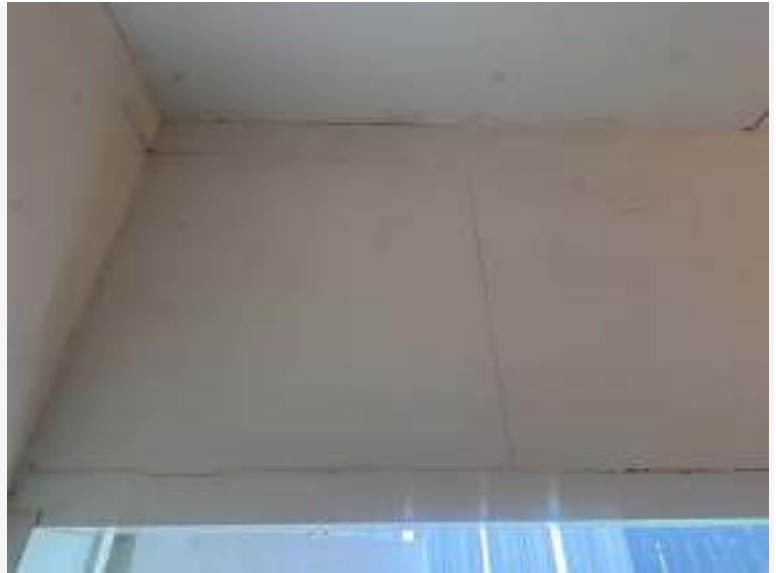
A crack was observed along a wall lining joint at the time of inspection.

If the crack is minor and stable, treat as a cosmetic maintenance item: re-stop/fill the crack, sand, seal/prime, then repaint to restore a tidy finish.

Monitor the crack for widening/lengthening or reappearing after repair.

If the crack is significant, recurring, or associated with other movement signs (e.g., doors sticking, uneven gaps), engage a suitably qualified builder to assess.

Trades to engage: Plasterer/Stopper (re-stopping), Painter/Decorator (repaint). Builder (if movement is suspected).
