Cozy Building Compliance

Pre-Purchase House Inspection

ADDRESS:	Sample report
CLIENT:	Young
AGENT:	Sample
INSPECTION DATE & Weather Conditions:	
PEOPLE PRESENT:	Buyer
TENANTS DETAILS:	The property was vacant at time of inspection.

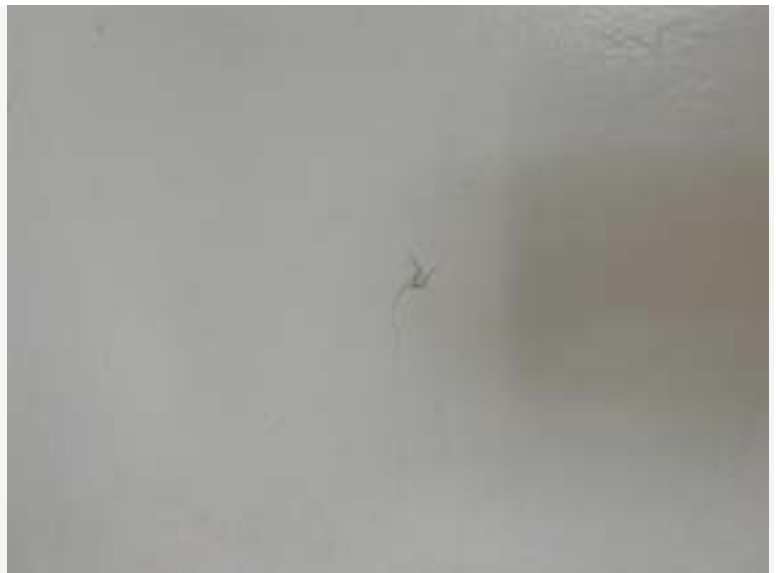
Interior Wall Plaster (Crack Present)
Observation / Limitation (What we saw + what we couldn't confirm)

A crack was observed to the wall plaster/skim coat at the time of inspection. Plaster cracking can occur due to minor building movement, shrinkage as materials dry, impact, or ageing of previous stopping/repairs.

A crack was observed to the wall plaster/skim coat at the time of inspection. Plaster cracking can occur due to minor building movement, shrinkage as materials dry, impact, or ageing of previous stopping/repairs. In many cases this is cosmetic, but cracks that are widening or recurring can indicate ongoing movement.

This inspection is visual only. The condition of the substrate (plasterboard/wall framing) behind the plaster and the full cause of the cracking cannot be confirmed without further investigation/opening up.

If minor and stable: treat as a maintenance/cosmetic item repair by re-stopping (mesh/tape where required), skim, sand smooth, then prime and repaint.

Monitor the crack for changes (widening, lengthening, or reappearing).

If cracking is significant, widespread, or associated with other movement signs (e.g., door misalignment, uneven floors), engage a suitably qualified builder to assess the underlying cause.

Trades to engage: Plasterer/Stopper (plaster repair). Painter/Decorator (finish coat/repaint). Builder (if movement is suspected).

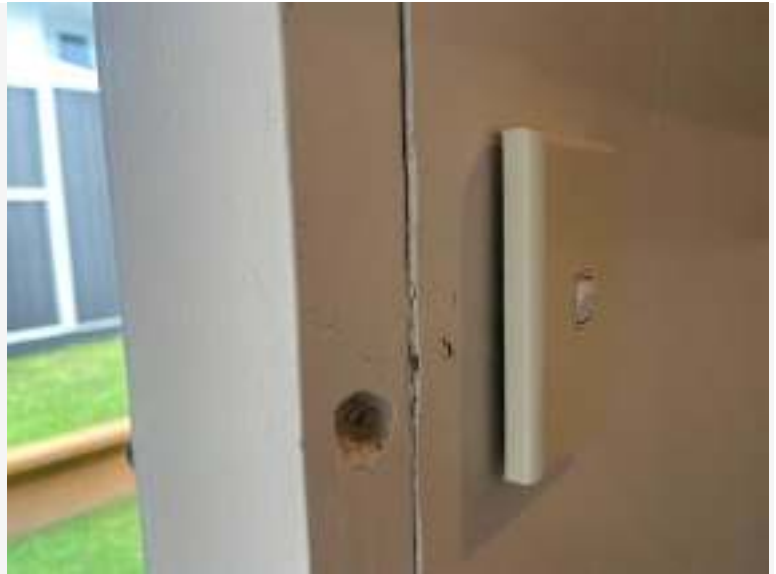
A gap was observed between the light switch cover plate and the wall lining at the time of inspection. This may be due to an uneven wall surface, loose fixings, an incorrectly sized/installed flush box, or prior painting/stopping work.

Ensure the switch plate is securely fixed and sitting flat; tighten fixings carefully (do not overtighten). If the wall is uneven or the box is not sitting correctly, a registered electrician should check and refit the switch/flush box to ensure it is secure and correctly installed. Minor cosmetic gaps around the plate can be finished by a painter/handyman after the plate is correctly seated (avoid sealing in a way that restricts future access).

Trades to engage: Registered electrician (if refit/box alignment required). Painter/Handyman (cosmetic tidy-up).

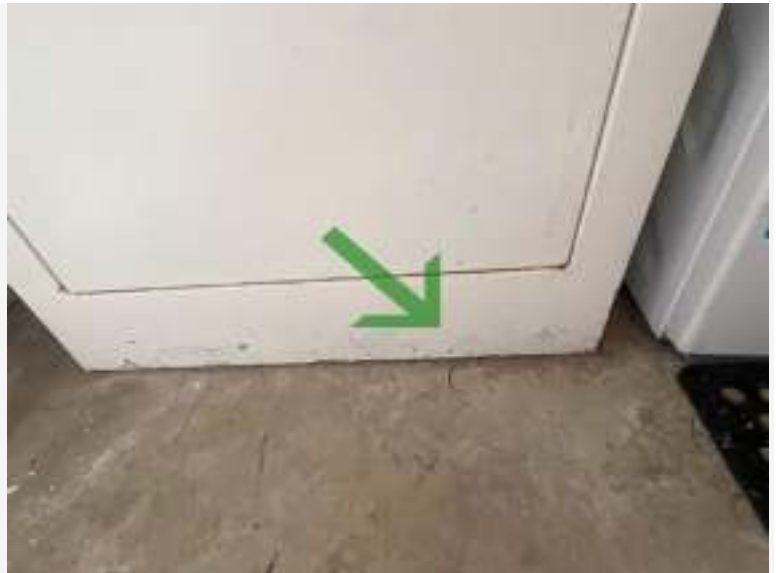
Rust/corrosion was observed at the bottom of the laundry tub at the time of inspection. This may be surface corrosion from prolonged moisture exposure, trapped water, or deterioration of protective coatings/finish.

Treat as a maintenance item: clean and dry the area, and monitor for signs of leakage (dampness in the cabinet, water marks, ongoing rust growth).

If corrosion is advanced, the tub is thinning, or any leaks are present, arrange for replacement of the laundry tub.

Check for contributing factors (drips from taps/waste, poor sealing at edges, standing water) and rectify to reduce recurrence.

Trades to engage: Registered plumber (assessment and replacement if required).

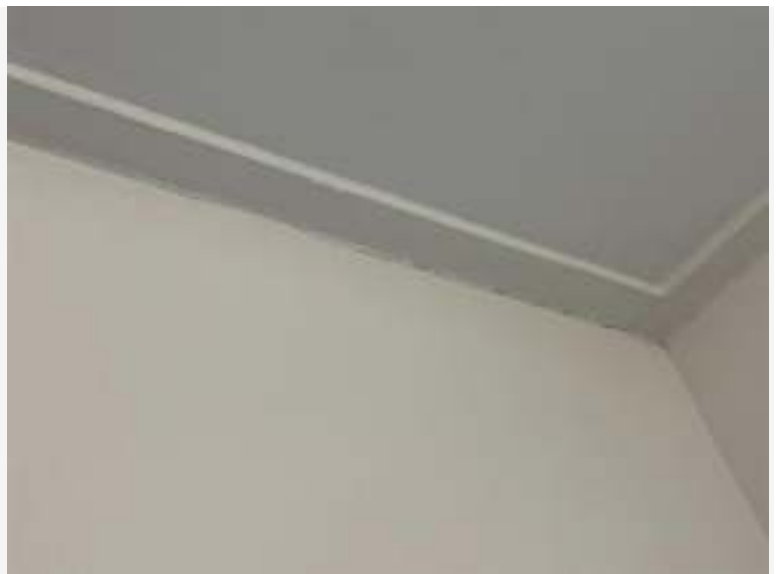
The ceiling paint finish was observed to be aged, with areas of peeling/flaking at the time of inspection.

The ceiling paint finish was observed to be aged, with areas of peeling/flaking at the time of inspection. This can occur due to normal ageing, poor previous surface preparation, and/or moisture/condensation (commonly in kitchens, bathrooms, laundries, or where roof/plumbing leaks have

occurred).

This inspection is visual only. The condition of the ceiling substrate and whether moisture is contributing to the paint failure cannot be fully confirmed without further investigation and surface preparation.

Treat as a maintenance item: scrape/remove loose paint, prepare the surface, apply a suitable primer/sealer, and repaint.

If there are signs of moisture (staining, mould, damp smell), identify and rectify the moisture source before repainting (improve ventilation and/or repair leaks).

Monitor for recurring peeling or staining if it returns, arrange further assessment.

Trades to engage: Painter/Decorator (prep and repaint). Builder (if roof leak suspected)

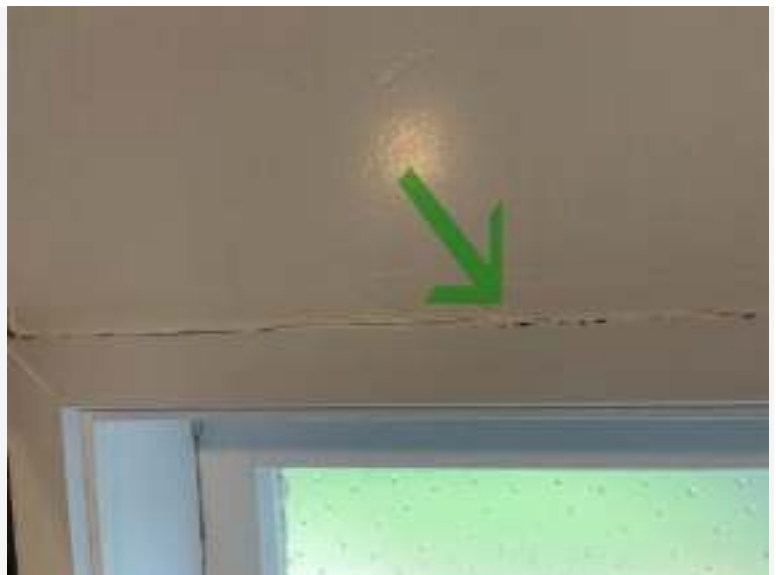
A gap was observed between the window architrave (trim) and the adjacent wall lining at the time of inspection.

If the architrave is secure and the gap is minor: fill and seal with a paintable decorators caulk/flexible filler, then repaint/touch up for a tidy finish.

If the architrave is loose or the gap is large/uneven: engage a builder/joiner to refix/adjust the architrave before sealing and painting.

Trades to engage: Builder/Joiner (refix/adjust if needed).
Painter/Decorator (fill and repaint).

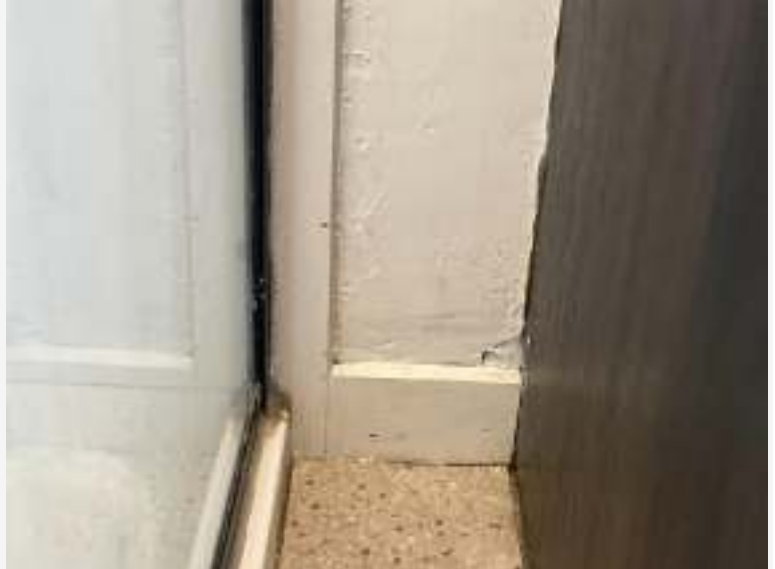
An area of wall lining was observed to be uneven and untidy at the time of inspection. This appears primarily cosmetic, however uneven surfaces can indicate incomplete repairs or poor workmanship.

Treat as a cosmetic maintenance item: carry out proper re-stopping/plaster finishing to level the surface, then sand smooth, seal/prime, and repaint to achieve an even finish.

If the unevenness is due to damaged plasterboard or loose lining, engage a builder to repair/refix the wall lining before finishing.

Trades to engage: Plasterer/Stopper (make smooth/level).
Painter/Decorator (prime and repaint). Builder (if lining repair is required).

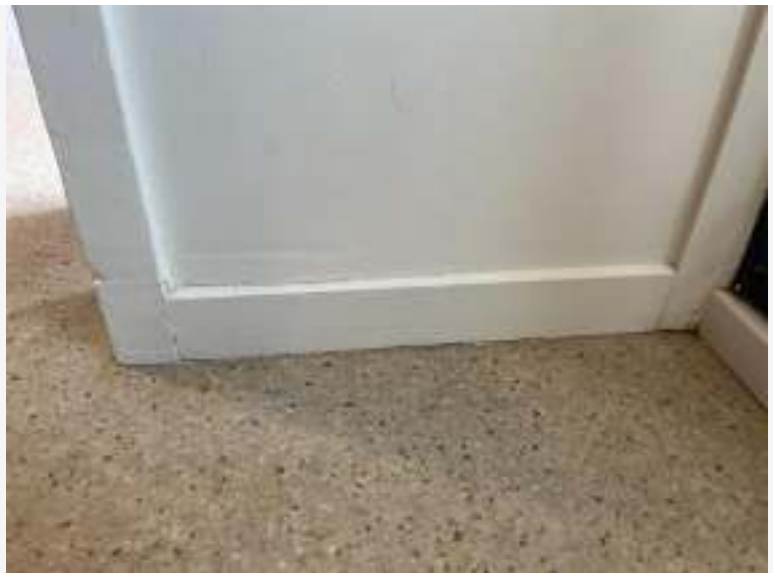
An area of wall lining was observed to be uneven and untidy at the time of inspection.

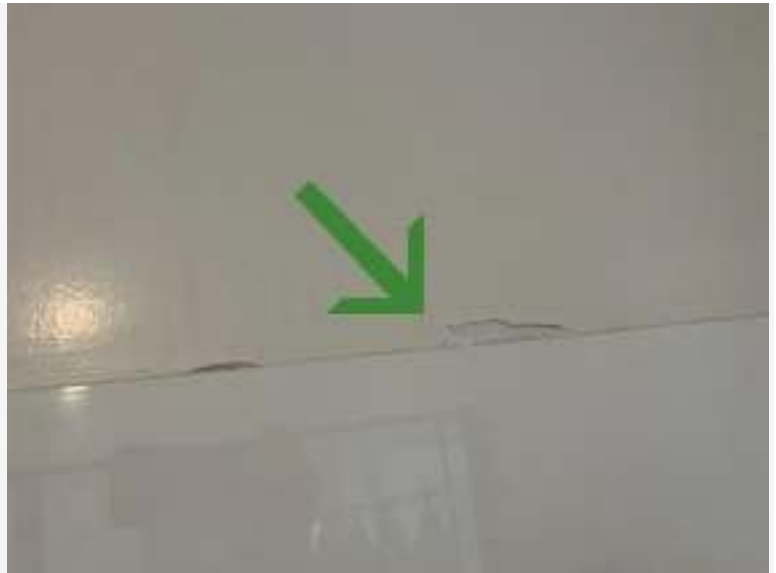
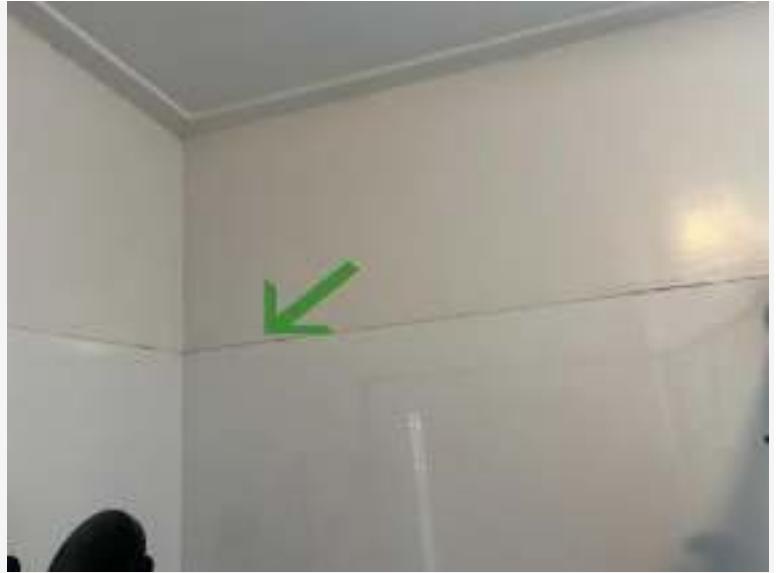
Paint peeling was observed at the top section of the shower lining / shower wall area at the time of inspection. Paint failure in this location commonly occurs due to steam/condensation, repeated moisture exposure, inadequate ventilation, or poor previous surface preparation. In some cases, it can also be associated with water ingress from failed junction seals or leaks.

Paint peeling was observed at the top section of the shower lining / shower wall area at the time of inspection.

Check and renew sealant at shower junctions if cracked/failed.

Repair the affected area: remove loose paint, dry the surface, apply a suitable sealer/primer, then repaint using an appropriate wet-area paint system.

Trades to engage: Painter/Decorator (prep and repaint), Builder (if lining/substrate repair required)

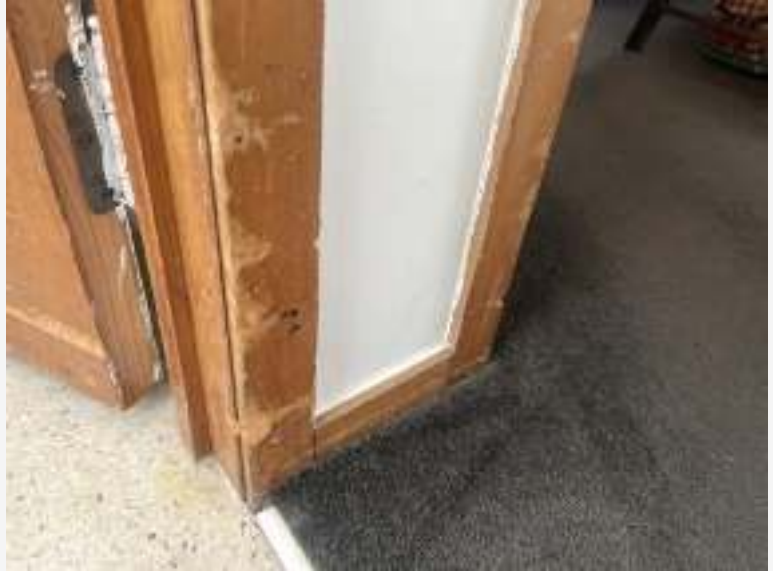
Impact damage was observed at the bottom section of the door jamb at the time of inspection.

Recommendation
minor/cosmetic: repair by filling and sanding the damaged area, then seal/prime and repaint to protect the timber and restore appearance.

Trades to engage: Builder/Joiner (repair/replace if needed).
Painter/Decorator (finish/repaint).

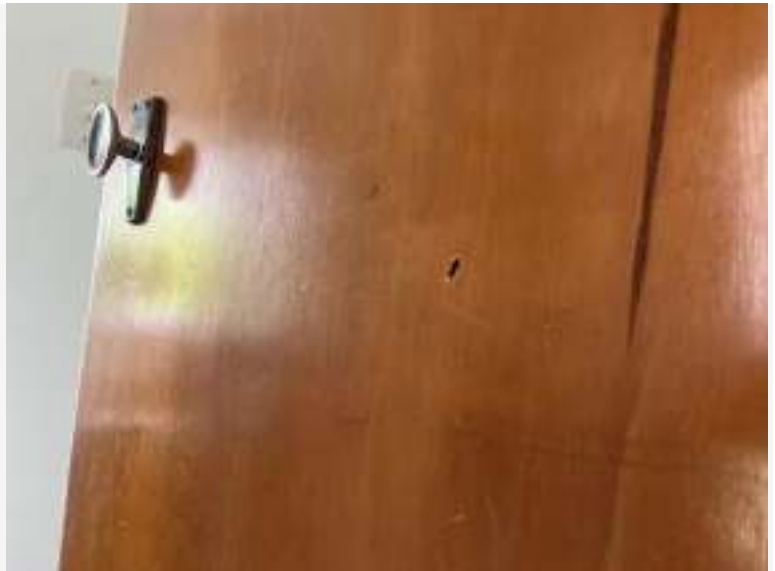
A hole was observed in the door leaf at the time of inspection.

Recommendation
Minor and the door is otherwise sound, repair using an appropriate patch/filler system, sand smooth, then prime and repaint.

Trades to engage: Builder/Joiner (repair or replace door leaf).
Painter/Decorator (finish/repaint).

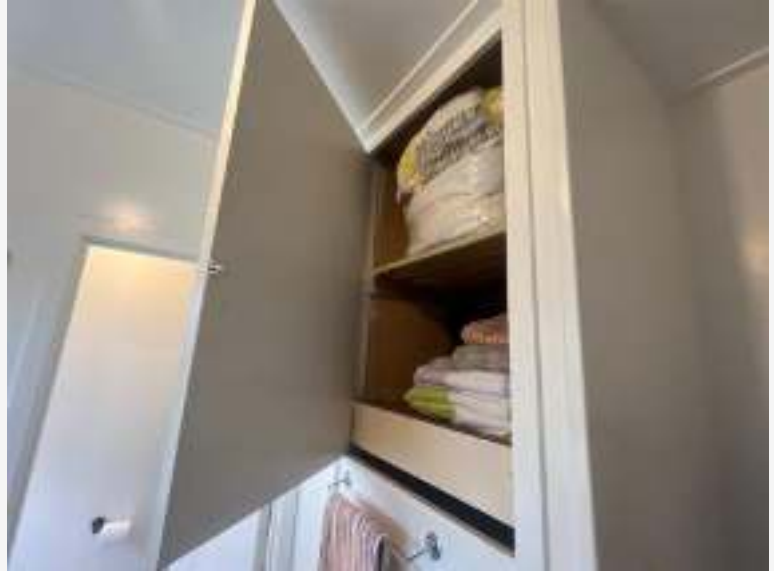
Storage. The cupboard contained stored items, which prevented a detailed inspection of the lower portion of some of the walls and flooring.
