# Cozy Building Compliance

# Pre-Purchase House Inspection

| <b>ADDRESS:</b> | New Lynn, Auckland |
| <b>INSPECTION DATE &amp; Weather</b> | 08/02/2026 |

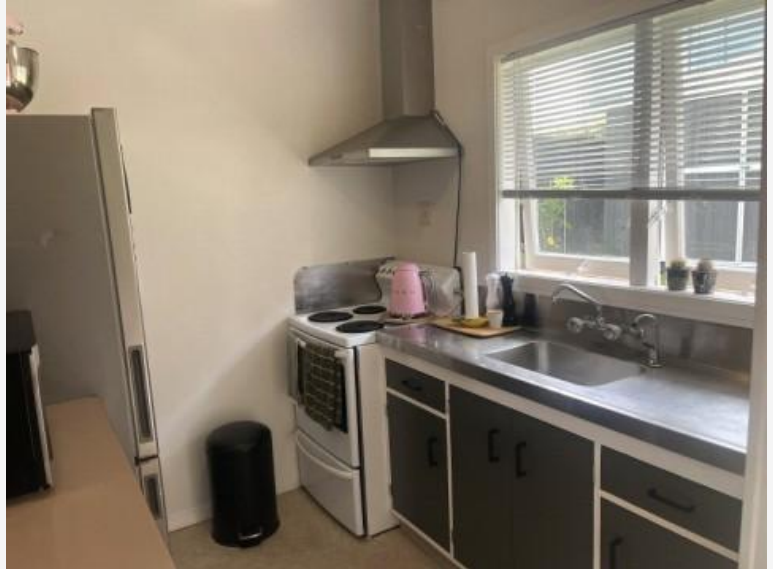
Back.

A section of skirting board was observed to be missing at the time of inspection. This is a visible finishing defect and repair is recommended to reinstate the wall lining trim.

Recommendation: Arrange for a qualified builder to repair or replace the missing skirting.

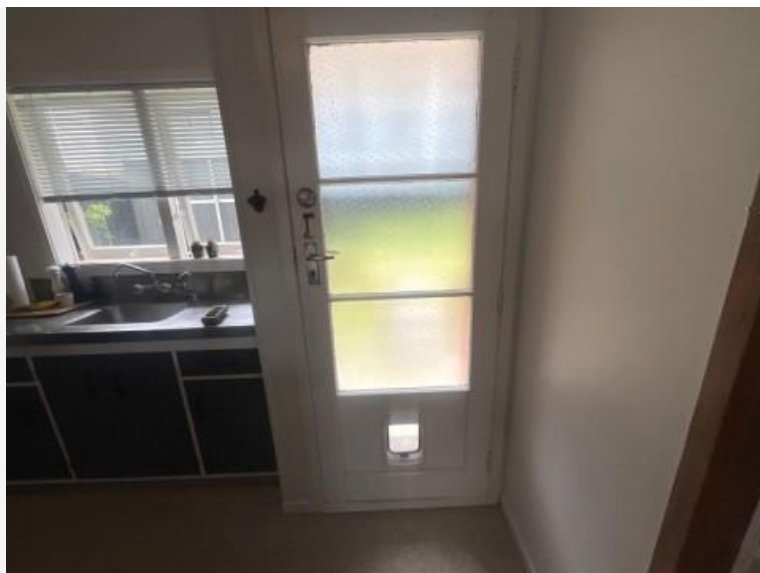
A crack line was observed at the door sill/threshold area at the time of inspection. This is a visible defect and repair is recommended to prevent further deterioration.

Recommendation: Arrange for a qualified builder to assess and repair the affected area.

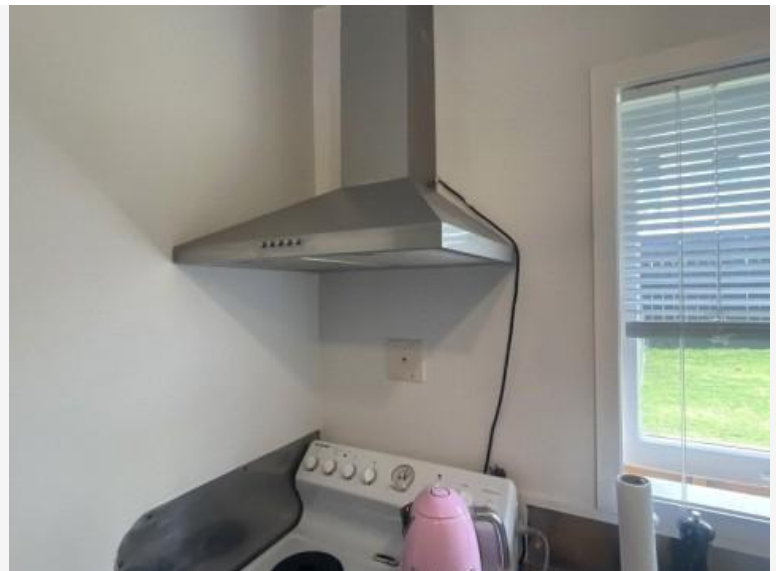
No accessible power point was present to operate the rangehood at the time of inspection. As a result, the rangehood could not be tested for operation.

Recommendation: A registered electrician should be engaged to assess and install an appropriate power point/power supply as required.

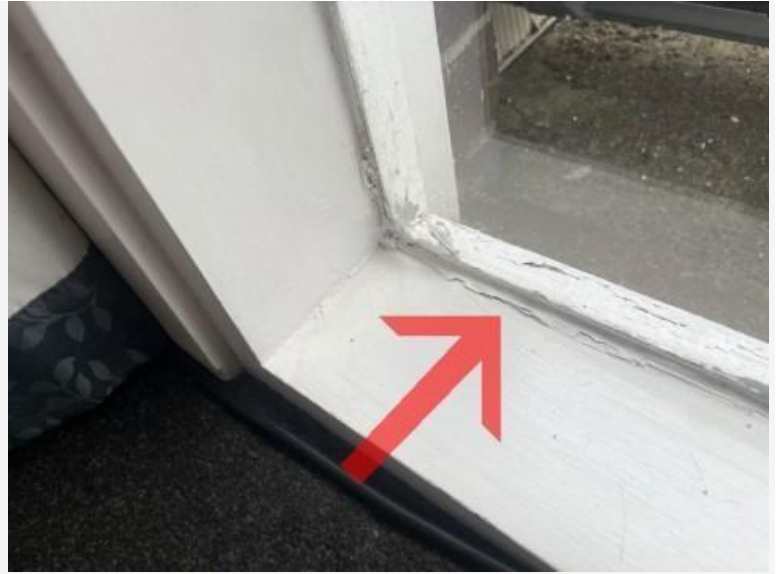
The paint finish around the window was observed to be aged and peeling at the time of inspection. This is a visible maintenance defect and repainting is recommended.

Recommendation: Arrange for a suitably qualified painter to prepare, repair, and repaint the affected area as required.

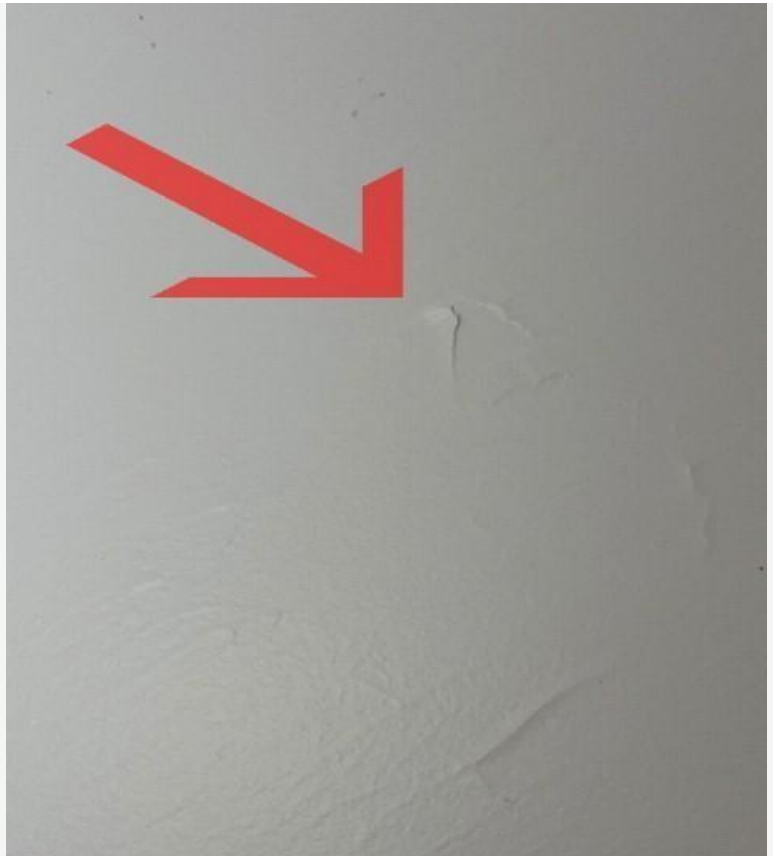
The ceiling paint finish was observed to be aged, with localised areas of peeling/flaking noted at the time of inspection. This is a visible maintenance defect and repainting is recommended.

Recommendation: Arrange for a qualified painter to prepare, repair, and repaint the affected areas as required.

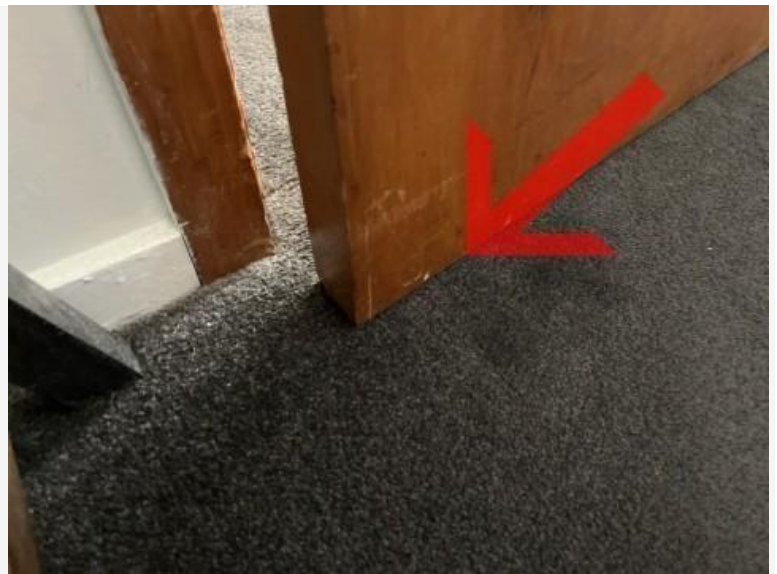
The door was observed to rub/slightly stick on the carpet during operation at the time of inspection. Minor adjustment is recommended to prevent ongoing wear.

Recommendation: Arrange adjustment/repair by a qualified builder or handyman as required.

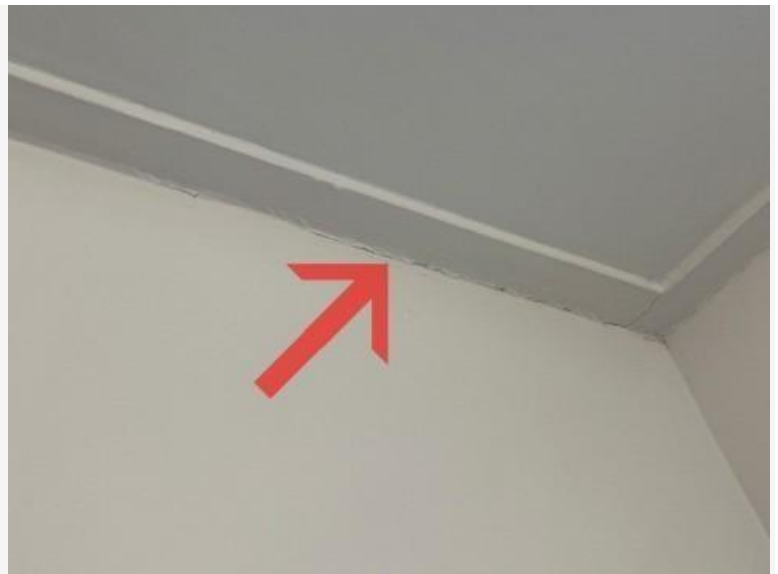
The ceiling paint finish was observed to be aged at the time of inspection. This is a maintenance item and repainting may be required.

Recommendation: Arrange for a suitably qualified painter to prepare and repaint the affected area as required.

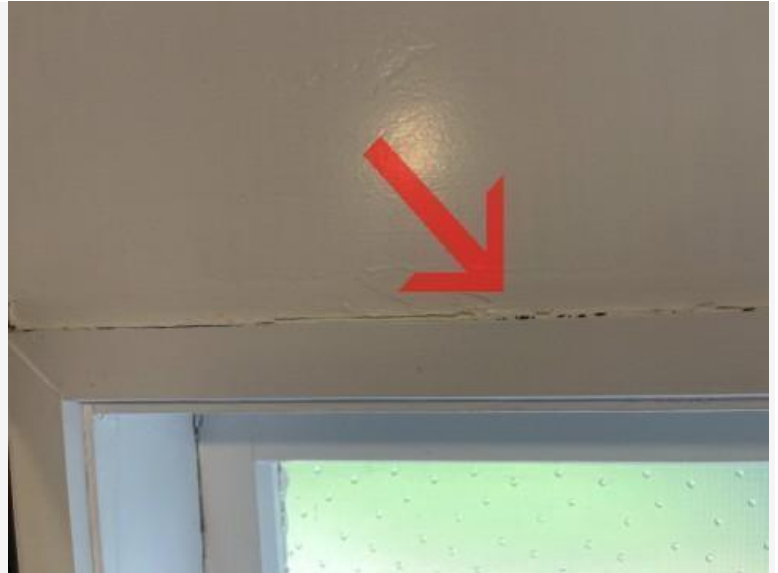
A gap was observed between the window architrave (trim) and the adjacent wall lining at the time of inspection. This is a visible finishing defect and repair is recommended.

Recommendation: Arrange for the affected gap to be filled/repared and made good by a suitably qualified builder or painter as required.

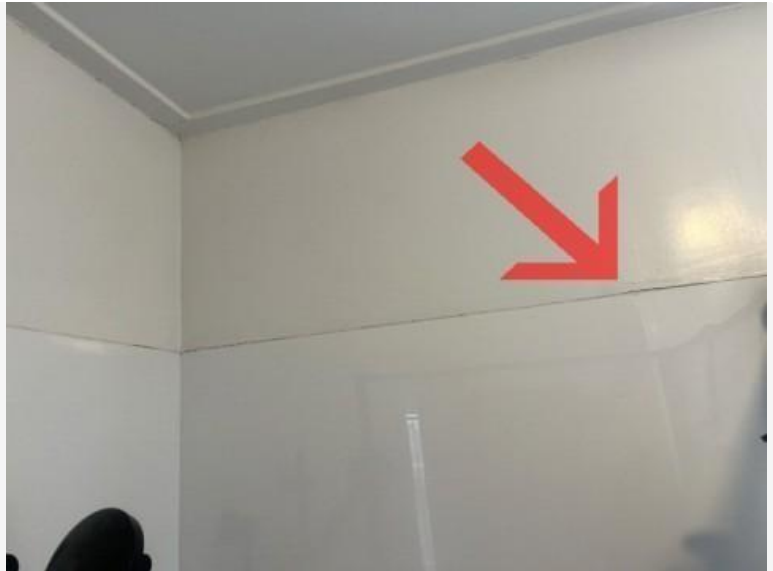
Paint peeling was observed at the upper section of the shower lining/shower wall area at the time of inspection. Deterioration in this location is commonly associated with steam and condensation, repeated moisture exposure, inadequate ventilation, poor previous surface preparation, or failure of adjacent seals/junctions. In some cases, it may also indicate moisture ingress or a leaking condition.

Recommendation: Arrange for the affected area to be assessed and repaired as required. This should include checking adjacent seals/junctions and ensuring adequate ventilation. Repairs and repainting should be carried out by a suitably qualified contractor.

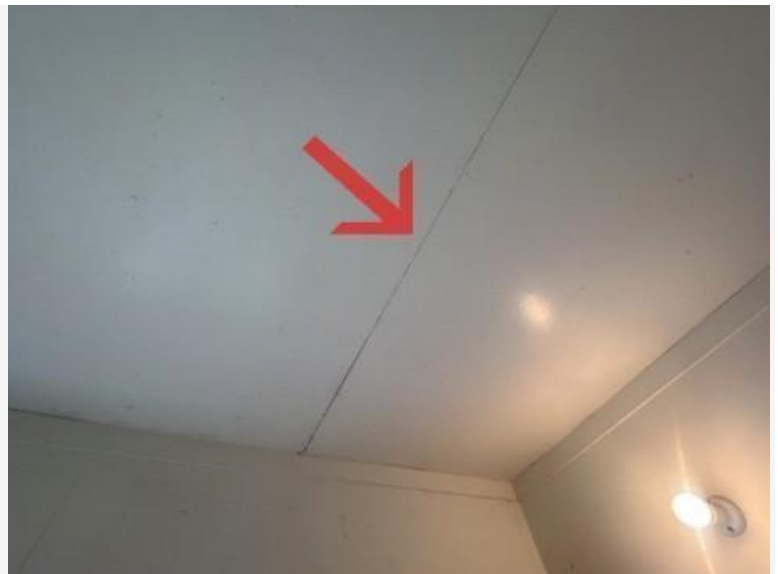
The ceiling sheet joint was observed to be uneven and untidy at the time of inspection, with visible finishing defects noted.

Recommendation: Arrange for a suitably qualified plasterer or painter to repair and make good the affected area to achieve a neat and even finish.

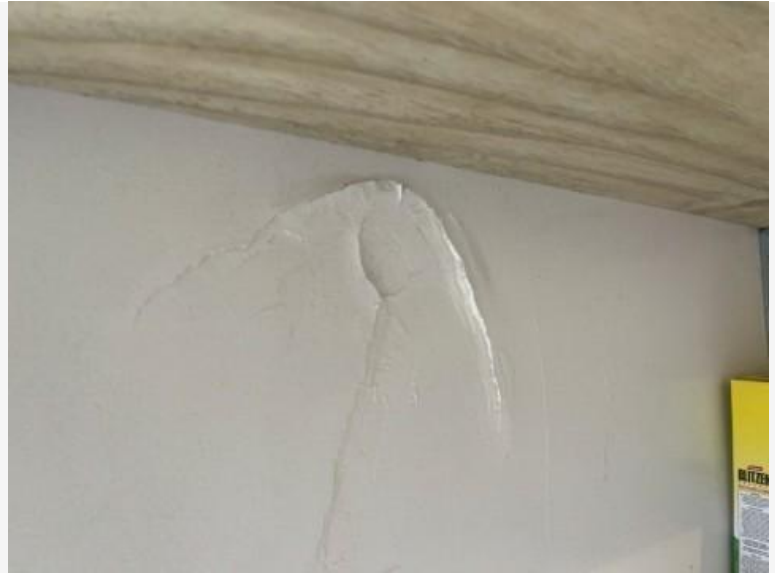
An area of wall lining/finish was observed to be uneven and untidy at the time of inspection. This appears to be a finishing defect, and remedial work is recommended to achieve a neater finish.

Recommendation: Arrange for a suitably qualified plasterer or painter to repair and make good the affected area.

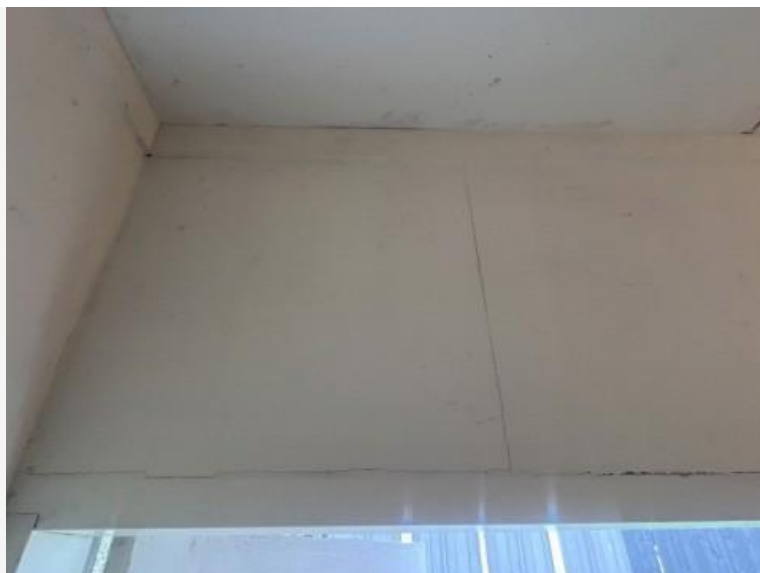
Cracking was observed along a wall lining joint at the time of inspection. Localised repair is recommended to reinstate the wall finish.

Recommendation: Arrange for a suitably qualified plasterer or painter to repair and make good the affected area.

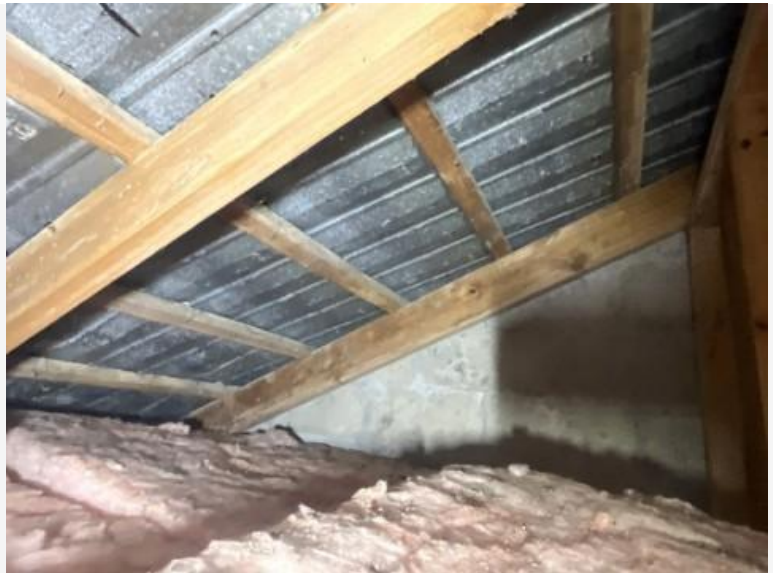
Dry water staining was observed on a roof purlin (timber member) at the time of inspection. This is a moisture-related indicator and may be associated with previous moisture ingress. No active moisture was confirmed at the time of inspection.

Recommendation: Continue to monitor the area, and arrange further assessment by a suitably qualified builder or roofing contractor if any evidence of active leakage or ongoing moisture ingress becomes apparent.

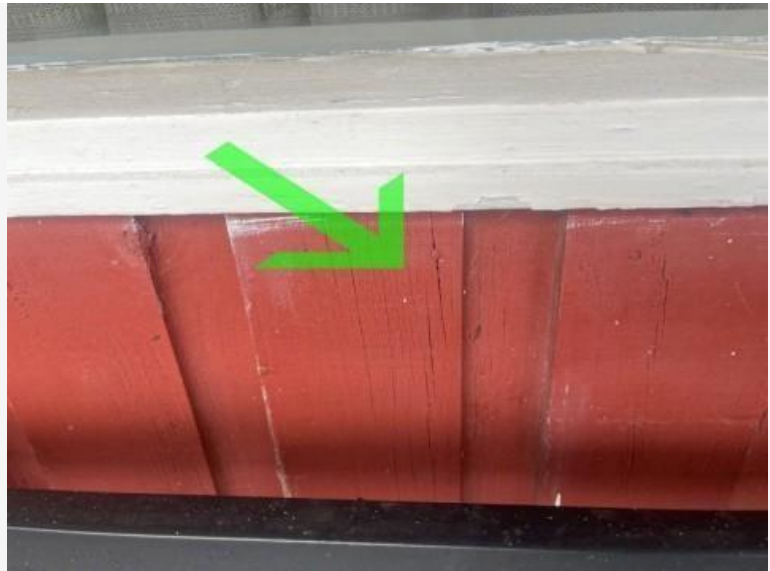
Crack lines / hairline splits were observed to sections of the timber weatherboard cladding at the time of inspection. These defects may permit moisture ingress over time.

Recommendation: Arrange for assessment and remedial work by a suitably qualified cladding contractor or LBP builder experienced in weathertightness remedial work.

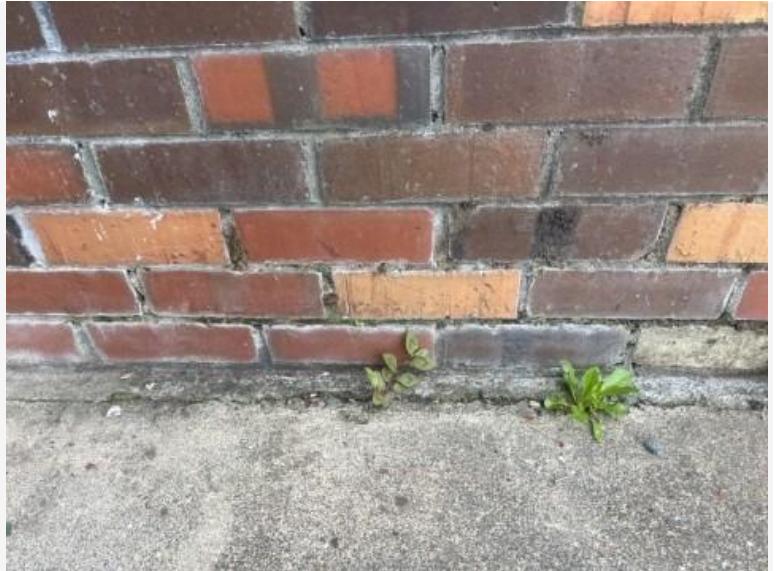
- No weep holes were observed to the brick walling. If the wall is of brick veneer construction, the absence of weep holes may restrict cavity drainage and ventilation and increase the risk of trapped moisture within the wall assembly.

The condition of any concealed internal timber framing or substrate behind the cladding could not be determined by visual inspection alone.

Recommendation: Arrange for a suitably qualified builder or bricklayer to assess the wall construction and install weep holes if required.

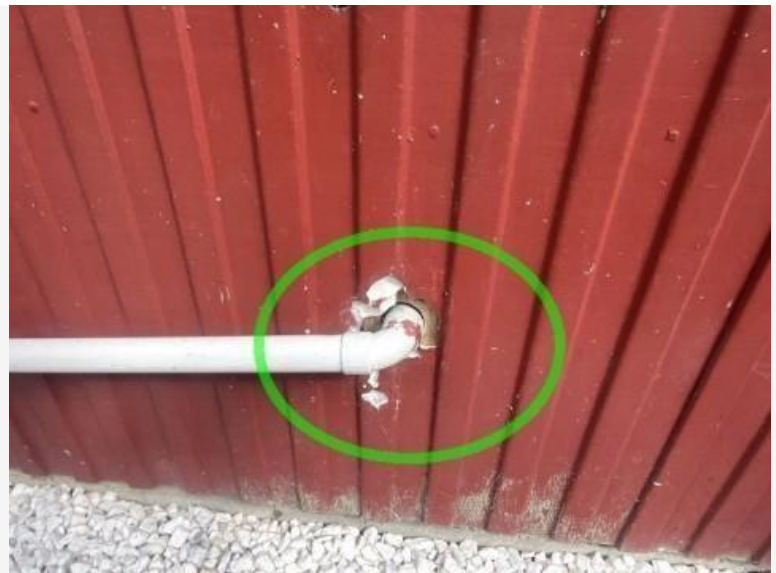
The condition of any concealed internal timber framing or substrate behind the cladding could not be determined by visual inspection alone.

Recommendation: Arrange for a suitably qualified cladding contractor or LBP builder experienced in cladding / weathertightness remedial work

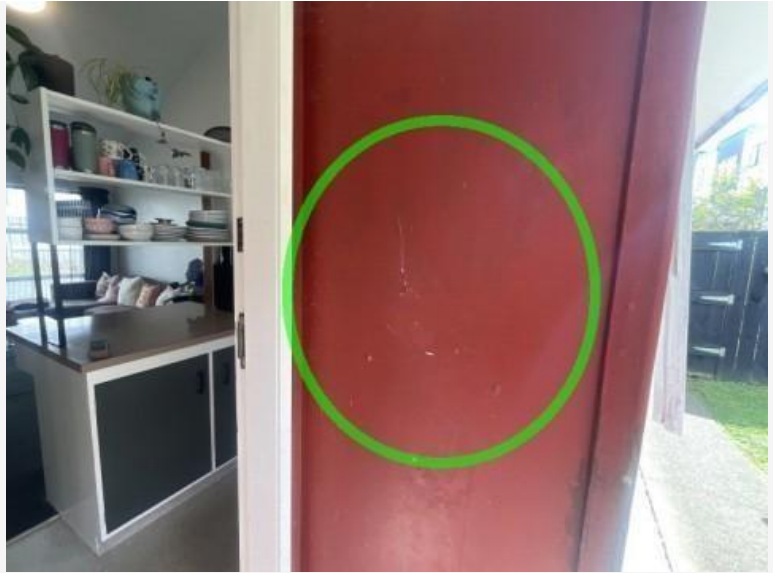
A section of exterior cladding was observed to be broken/damaged at the time of inspection. This is a visible defect and may reduce the weathertight performance of the cladding if left unaddressed.

Recommendation: Arrange for a suitably qualified cladding contractor or LBP builder experienced in cladding / weathertightness remedial work

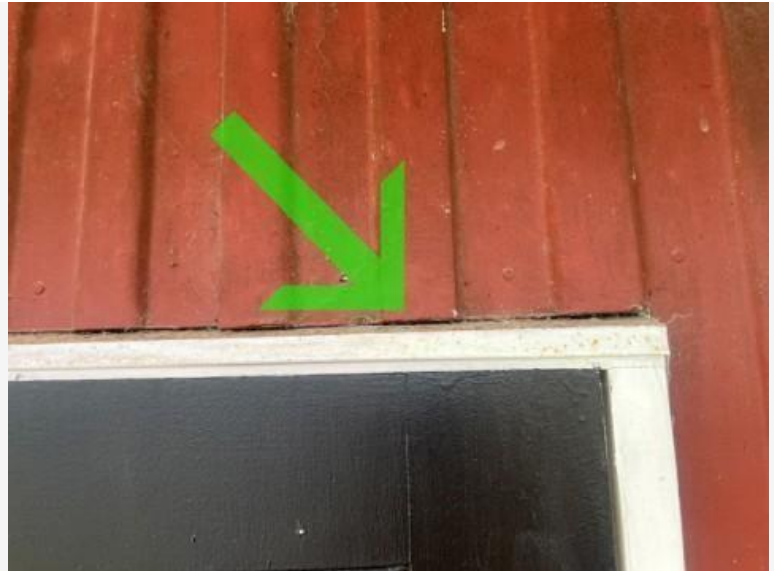
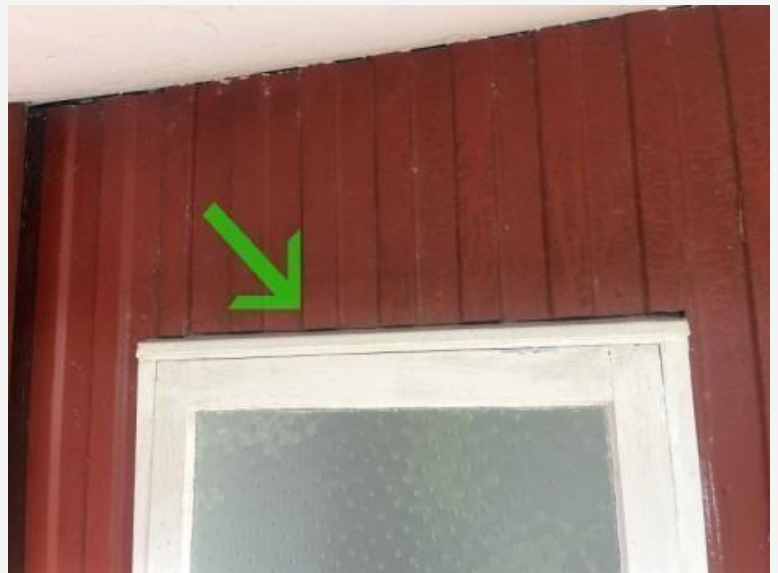
Minimal clearance was observed between the cladding and some head flashings at the time of inspection, and rusting was also noted to some flashings. Flashing detailing around the joinery could not be confirmed to provide robust drainage and weather protection. These defects are considered evident weathertightness defects, as they may restrict drainage and drying at the opening junction and increase the risk of moisture ingress and concealed deterioration over time.

Recommendation: Arrange for a suitably qualified cladding contractor or LBP builder experienced in weathertightness remedial work to assess and rectify the affected junctions, including flashing repair/replacement as required.

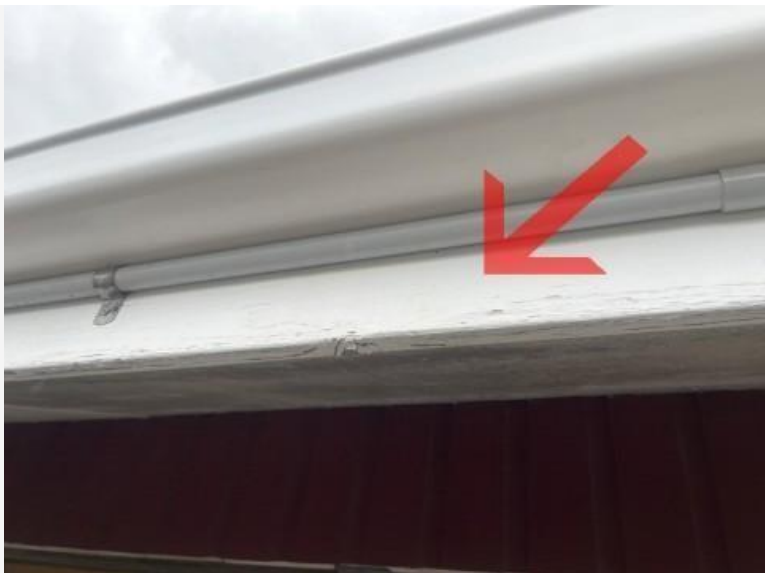
The paint finish to the fascia boards was observed to be aged/deteriorated, with peeling present at the time of inspection.

Recommendation: Arrange for a suitably qualified painter to prepare, repair, and repaint the affected fascia boards as required.

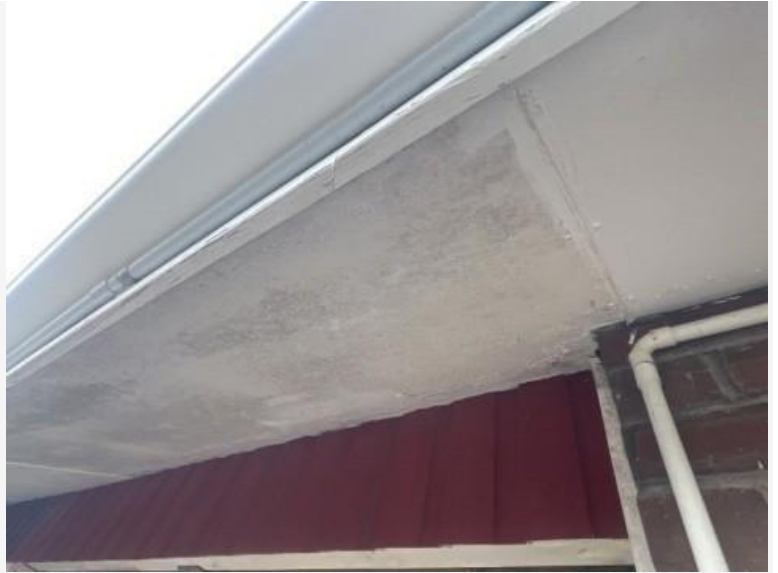
The paint finish to the soffit was observed to be peeling at the time of inspection. This is a visible maintenance defect, and remedial work is recommended to prevent further deterioration and maintain durability.

Recommendation: Arrange for a suitably qualified painter to prepare, repair, and repaint the affected soffit area as required.

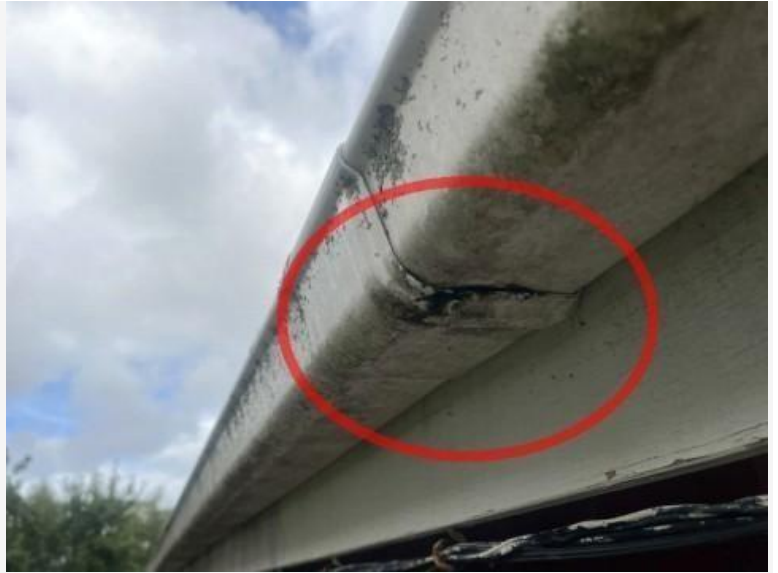
- Water dripping was observed from a gutter joint, and debris build-up was present within the spouting/guttering. These defects may restrict stormwater discharge and increase the likelihood of overflow and moisture discharge to adjacent building elements.

Water dripping was observed from a gutter joint at the time of inspection. This indicates leakage at the joint and maintenance/repair is recommended to prevent ongoing moisture discharge to adjacent areas.

Recommendation: Arrange for a suitably qualified roofer or builder to repair the leaking gutter joint.

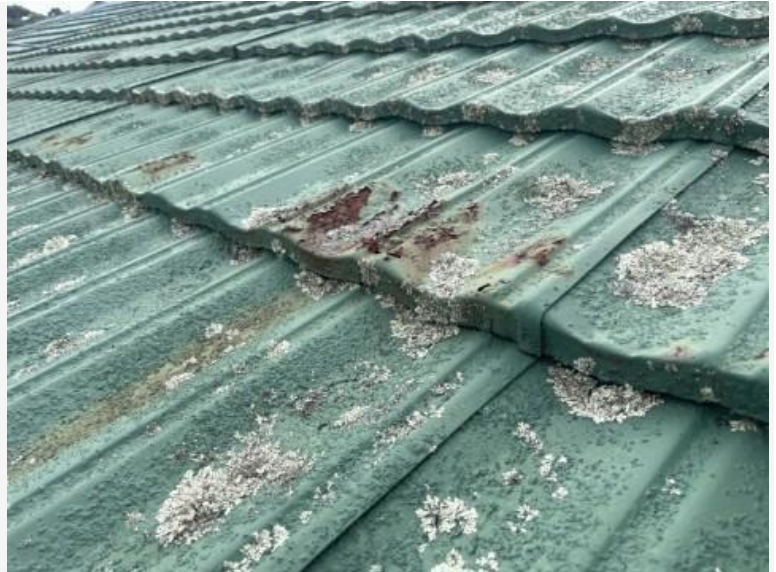
A localised hole/opening associated with corrosion was observed to the pressed metal roof cladding at the time of inspection. This is considered an evident weathertightness defect, as openings in the roof covering may allow direct moisture ingress into the roof structure and contribute to concealed deterioration over time.

Recommendation: Arrange for a suitably qualified roofing contractor to assess and repair the affected roof area promptly. Depending on the extent of corrosion, localised repair or partial replacement may be required.

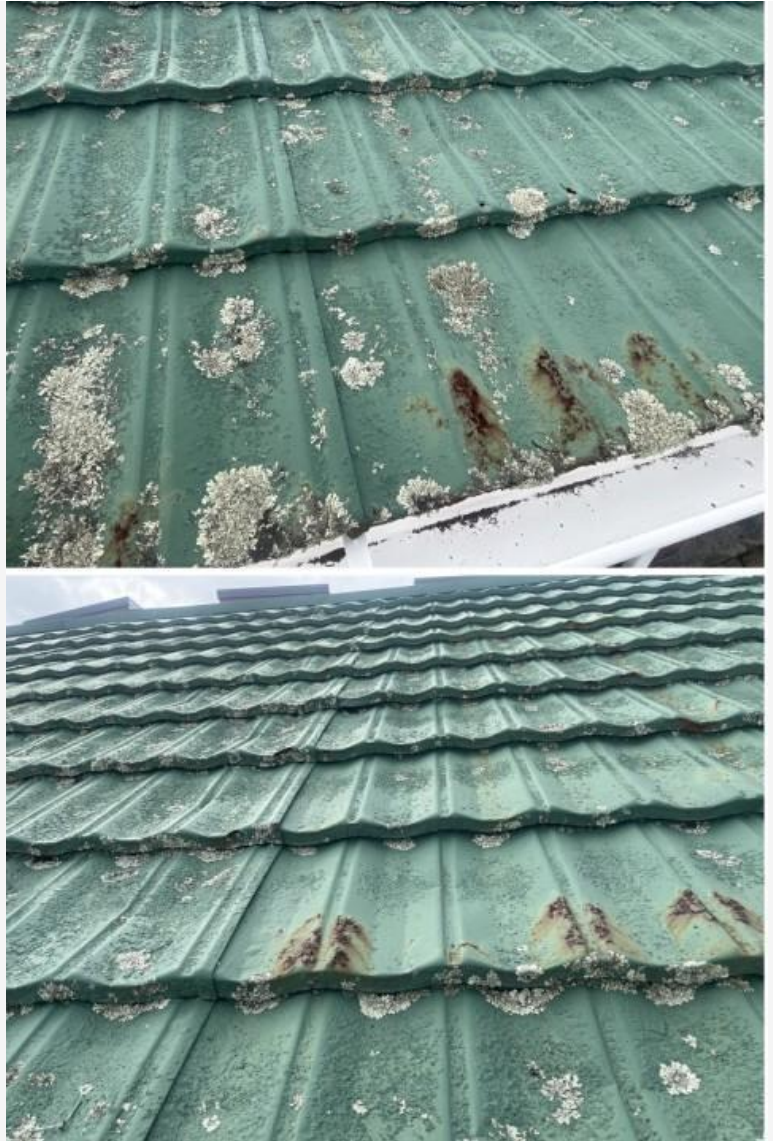
Rust damage and surface corrosion were observed to the back roof area at the time of inspection. This is considered an evident weathertightness defect, as corrosion may reduce the integrity of the roof cladding and increase the risk of moisture ingress if left unaddressed.

Recommendation: Arrange for a suitably qualified roofing contractor to assess, repair, and treat the affected roof areas as required. If corrosion is advanced or perforation is present, partial repair or replacement may be necessary.

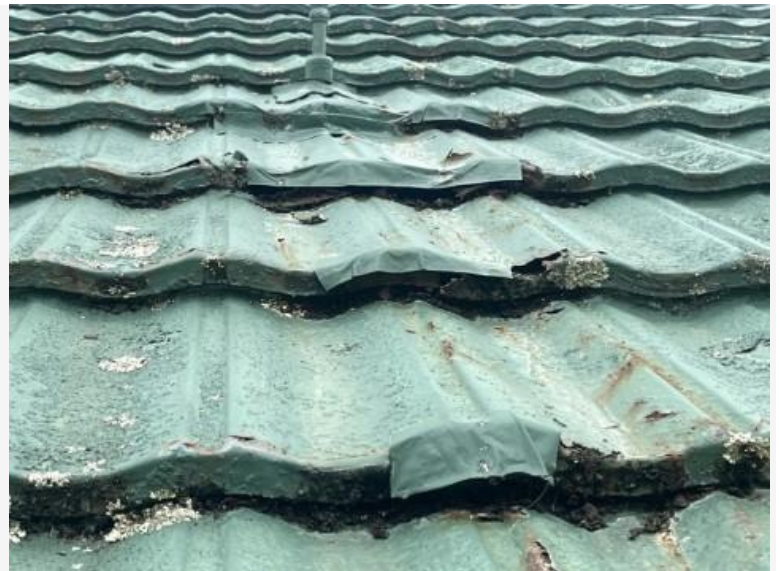
The flashing to the roof vent was observed to require repair at the time of inspection. This is considered a weathertightness defect, as defective flashing may allow moisture ingress at the roof penetration.

Recommendation: Arrange for a suitably qualified roofing contractor to repair or replace the affected flashing as required to reinstate weathertightness.

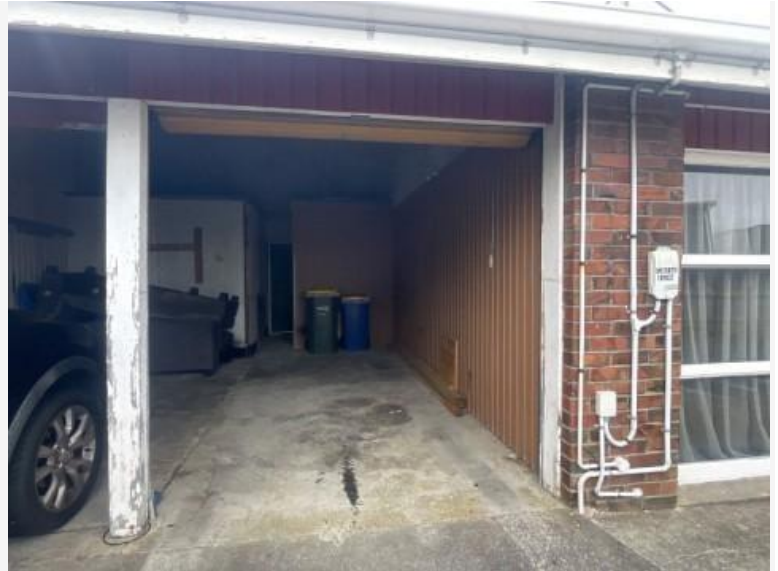
A fibre-cement sheet was observed to be loose at the time of inspection. This is a visible defect and repair is recommended to prevent further movement or deterioration.

Recommendation: Arrange for a suitably qualified builder to secure and repair the affected sheet as required.

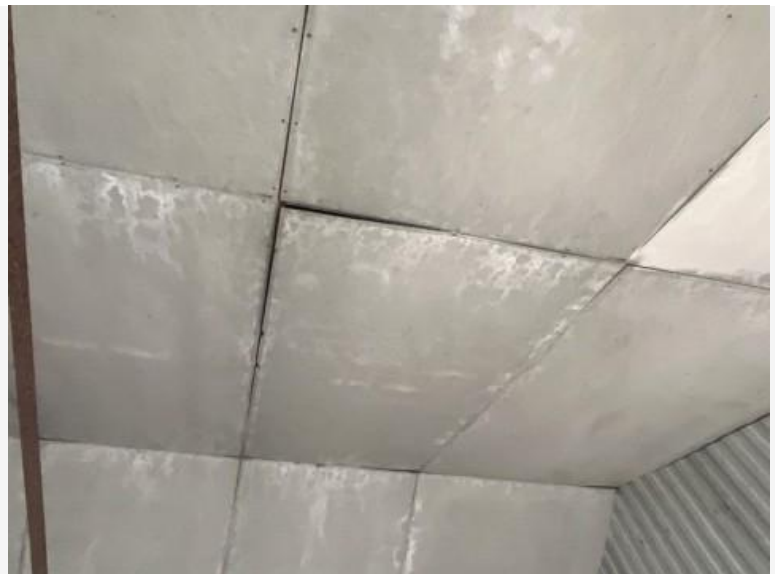
White marking/efflorescence was observed to a fibre-cement sheet at the time of inspection. Due to the height/location, close inspection was not possible, and the cause and extent of the marking could not be confirmed.

Recommendation: Arrange for closer inspection by a suitably qualified builder or relevant contractor, and carry out maintenance/repair as required based on findings.

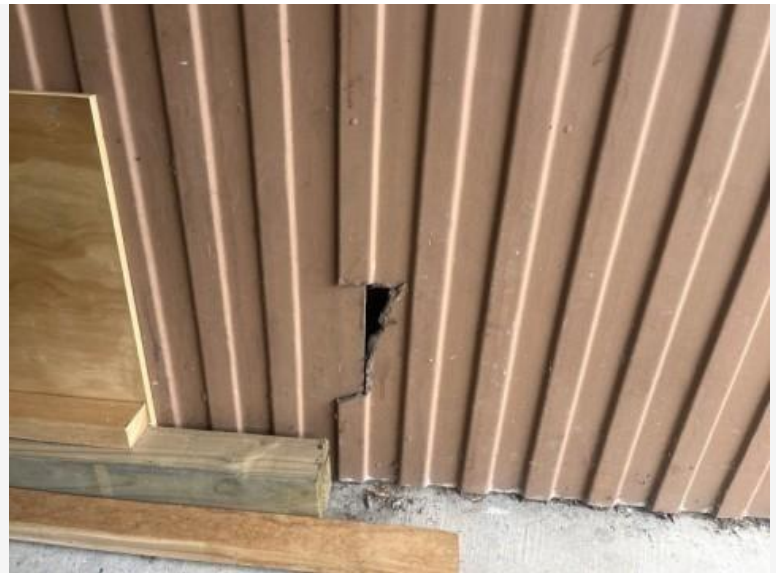
A fibre-cement board was observed to be broken/damaged at the time of inspection. This is a visible defect and repair or replacement is recommended.

Recommendation: Arrange for a suitably qualified builder to repair or replace the affected fibre-cement board as required.

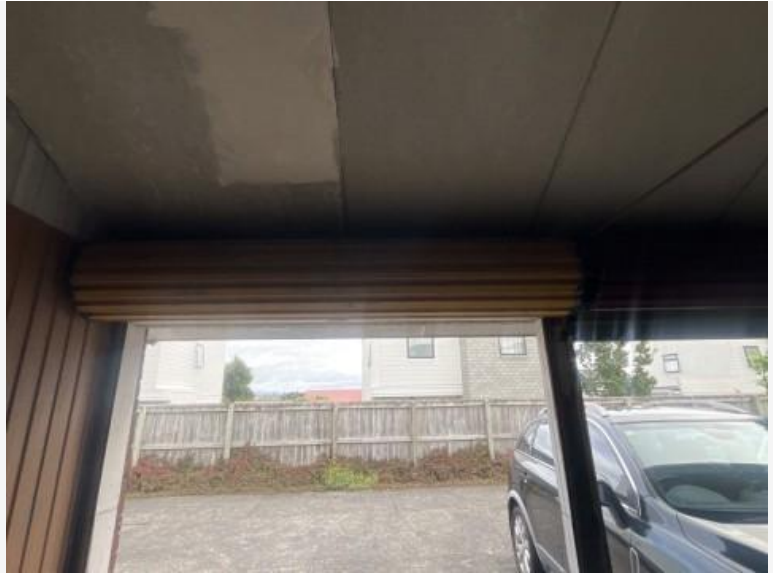
The vehicle roller door was secured/locked with a screw at the time of inspection; therefore, its operation could not be tested.

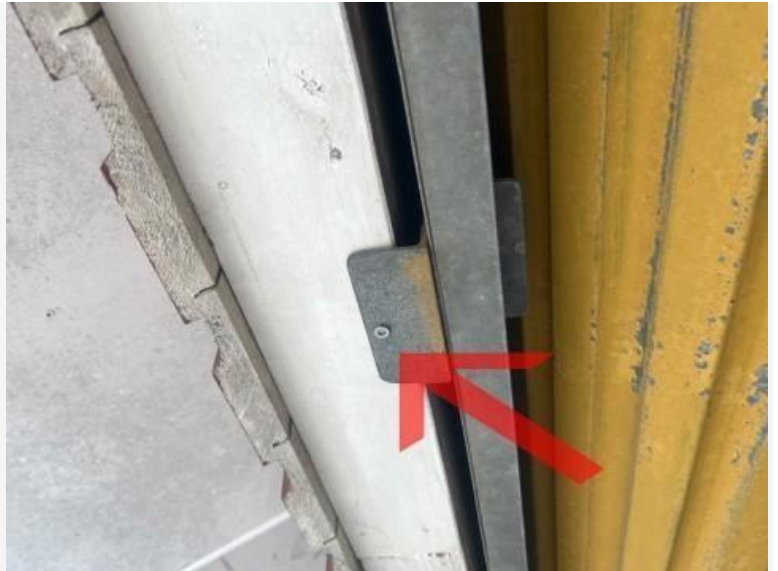
The track to the vehicle door was observed to be bent/damaged at the time of inspection. This may affect the safe and reliable operation of the door.

Recommendation: Arrange for a suitably qualified garage door contractor to assess and repair the affected track.

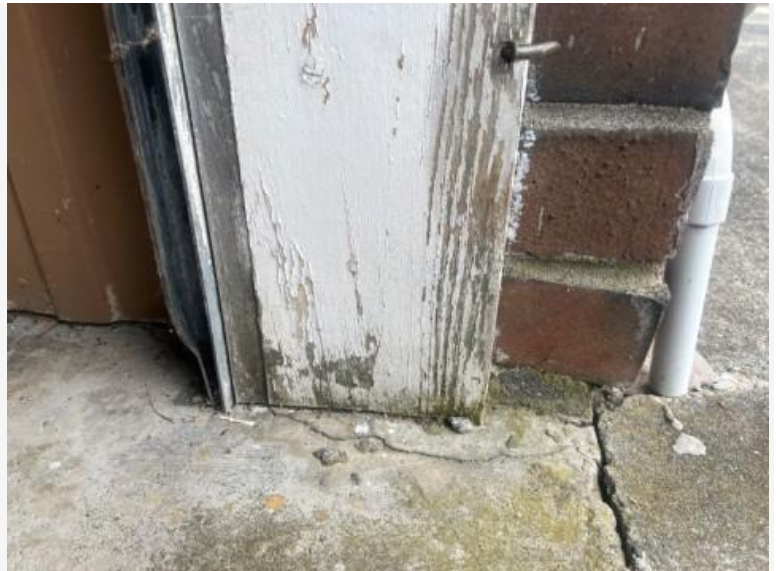
A timber post within the garage was observed to be out of plumb at the time of inspection. This may indicate movement, distortion, or previous impact, and further assessment is recommended.

Recommendation: Arrange for a suitably qualified builder to assess the post and carry out remedial work as required.

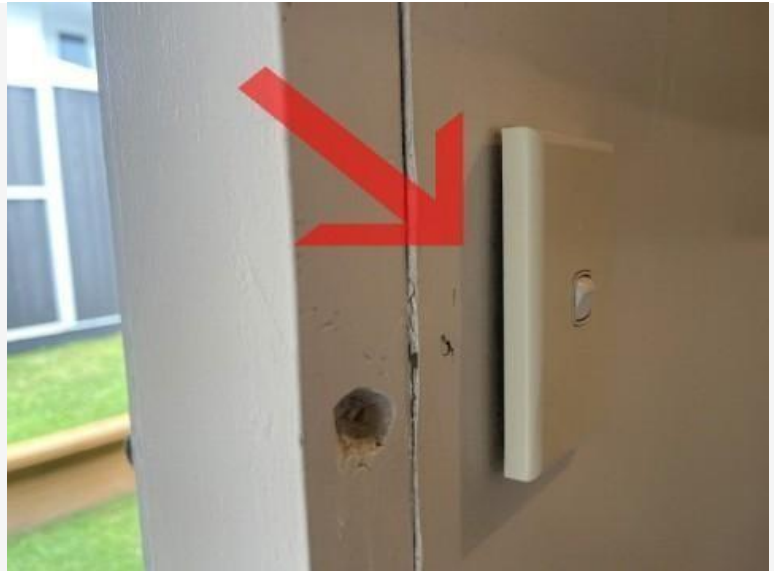
A gap was observed between the light switch cover plate and the wall lining at the time of inspection.

Recommendation: Arrange for a suitably qualified electrician to repair.

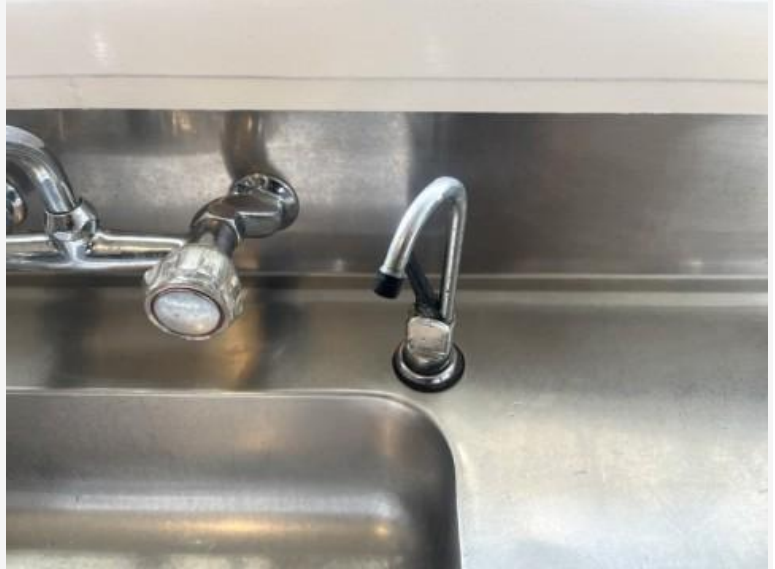
The drinking water tap was tested at the time of inspection; however, no water flowed from the outlet. This may indicate the system is not operational, is isolated, or requires maintenance.

Recommendation: Arrange for the system to be checked and serviced as required by a qualified plumber or relevant service technician.
