# Cozy Building Compliance

# Pre-Purchase House Inspection

| <b>ADDRESS:</b> | <b>Otahuhu, Auckland</b> |
| <b>INSPECTION DATE &amp; Weather Conditions:</b> | <b>13/12/2025<br/>Sunny</b> |

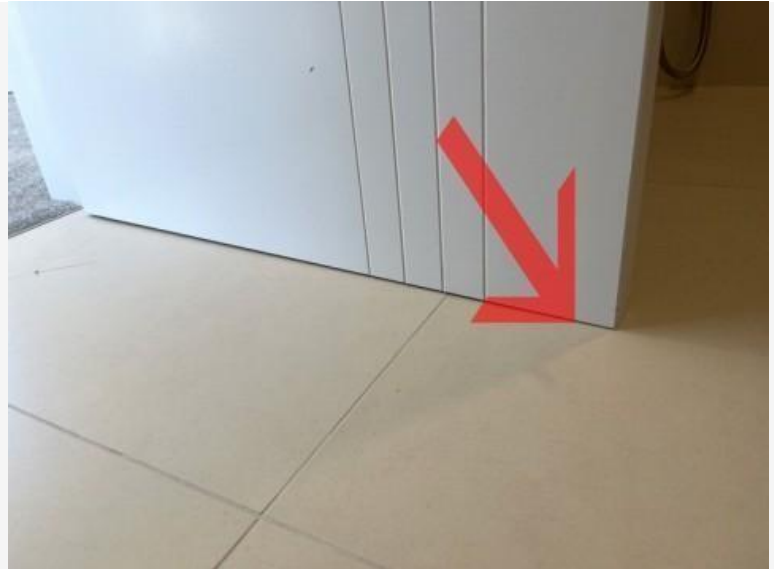
The door leaf was observed to stick on the tiled floor surface during operation. This may indicate misalignment, hinge movement, or floor/door clearance issues and may cause ongoing wear to the door and floor finish.

Recommendation: Have a qualified tradesperson assess and adjust the door (e.g., hinges/strike/door trimming) to achieve appropriate clearance and smooth operation.

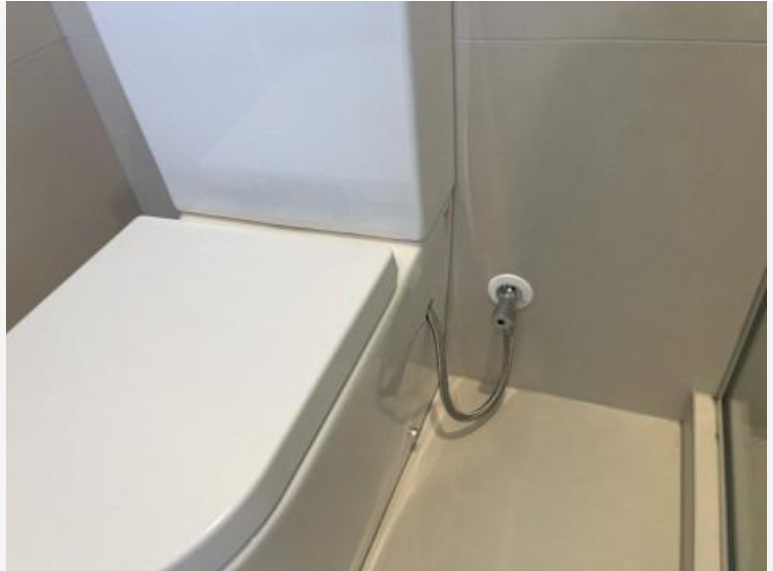
**Toilet:**

Toilet type. Floor mounted.  
Capacity. Not determined.  
Dual flush.

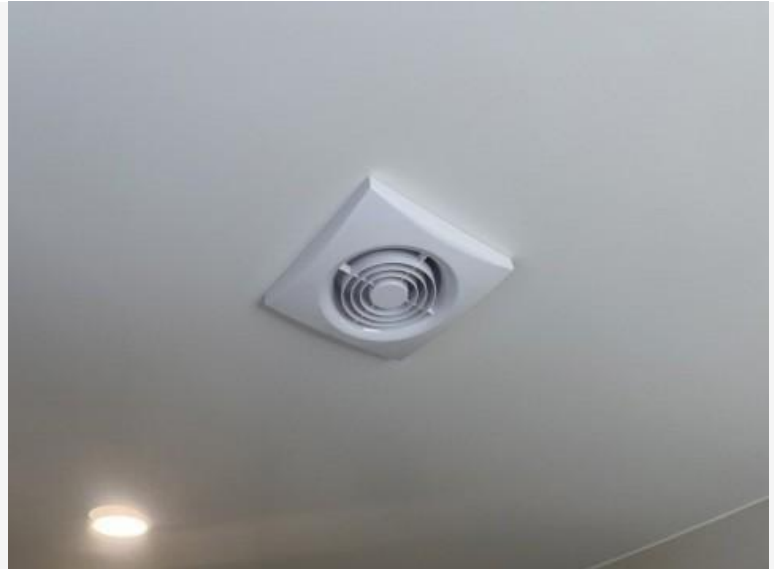
No exceptions noted at time of inspection.

Point of discharge. Exterior.

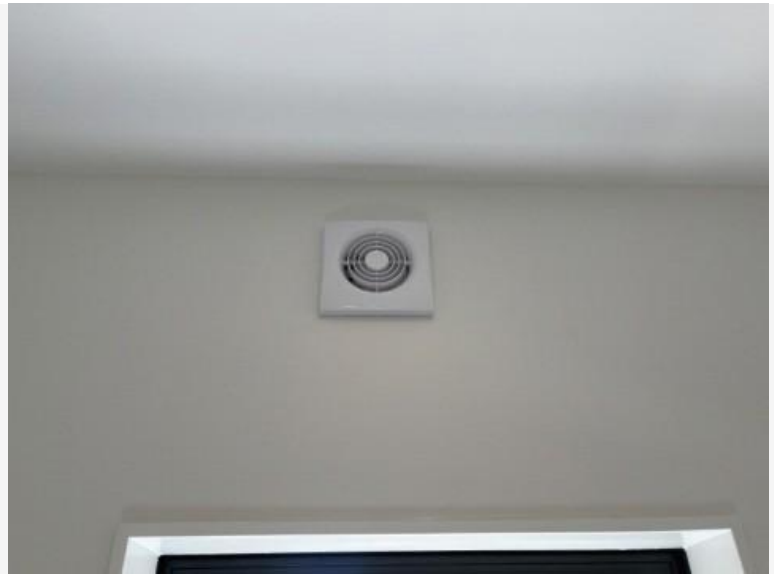
### **Ventilation:**

Type of vent. Mechanical.  
No visible defects were observed at the time of inspection. Operation was not verified beyond a basic functional observation Point of discharge. Exterior.

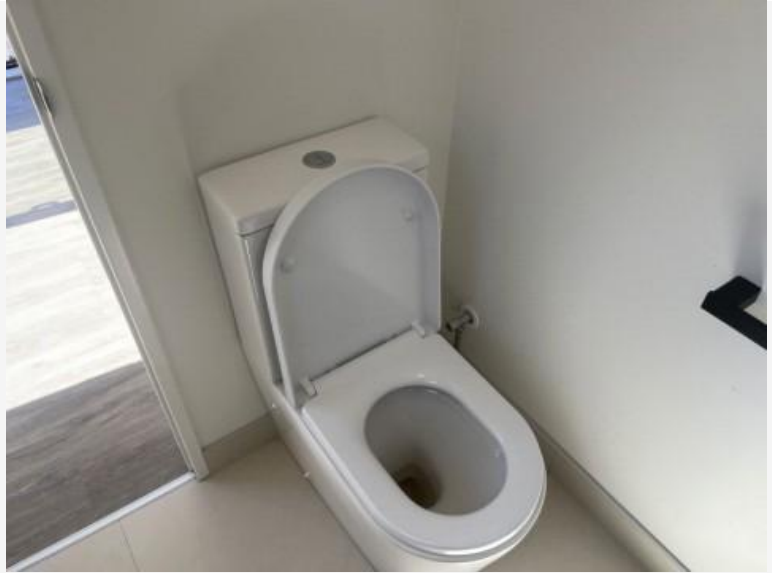
### **Toilet:**

Toilet type. Floor mounted.  
Capacity. Not determined.  
Dual flush.  
No visible defects/leaks were  
observed at the time of inspection.  
Operation was not verified beyond a  
basic functional observation

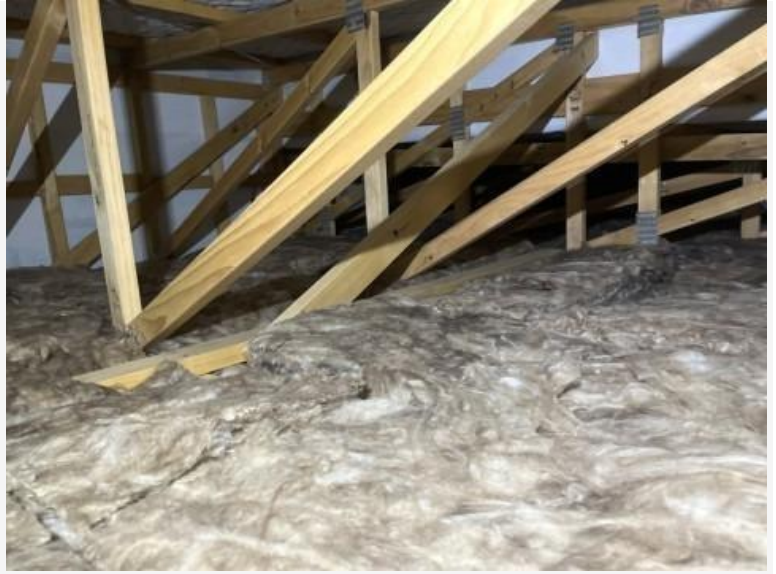
Due to the roof configuration (one side higher and the other side lower), the lower roof area was not accessible from the available inspection points at the time of inspection. As a result, we were unable to assess the condition of this lower roof area and we were unable to confirm any fire-rating/fire-resistance specification from visual inspection.

Scope limitation: This inspection is limited to accessible and visible areas only.

Recommendation: Obtain relevant building documentation (plans/specifications/Code Compliance Certificate where applicable) or engage a suitably qualified contractor (e.g., roofer/building professional) to inspect this area further, including by invasive access if required.

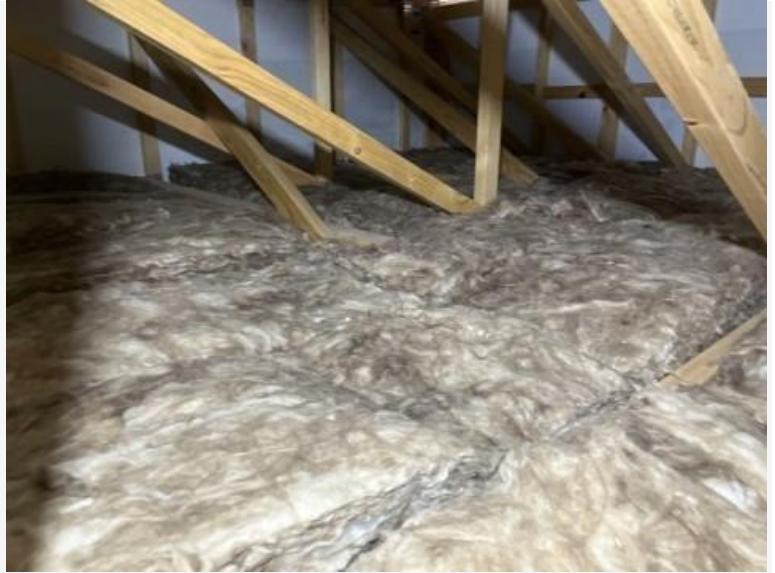
### **Insulation:**

Material Type: Glasswool  
Type: Segment.  
Thickness: The insulation is approximately 150 mm in thickness.  
Coverage: Insulation appeared generally continuous where visible.  
Full coverage cannot be confirmed due to access/visibility limitations.

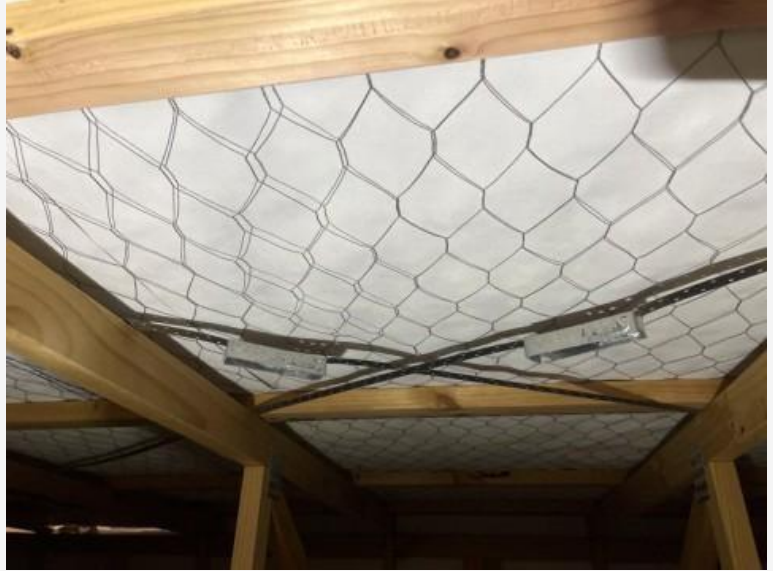
### **Roof Underlay:**

Roof underlay was observed where visible at the time of inspection. No exceptions were noted to the visible sections.

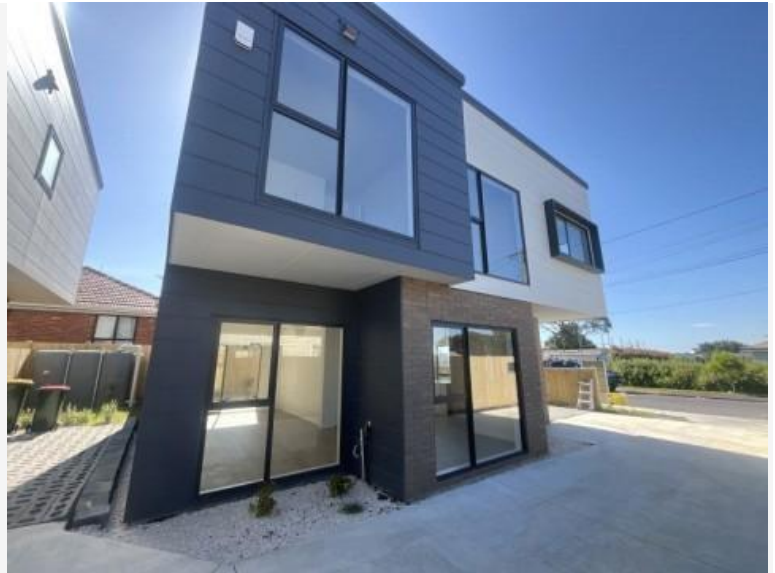
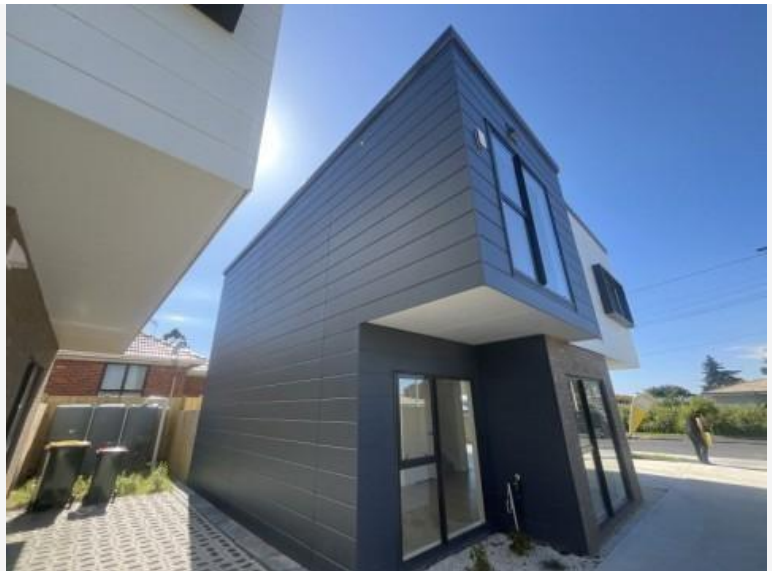
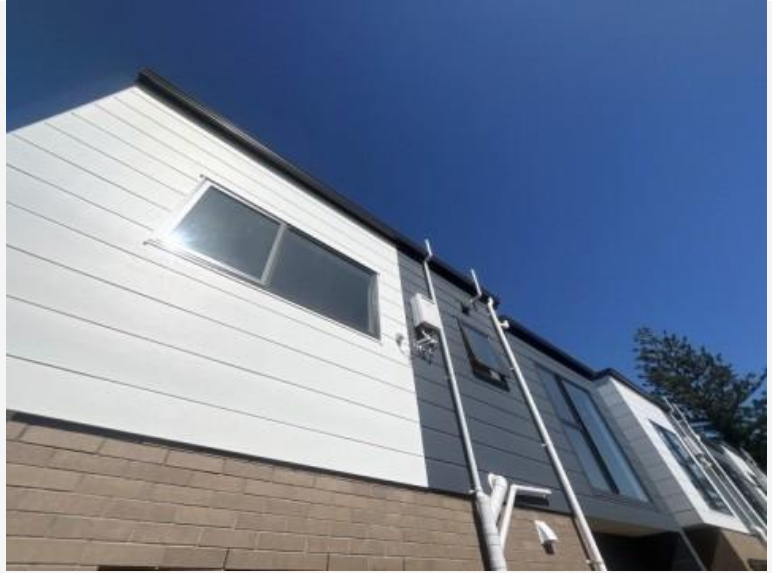
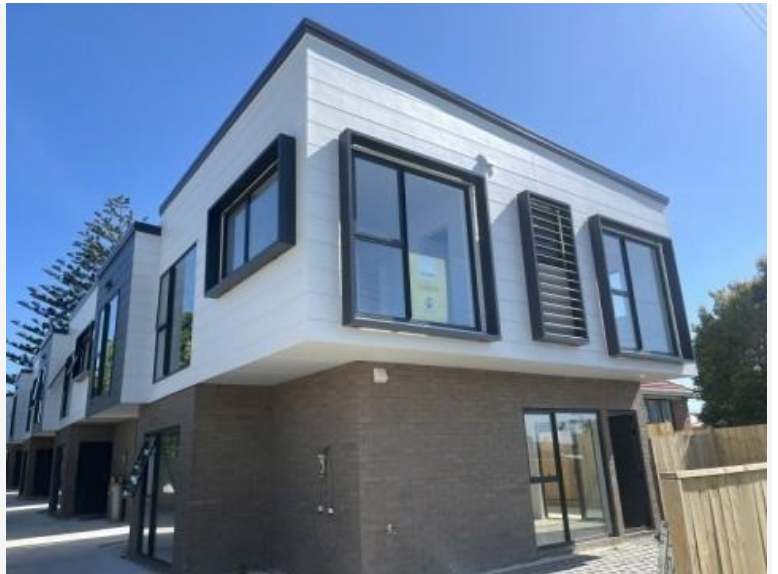
A gap was observed at the cavity closer to the exterior wall cladding (south elevation). This may reduce pest control effectiveness and compromise intended cavity performance.

A gap was observed at the bottom edge of the exterior wall cladding on the south elevation. This may allow pest entry and may increase moisture-related risk if the base detail is not performing as intended. Recommendation: Have a competent tradesperson assess the base detail and close/repair the gap as appropriate (including reinstating any required flashings/closures/sealant where applicable).

Recommendation: Engage a qualified cladding contractor / LBP builder (as appropriate) to tidy the cavity closer and close/seal the gap in accordance with good practice and manufacturer requirements.

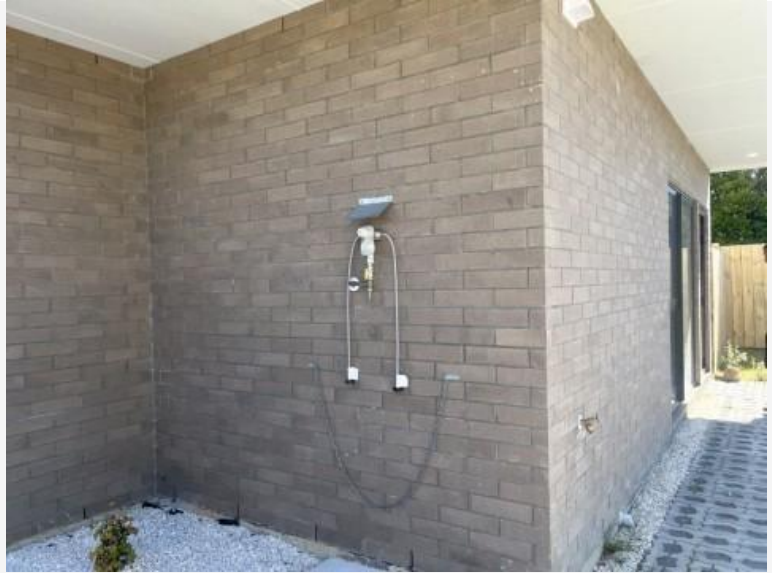
No exceptions noted to weep holes where visible at the time of inspection.

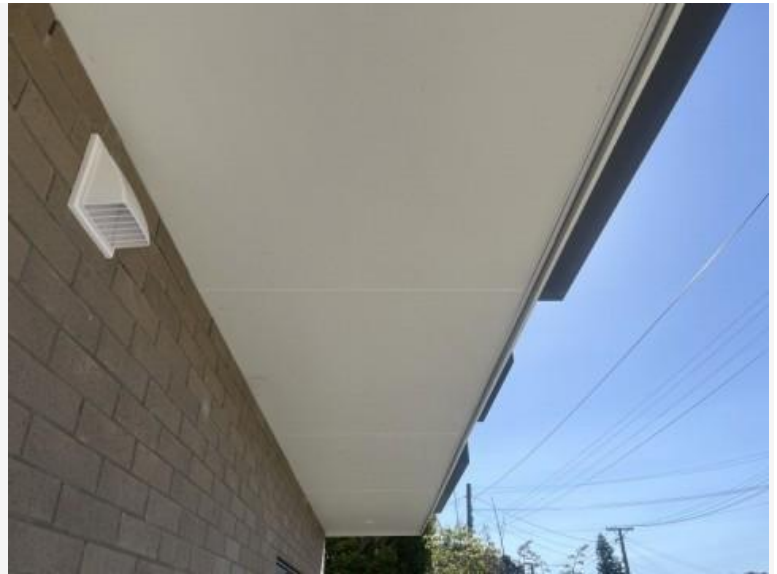
A nail hole was observed to the soffit lining. This may allow moisture entry and contribute to deterioration over time.

Recommendation: Seal and make good the penetration (fill, seal, and repaint) using a suitable exterior-grade system; monitor for any signs of moisture staining.

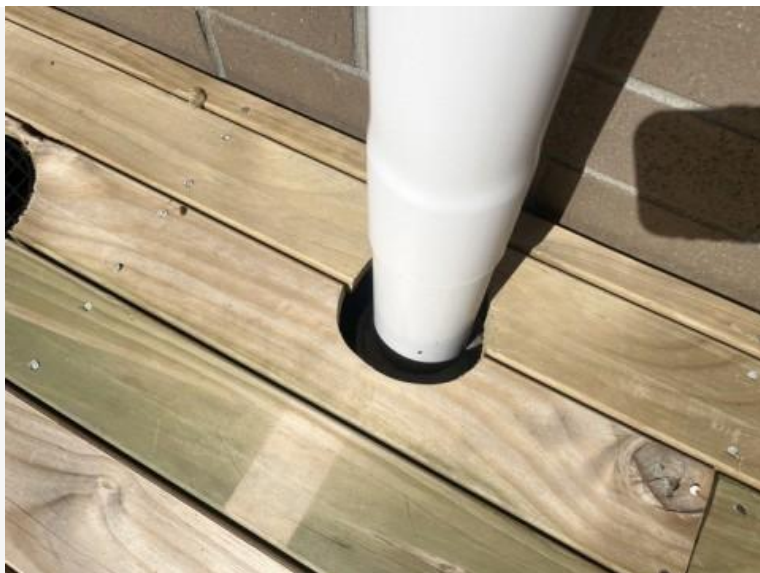
### **Visible Point of Discharge:**

The downpipes discharge into the ground, however we are unable to determine whether they connect into any other system.

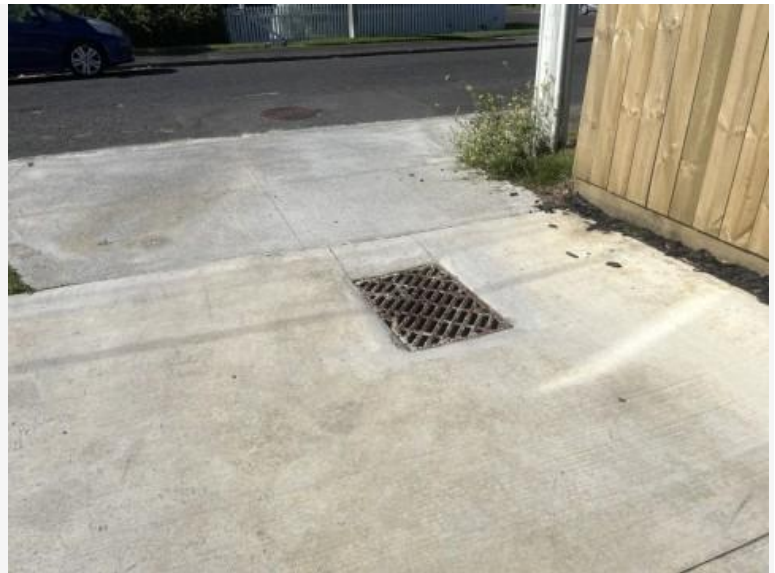
### **Surface Water Control:**

At the time of inspection, no ponding was observed at accessible areas. Site falls and below-ground stormwater discharge were not confirmed; monitor performance during rainfall.

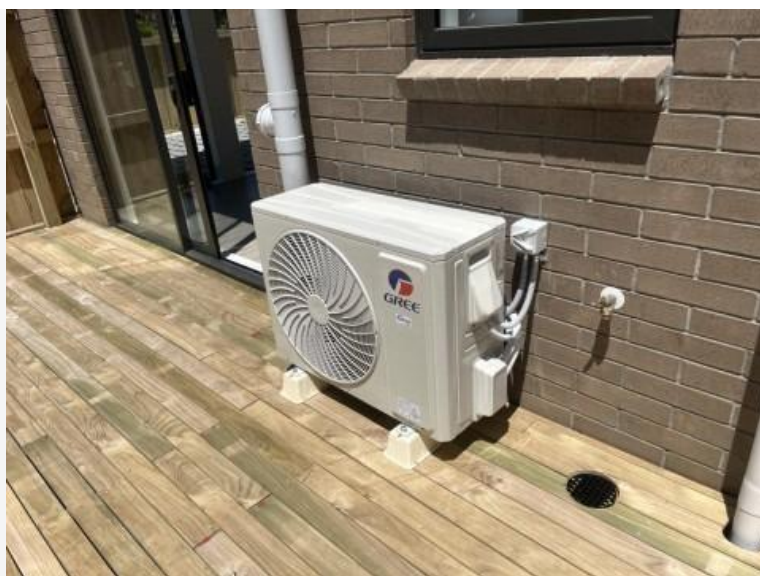
Not tested/operated at the time of inspection. No defects were observed to the accessible components at the time of inspection; however, performance testing and compliance certification were not within scope.

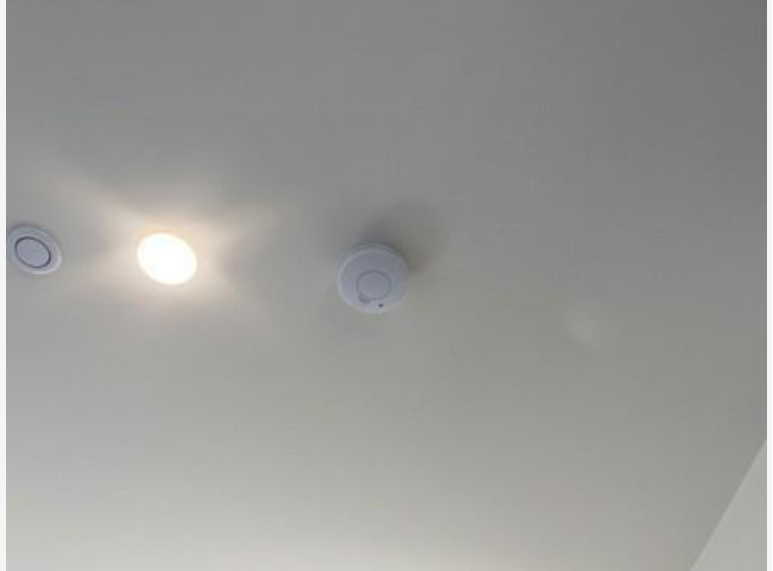
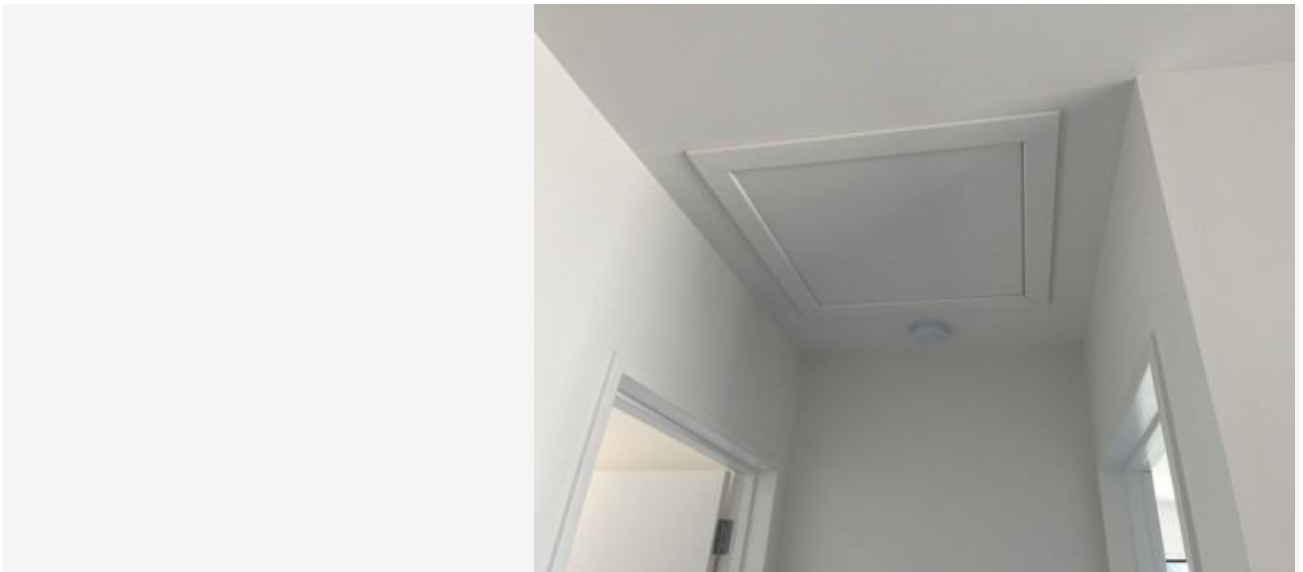
Battery operated smoke detectors.

Units were not tested as part of this inspection. Recommendation: Test alarms using the test button and replace batteries/units if inoperative or expired. Confirm the alarm type/location and any compliance requirements with a qualified electrician or the relevant guidance prior to rental or building work.
