# Cozy Building Compliance

# Pre-Purchase House Inspection

<b>ADDRESS:</b>	<b>Sample report</b>
<b>CLIENT:</b>	<b>Cozy Building Compliance</b>
<b>AGENT:</b>	<b>Young</b>
<b>INSPECTION DATE &amp; Weather Conditions:</b>	<b>13/12/2025</b> <b>Sunny</b>
<b>INSPECTION INSTRUCTIONS:</b>	<b>Pre-Purchase Visual Non-Invasive Property Inspection</b>
<b>Vendors' INSURANCE:</b>	<b>N/A</b>

**Client Name:** Sample Report  
**Inspection address:**  
**Date of inspection:** 13/12/2025  
**Property Inspector:** Young Tsai  
**Company:** Cozy Building Compliance Ltd  
**Scope of inspection:** The scope of the inspection is as set out in our Terms and Conditions and is limited to a visual Pre-Purchase, or Pre-Sale inspection, carried out in accordance with NZS4306:2005  
**Report number:** 13122025-003

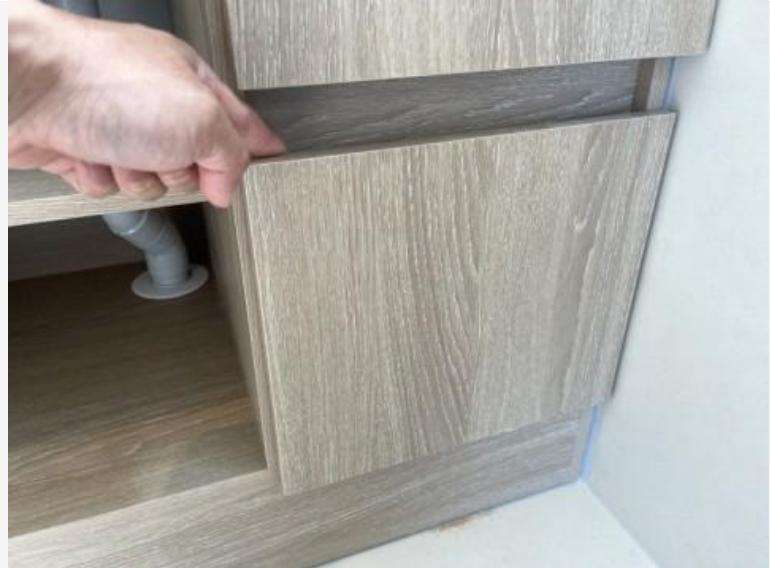
A drawer was unable to be opened at the time of inspection. The condition behind/within the drawer could not be assessed.

Recommendation: Arrange adjustment/repair by a cabinetmaker; re-check for any concealed damage once operable.

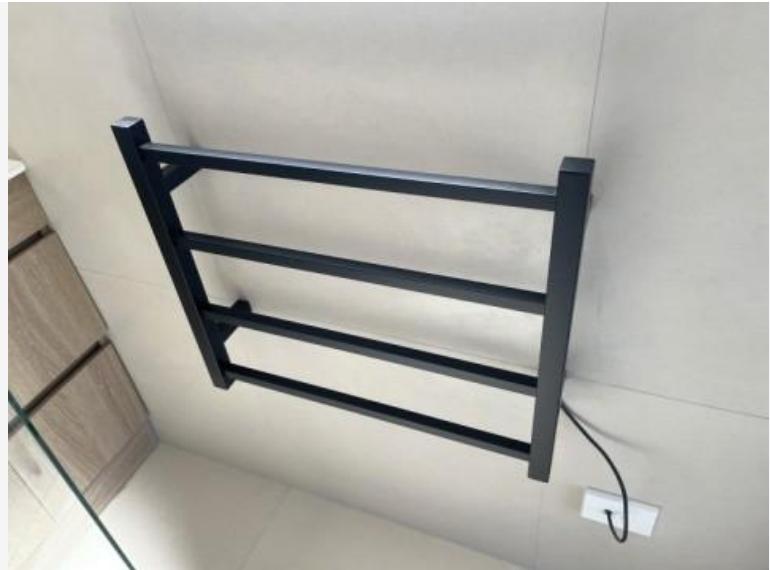
There is a heated towel rail. Not tested.

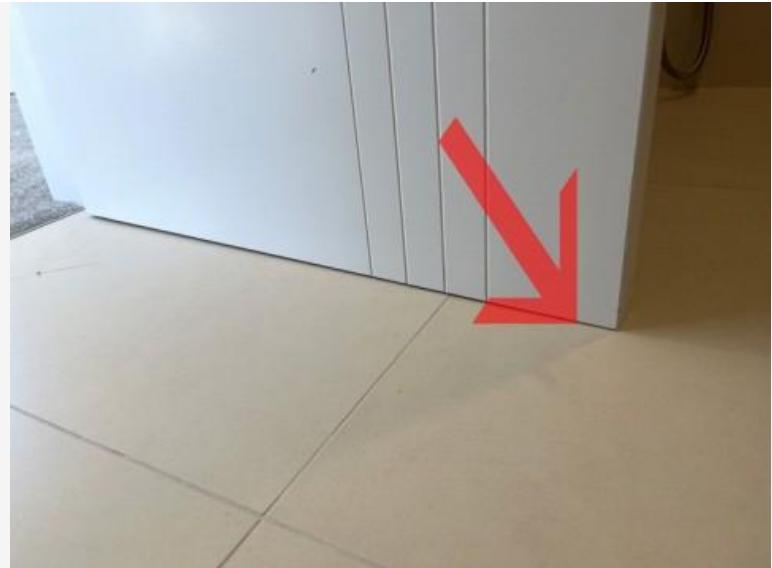
The door leaf was observed to stick on the tiled floor surface during operation. This may indicate misalignment, hinge movement, or floor/door clearance issues and may cause ongoing wear to the door and floor finish.

Recommendation: Have a qualified tradesperson assess and adjust the door (e.g., hinges/strike/door trimming) to achieve appropriate clearance and smooth operation.

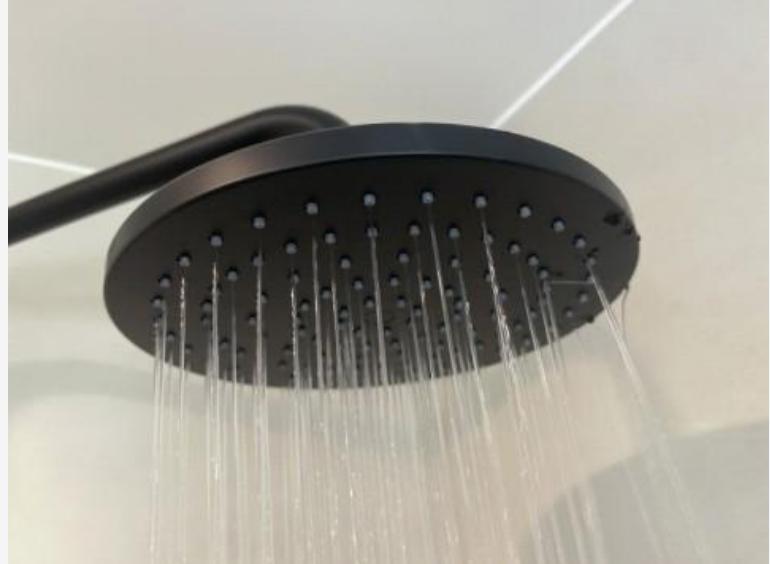
Uneven water discharge was observed from the shower rose, with some spray holes not discharging water at the time of inspection. This may indicate blockage or scaling within the shower rose.

Recommendation: Clean/descales or replace the shower rose and re-test. If the issue persists, engage a qualified plumber to further assess.

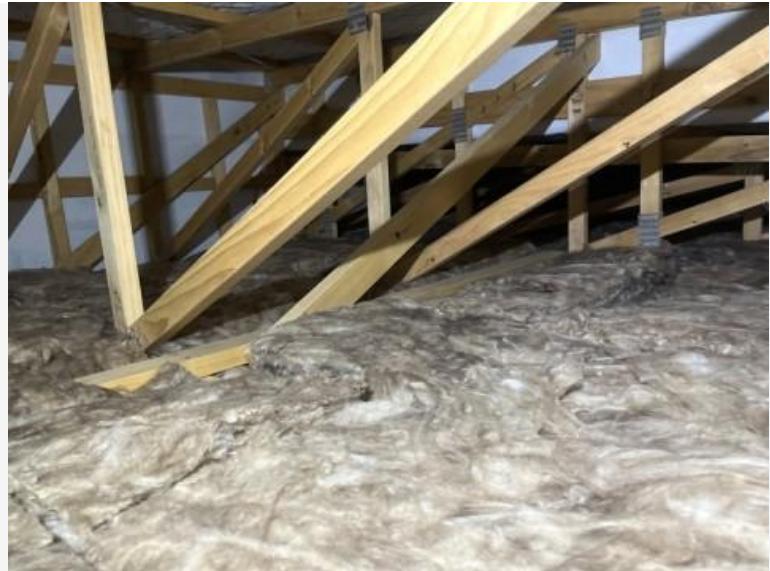
Due to the roof configuration (one side higher and the other side lower), the lower roof area was not accessible from the available inspection points at the time of inspection. As a result, we were unable to assess the condition of this lower roof area and we were unable to confirm any fire-rating/fire-resistance specification from visual inspection.

**Recommendation:** Obtain relevant building documentation (plans/specifications/Code Compliance Certificate where applicable) or engage a suitably qualified contractor (e.g., roofer/building professional) to inspect this area further, including by invasive access if required.

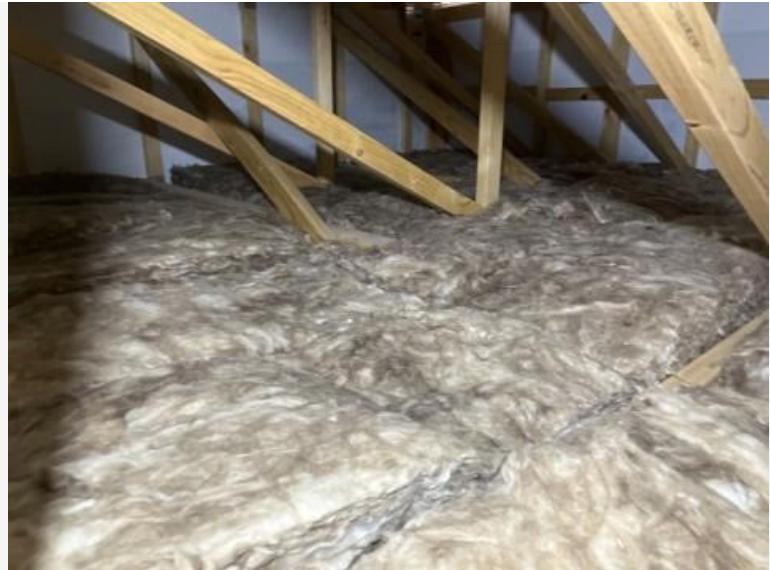
Material Type: Glasswool  
Type: Segment.  
Thickness: The insulation is approximately 150 mm in thickness.  
Coverage: Insulation appeared generally continuous where visible.  
Full coverage cannot be confirmed due to access/visibility limitations.

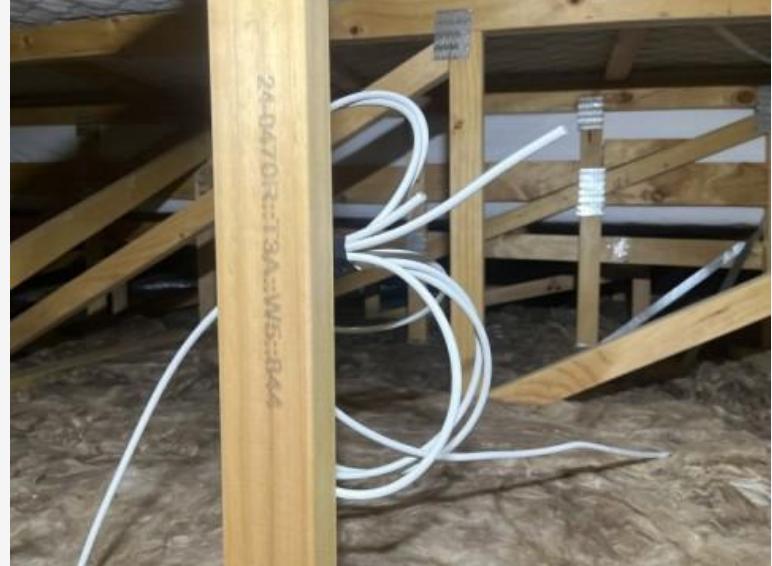
An unconnected electrical cable was observed. The purpose and status of this cable could not be confirmed at the time of inspection. The cut end was not suitably covered or protected. This presents a potential electrical hazard.

Recommendation: Engage a registered electrician to identify the cable, confirm whether it is live or redundant, and make it safe (e.g., isolate/terminate correctly and cover/protect as required).

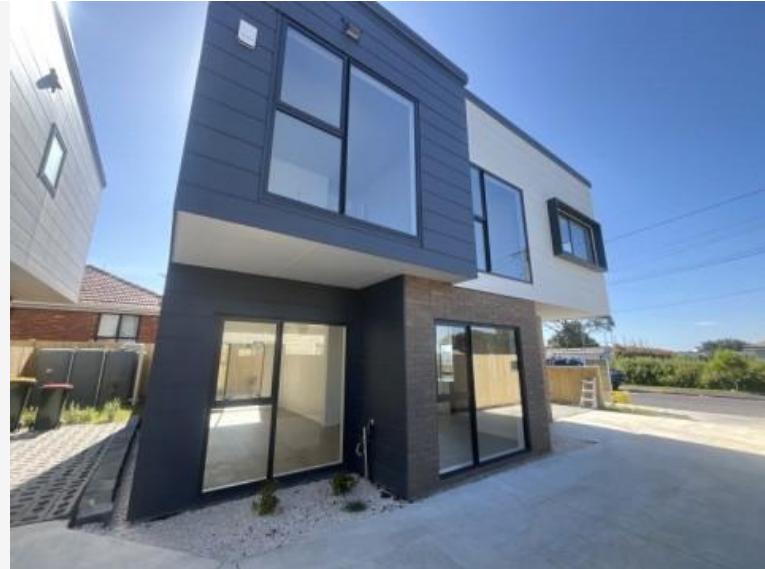
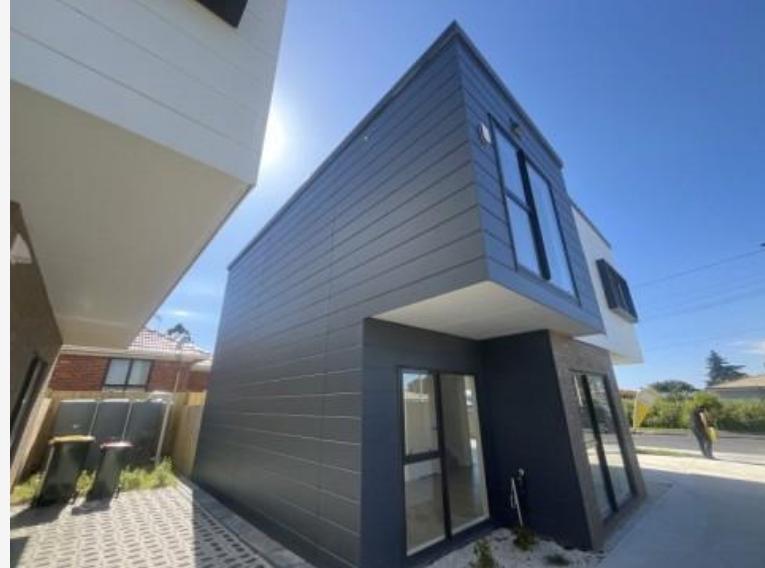
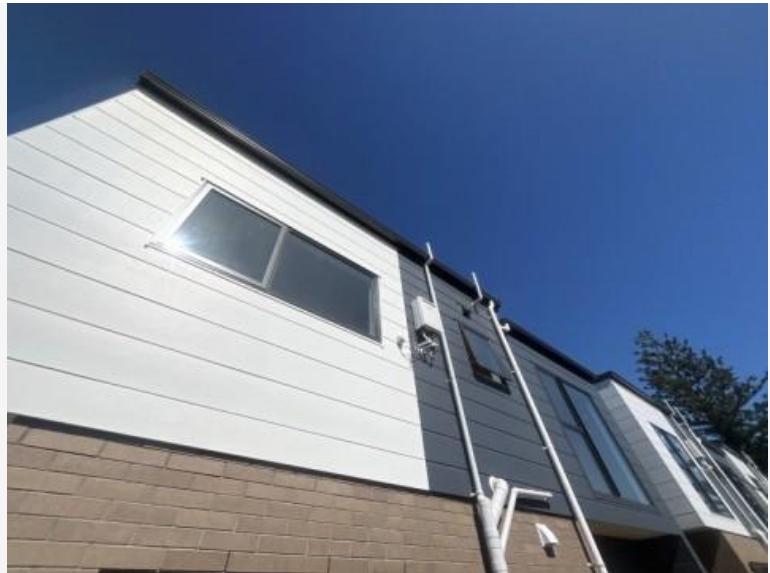
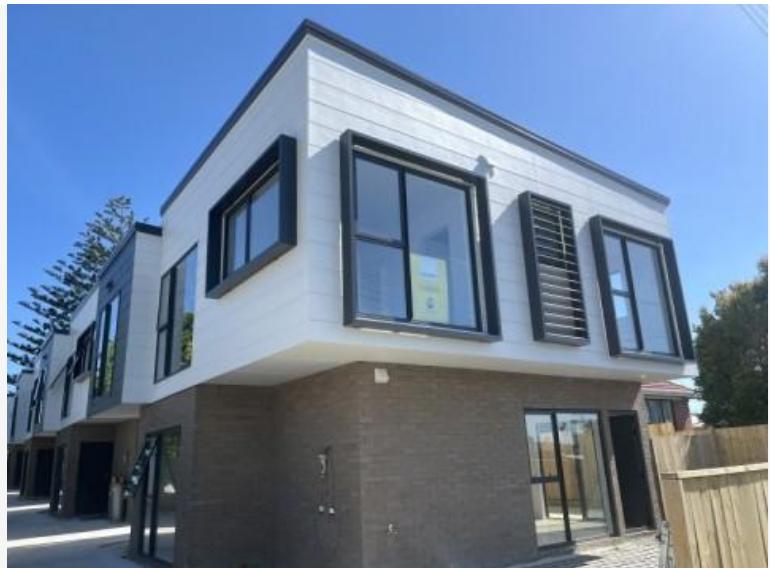
A gap was observed at the cavity closer to the exterior wall cladding (south elevation). This may reduce pest control effectiveness and compromise intended cavity performance.

Recommendation: Engage a qualified cladding contractor / LBP builder (as appropriate) to tidy the cavity closer and close/seal the gap in accordance with good practice and manufacturer requirements.

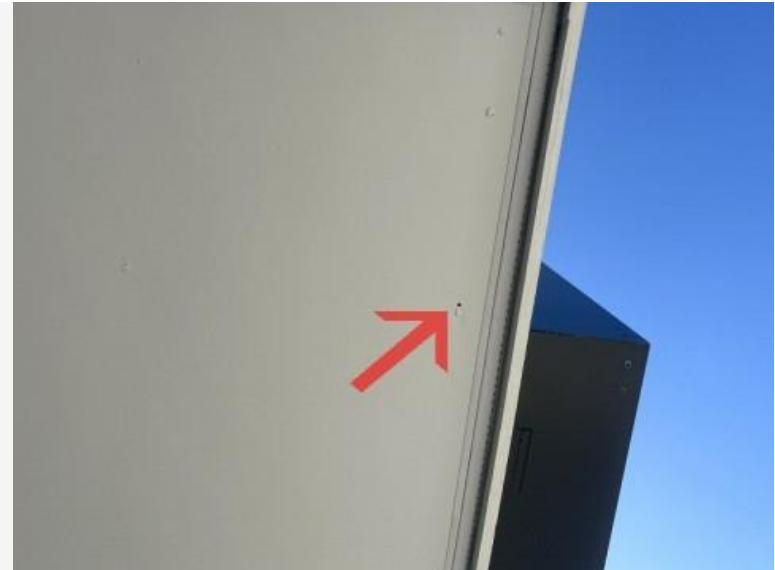
A nail hole was observed to the soffit lining. This may allow moisture entry and contribute to deterioration over time.

Recommendation: Seal and make good the penetration (fill, seal, and repaint) using a suitable exterior-grade system; monitor for any signs of moisture staining.

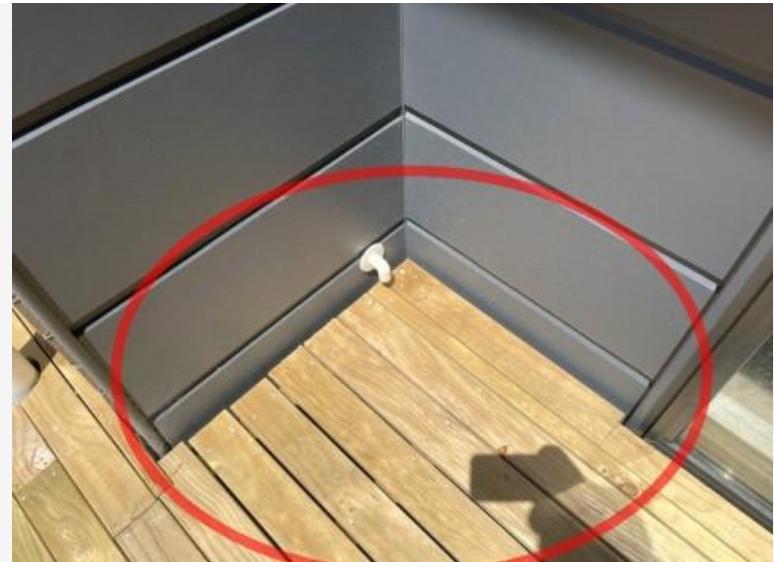
Squeaking was noted from the decking boards when walked on. A decking board also appeared to be in contact with a pipe adjacent to the deck. Uneven clearance was observed around the pipe penetration, with some sections too close to (or in contact with) the pipe. This may contribute to noise, ongoing movement, and potential wear to the decking and/or pipe over time.

A section of decking felt "floating" at the time of inspection, suggesting inadequate fixing. This may present a safety risk and may worsen over time.

**Recommendation:** We recommend you engage a Licensed Building Practitioner (LBP) assess and rectify, including re-fixing boards and trimming/adjusting the penetration to achieve suitable clearance around the pipe and confirm the pipe is not damaged.

**Recommendation:** Engage a suitably qualified builder to assess the decking structure and fixings and carry out repairs/re-fixing as required.

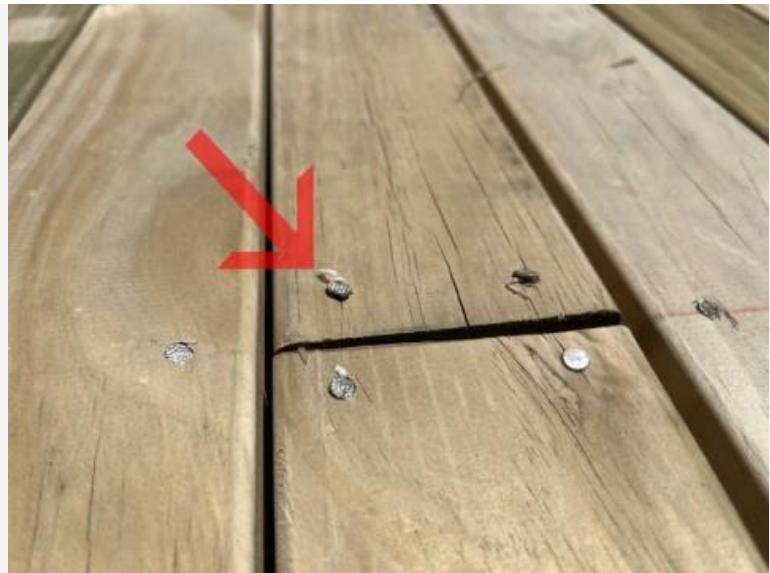
A nail was observed protruding ("popped out") from the decking surface. This presents a potential injury hazard and may indicate loosening fixings or board movement.

Recommendation: Have a Licensed Building Practitioner (LBP) refix/replace the fastening and check adjacent fixings/boards for movement; resecure as required.

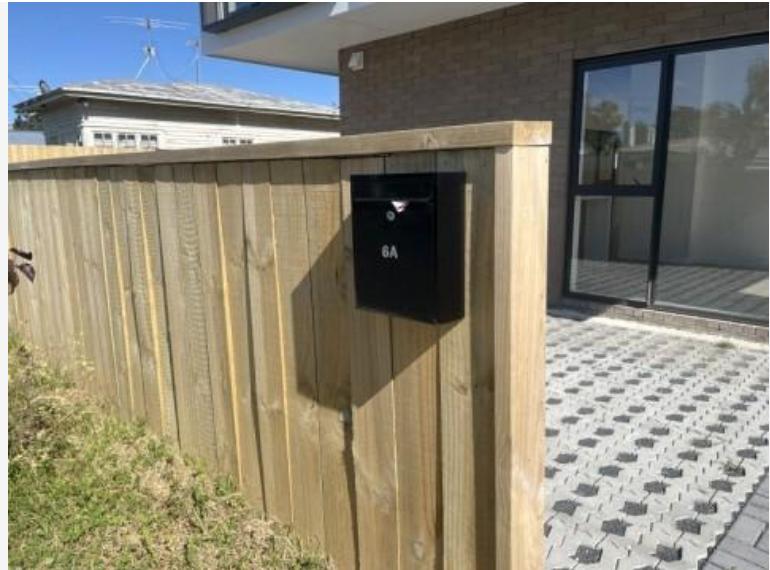
### **Letterbox**

Metal letterbox located on the front fence.

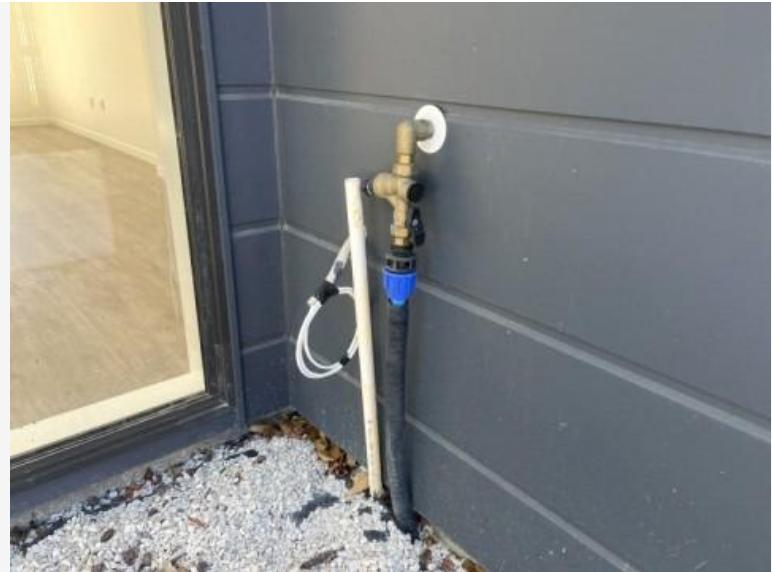
**Water Shut off Valve:**

Left side of house.

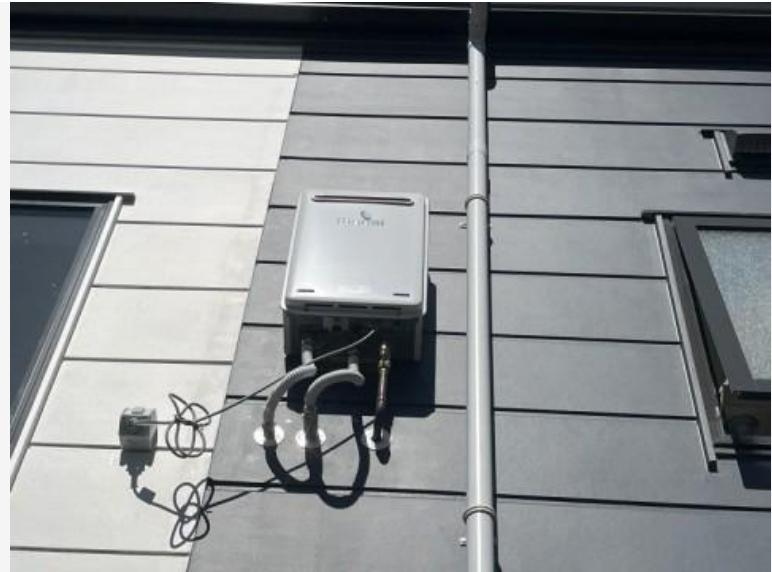
### **Location:**

Exterior.

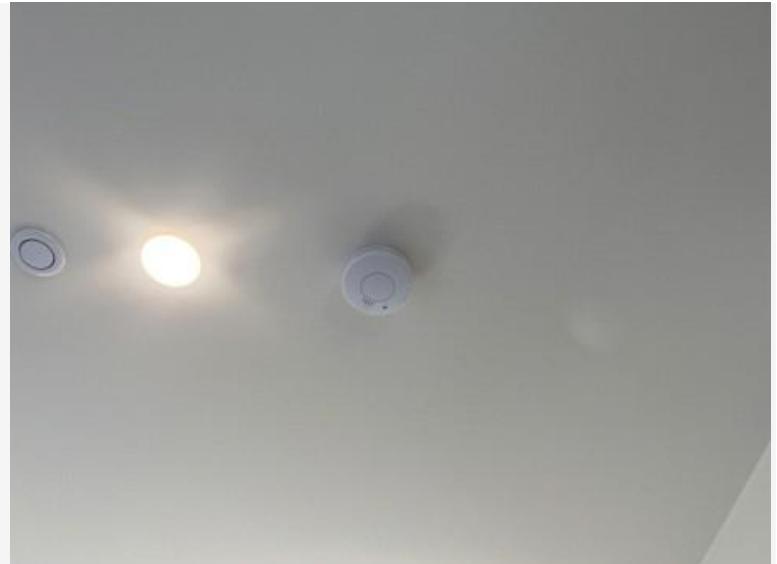
**Siren:**

Living area.

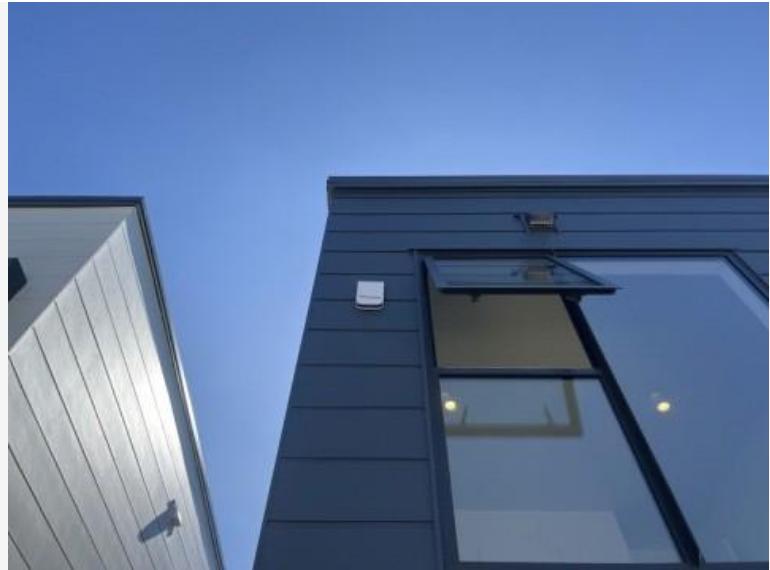
**Location of External**

Left side of home.

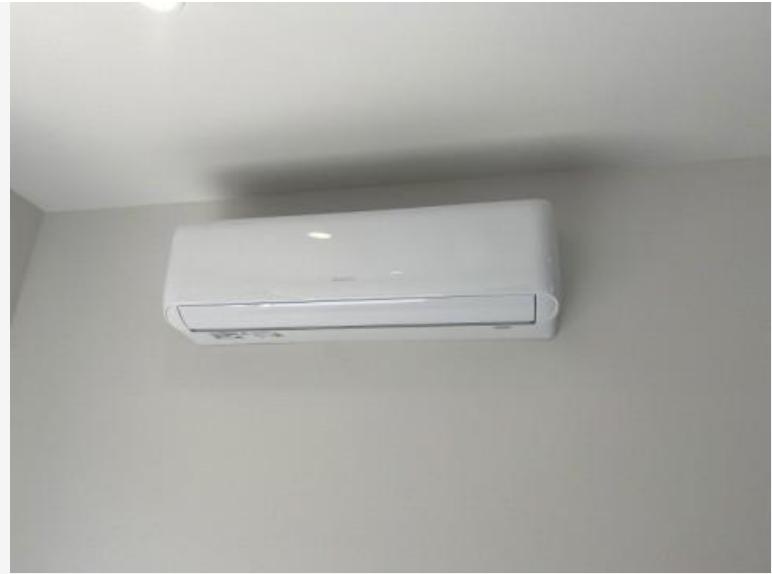
### **Type:**

Heat pump.

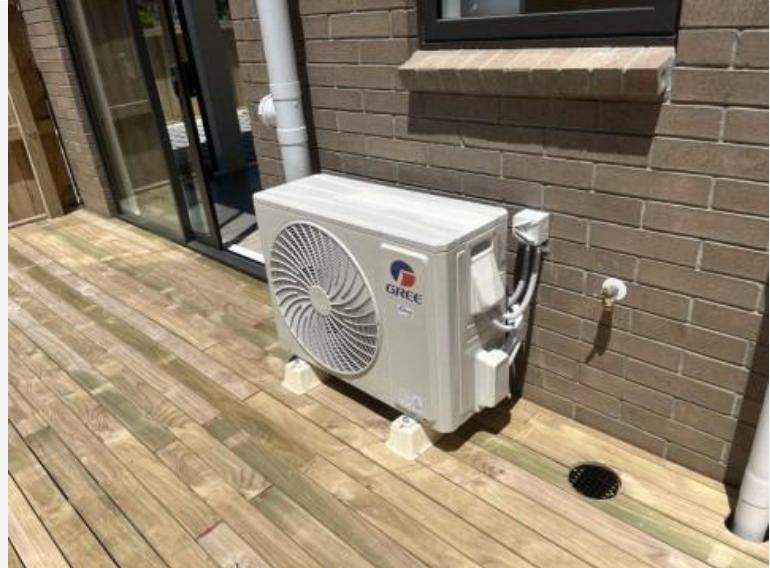
### **Location of Unit:**

Exterior of home.

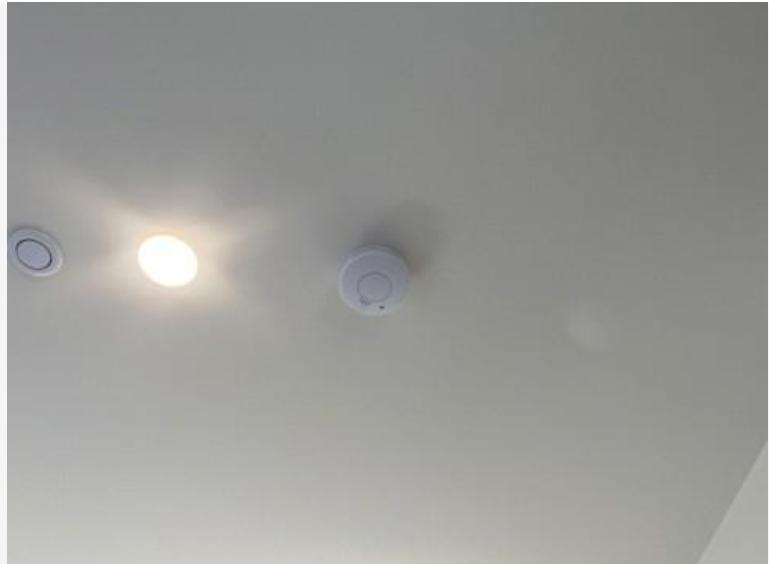
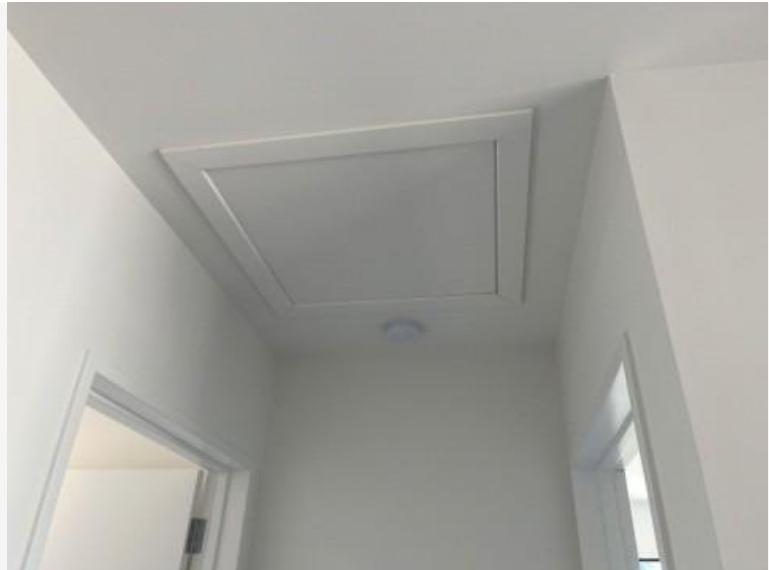
Battery operated smoke detectors.

Units were not tested as part of this inspection. Recommendation: Test alarms using the test button and replace batteries/units if inoperative or expired. Confirm the alarm type/location and any compliance requirements with a qualified electrician or the relevant guidance prior to rental or building work.

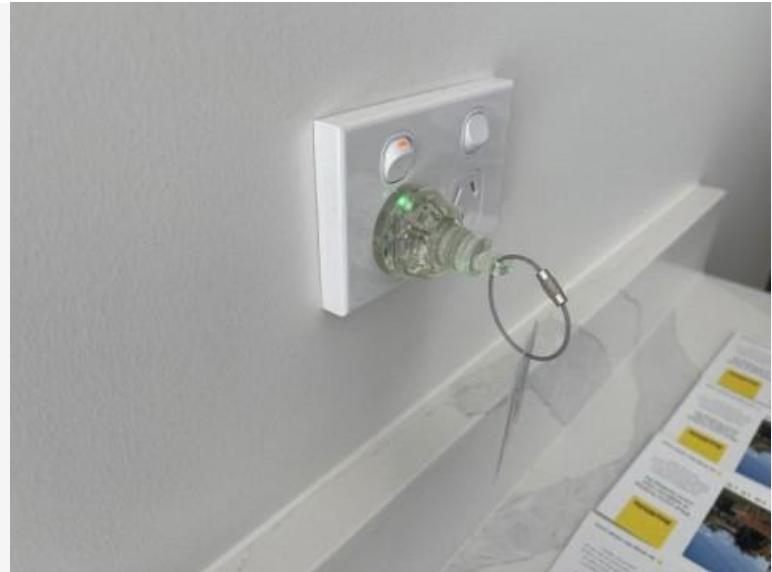
### **Lights and Power Points:**

Lights and accessible power points tested; no exceptions noted at time of inspection.

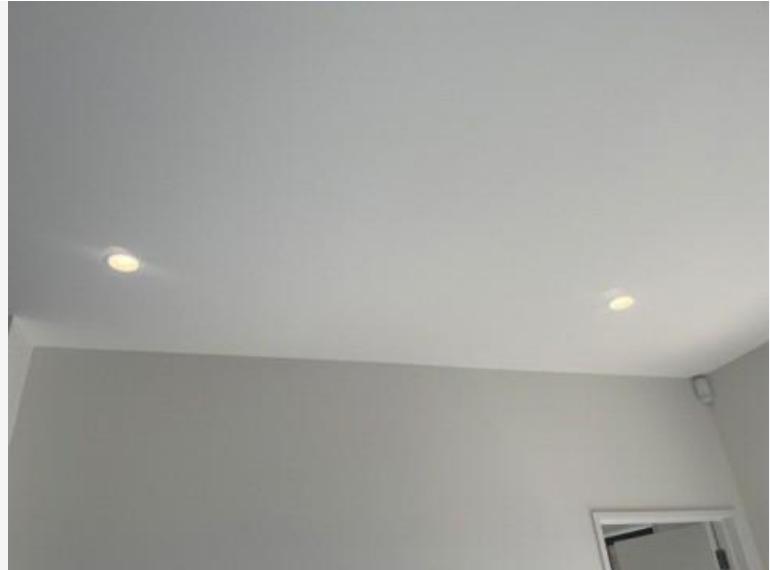
### **Entrance.**

Lights tested; no exceptions noted at time of inspection.

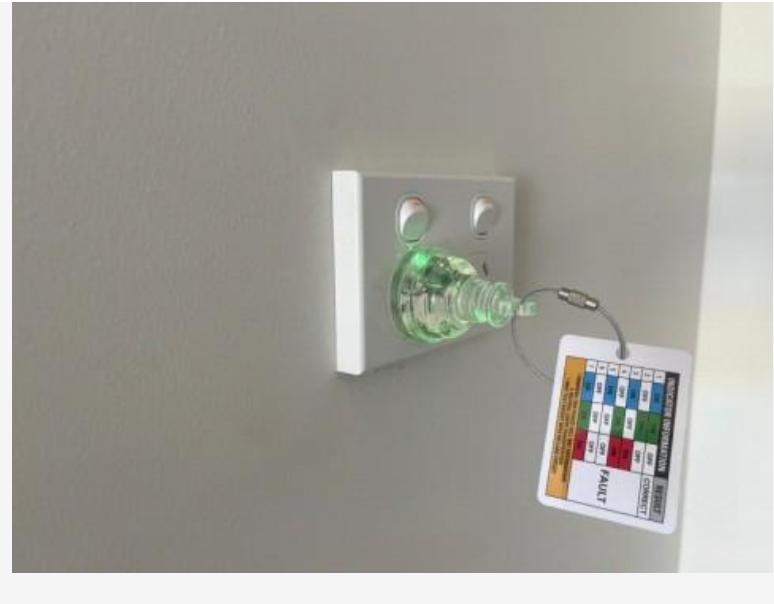
## Storage room.

Lights and accessible power points tested; no exceptions noted at time of inspection.

A power point was observed with a missing cover plate, with untidy/exposed cabling noted adjacent. This presents a potential electric shock and fire hazard. Recommendation: Arrange for a registered electrician to assess and rectify promptly, including reinstating an appropriate cover plate and securing/protecting cabling.

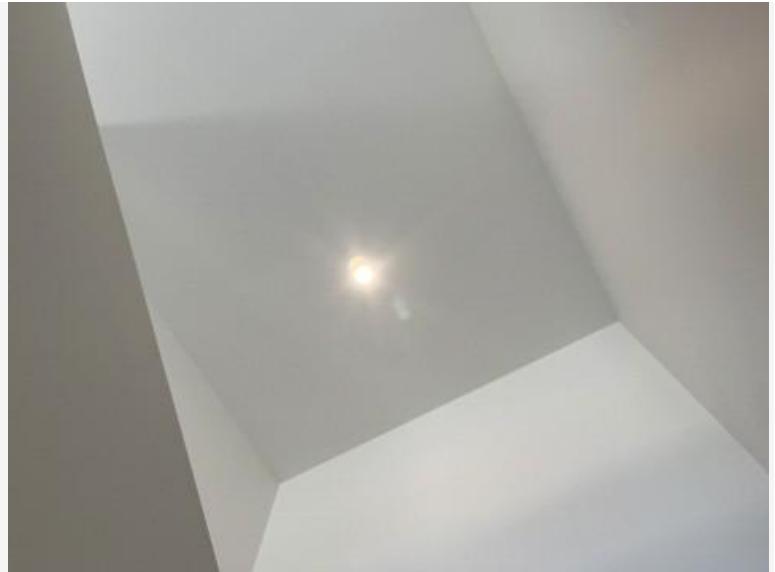
Lights tested; no exceptions noted at time of inspection.

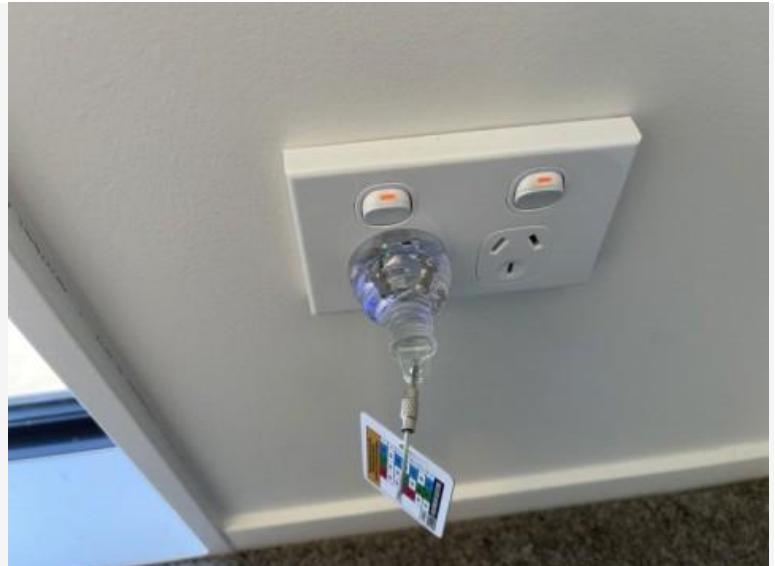
### **Bedroom 1.**

Lights and accessible power points tested; no exceptions noted at time of inspection.

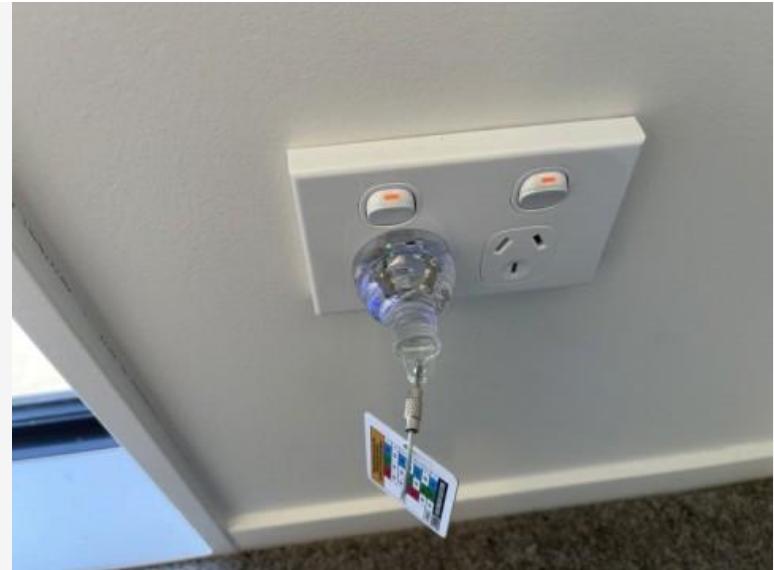
### **Bedroom 2.**

Lights and accessible power points tested; no exceptions noted at time of inspection.

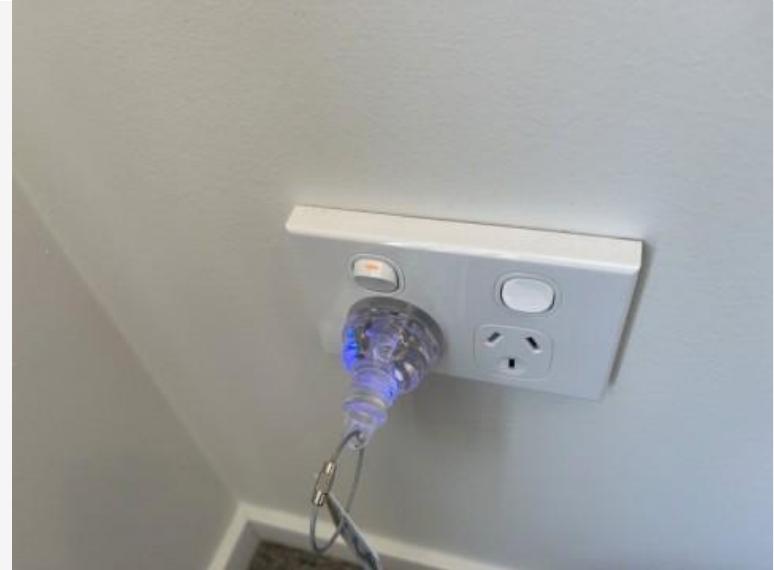
### **Bedroom 3.**

Lights and accessible power points tested; no exceptions noted at time of inspection.

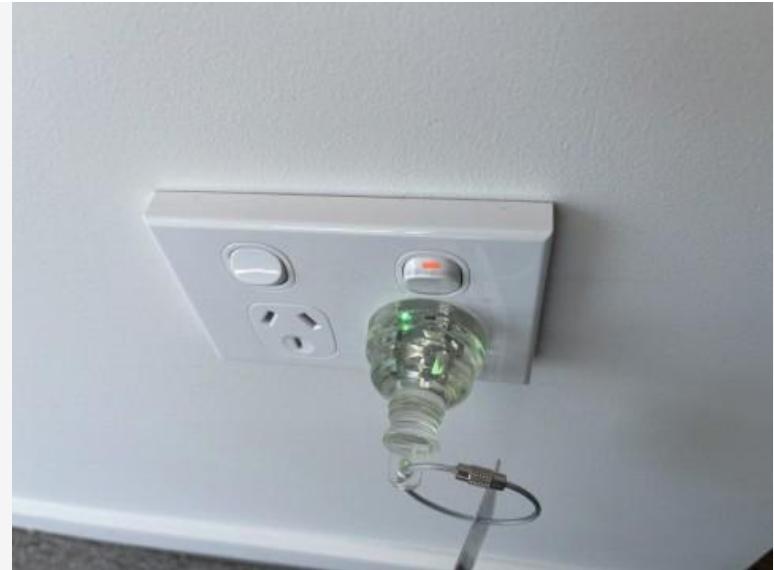
### **Bedroom 4.**

Lights and accessible power points tested; no exceptions noted at time of inspection.

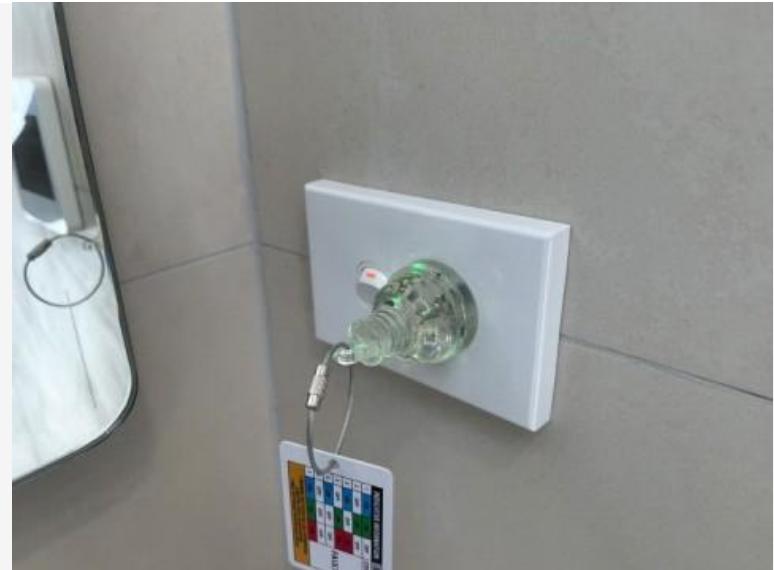
### **Bathroom 1.**

Lights and accessible power points tested; no exceptions noted at time of inspection.

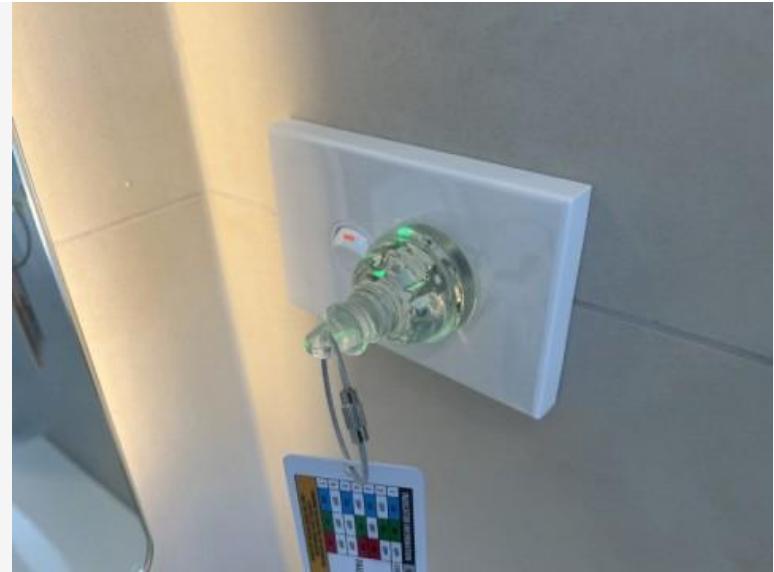
### **Bathroom 2.**

Lights and accessible power points tested; no exceptions noted at time of inspection.

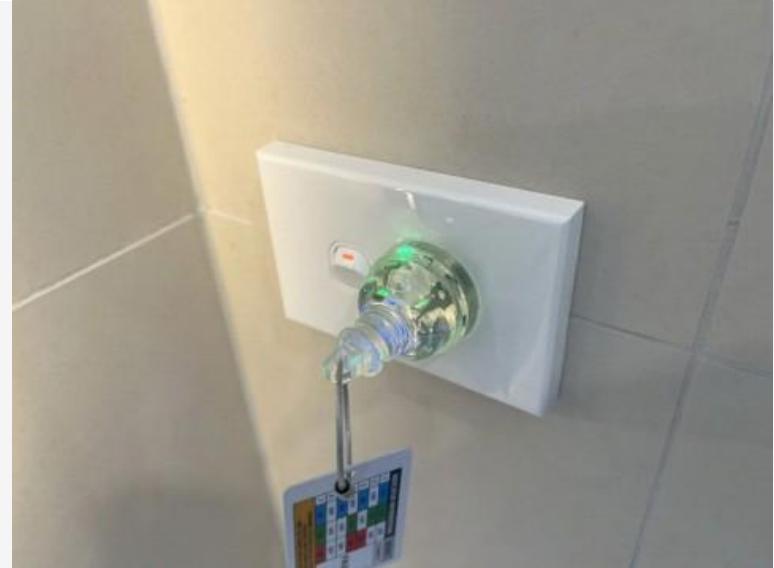
### **Bathroom 3.**

Lights and accessible power points tested; no exceptions noted at time of inspection.

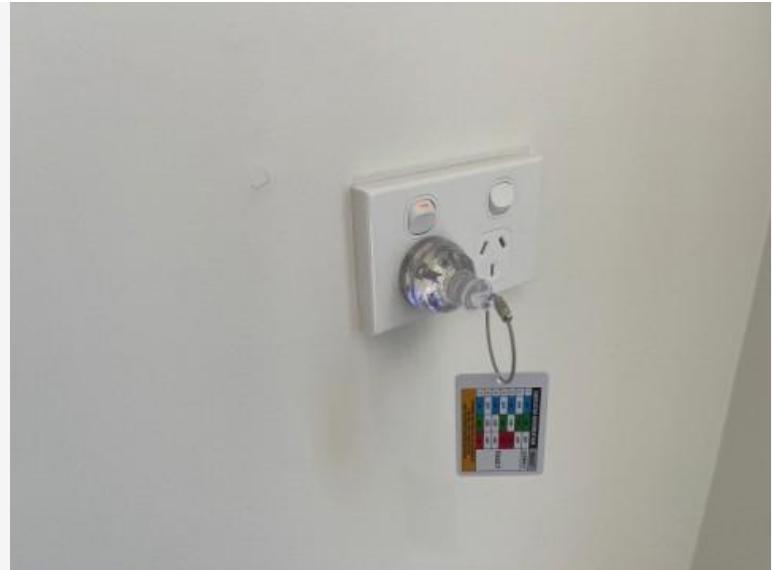
Lights and accessible power points tested; no exceptions noted at time of inspection.

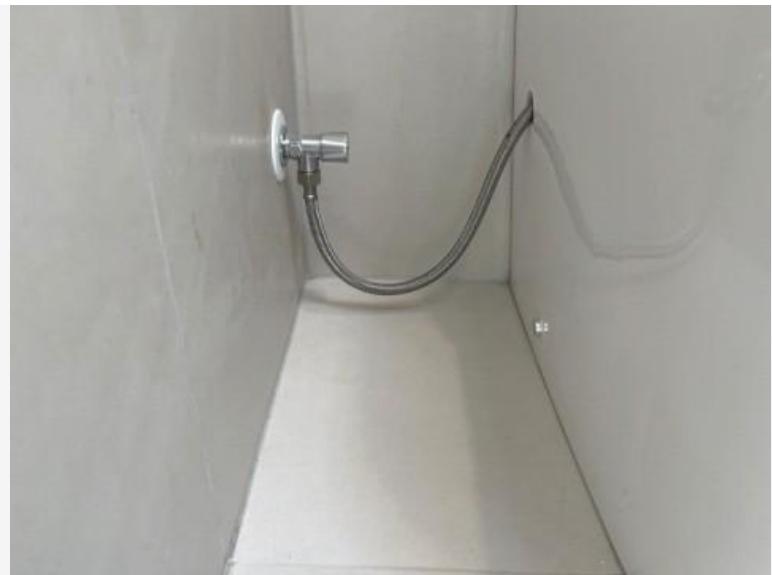
#### **Bathroom 1.**

Braided wire.

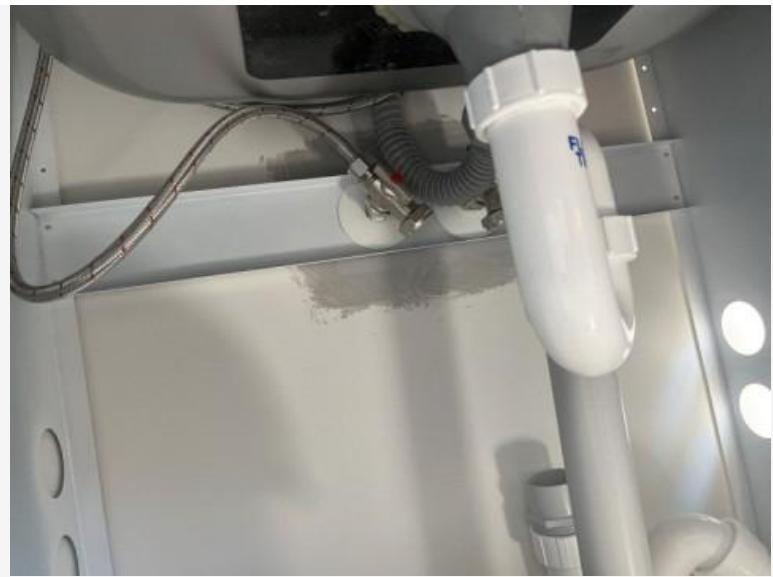
Braided wire. Plastic.

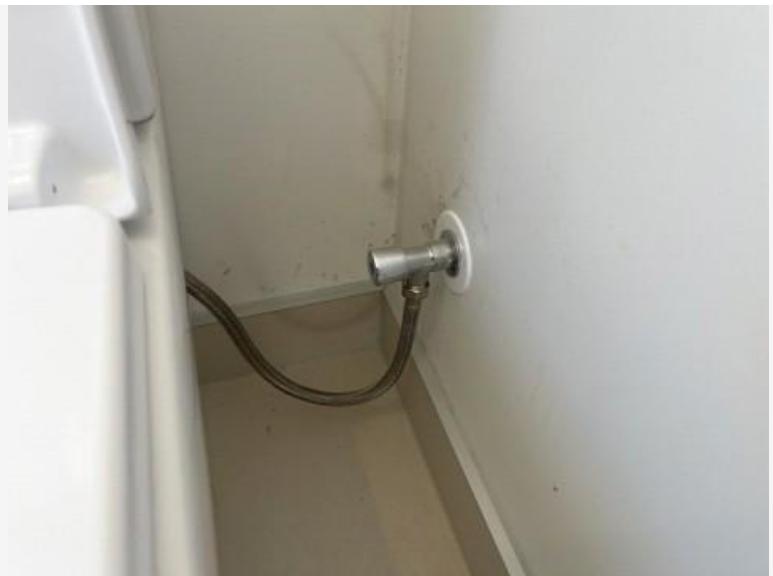
Braided wire.

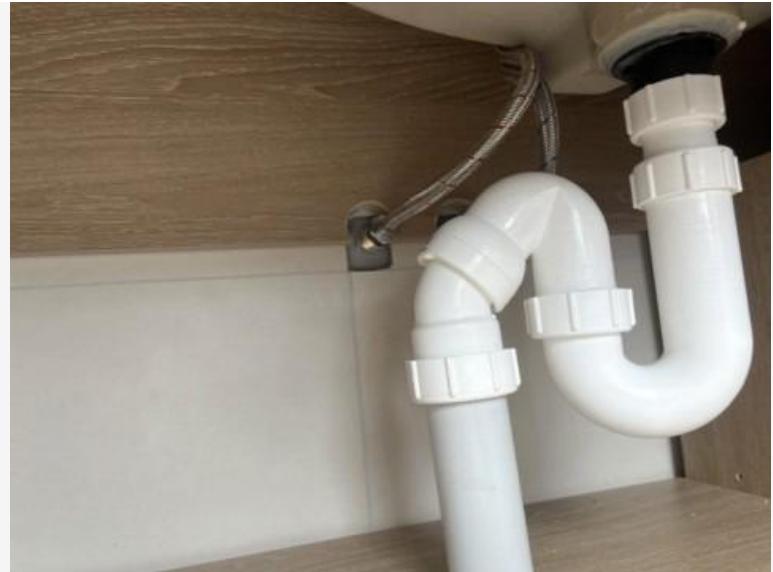
**Bathroom 1.**

Braided wire. Plastic.

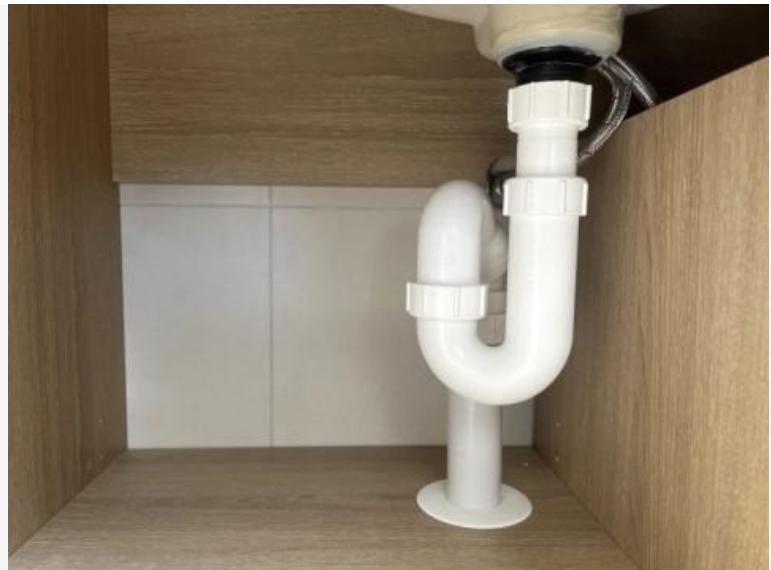
### **Bathroom 2.**

Braided wire. Copper.
